Penn State Altoona

Campus Exterior Architectural Plan
September 2008

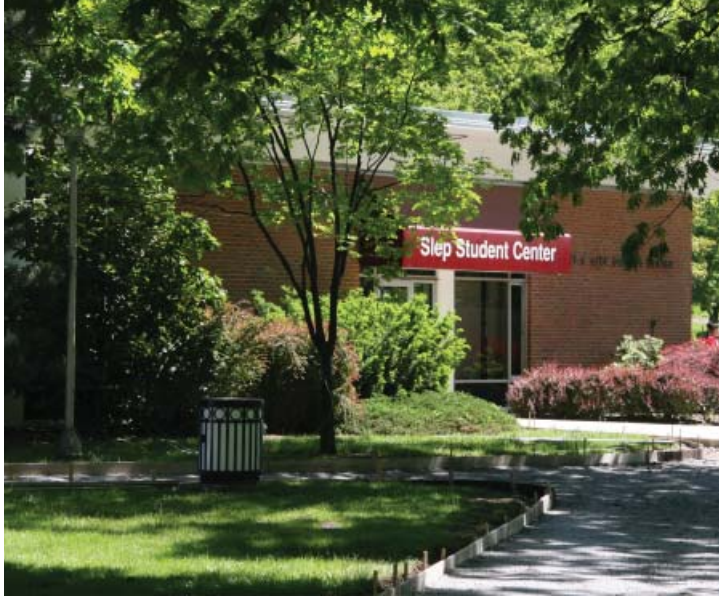
1A Awning Removal

The awning over the entrance to the Slep Student Center should be removed and standard University sign guidelines should be followed to identify the building.

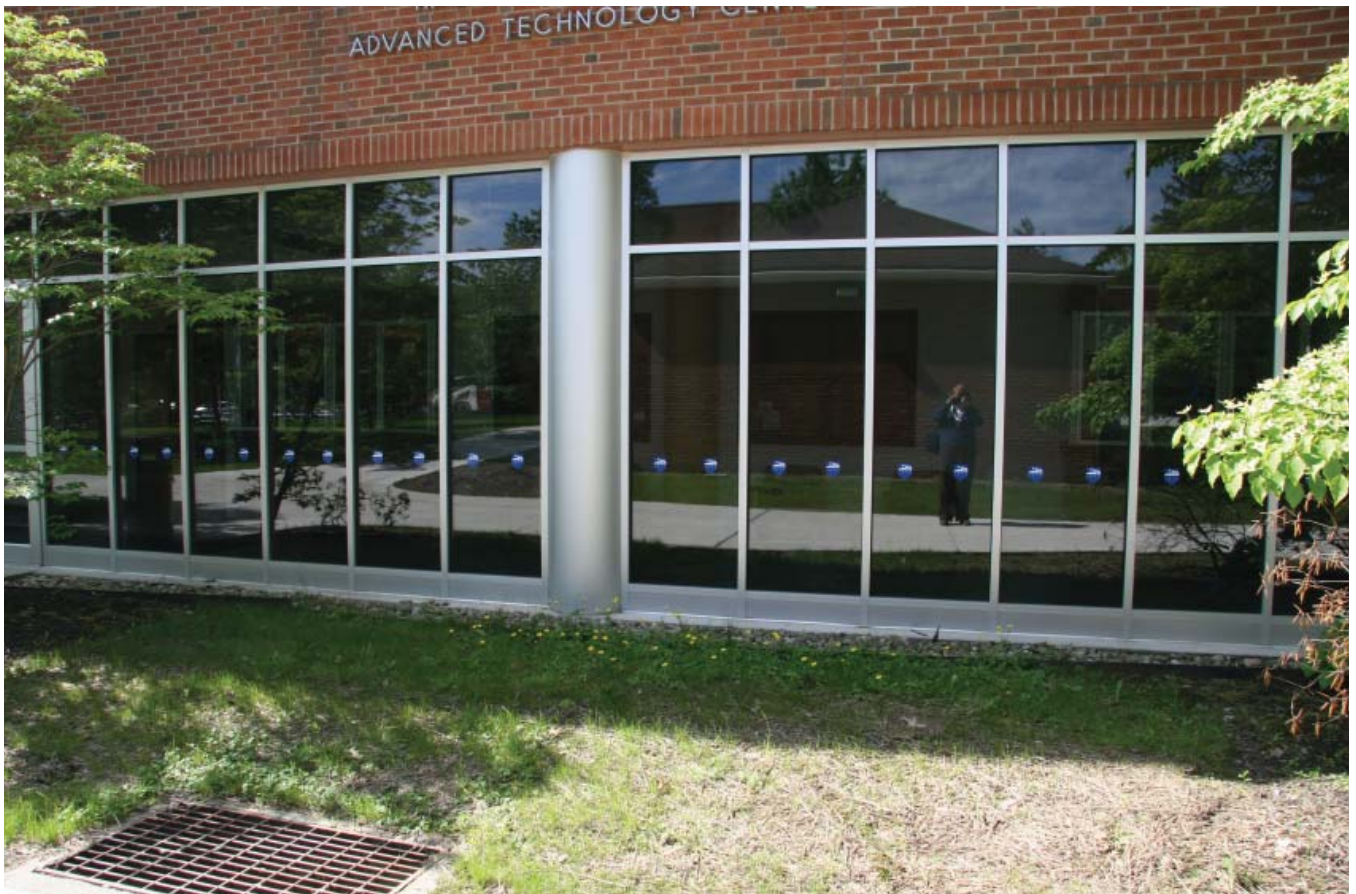
1B Window Stickers

The logo stickers on the windows of the Ralph and Helen Force Advanced Technology Center are used excessively without relevant need.

The ubiquitous presence of the mark diminishes its relevance as an identifier of Penn State. In addition, some of the appliques are peeling from the glass surface.

Decals should be removed from the windows.

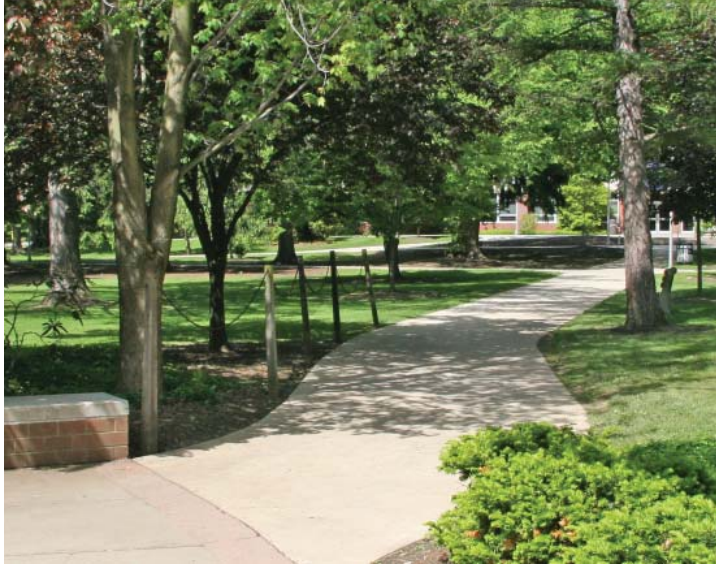
2c

Post and chain should be used sparingly to discourage pedestrian movement through planting areas. There are some areas on campus where existing post and chain do not appear to be serving a purpose and may, therefore, be removed.

Where post and chain is absolutely necessary, the University standard should be phased in.

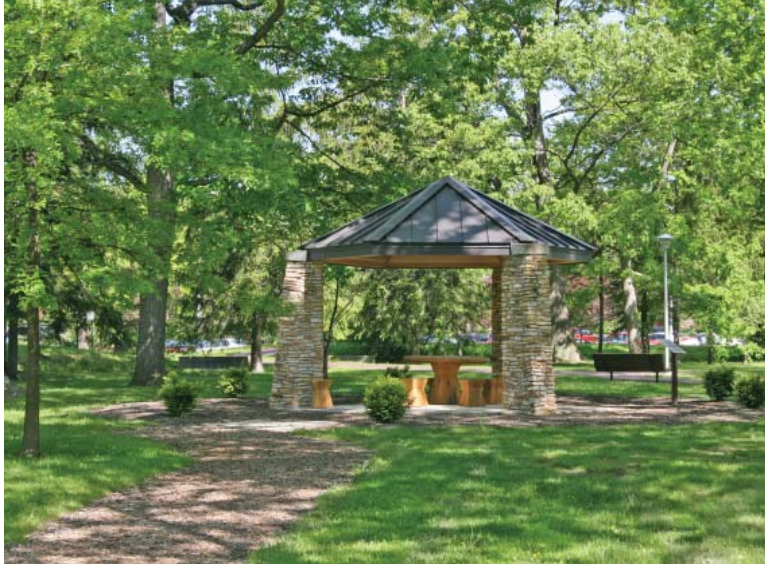
4A Christodoulos Gazebo

The gazebo occupies a prominent spot next to the east parking lot entrance to campus. Landscape plantings are sparse surrounding the gazebo and the wood chip paths leading to it are not universally accessible. A compacted crushed stone path would maintain the rustic character of the context while providing a suitable surface for handicapped users. The Penn State Dirt and Gravel Roads Studies "Trail Mix Specifications" should be used when specifying materials to assure a compact surface:

A naturalistic planting palette that harmonizes with the existing canopy trees would be preferable.

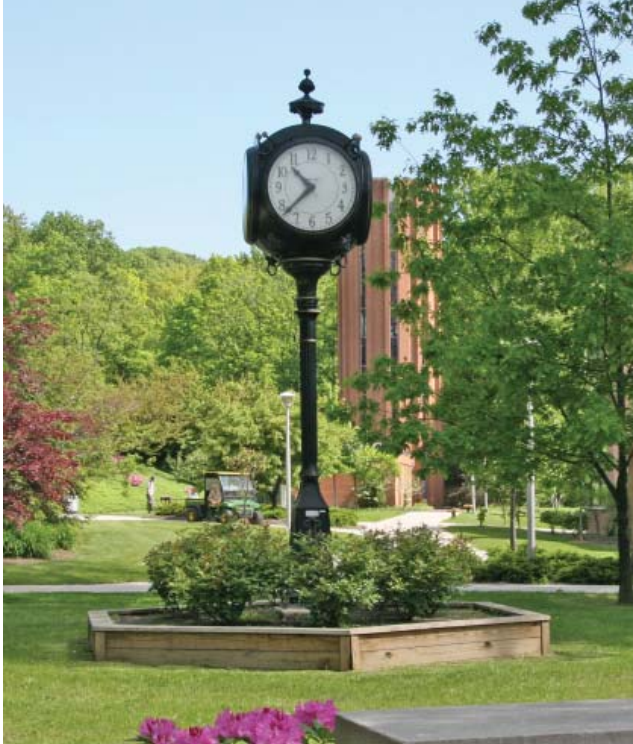
4B Campus Clock

The wooden raised bed at the base of the campus clock between Eiche Library and the Misciagna Performing Arts Center appears residential in character.

Recommend the replacement of the wooden raised wall with supplemental landscape planting.

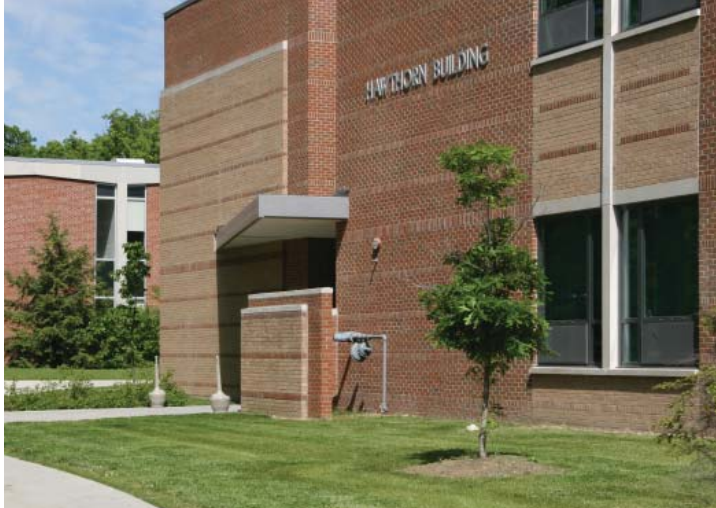
4C Camouflage Meter

The attempt to screen the existing utility meter at the entrance to Hawthorne Building using the masonry walls is unsuccessful from the parking lot approach.

Recommend the installation of evergreen landscape plant materials to complete the needed screen.

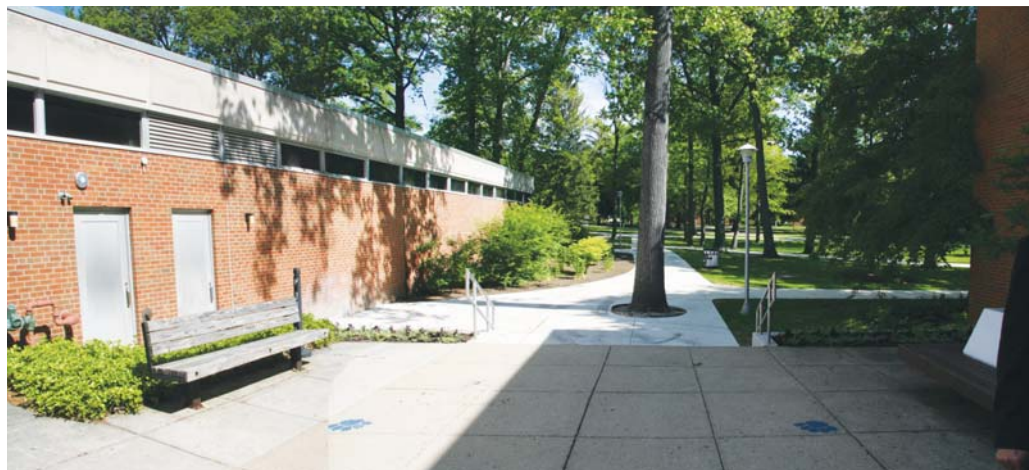
Existing Schneider Plaza

This patio area dedicated to a campus benefactor in 1987 is in need of renovation. The opportunity exists to provide ADA access to the patio and building as well as planting and furnishing upgrades to make the space more attractive and user friendly.

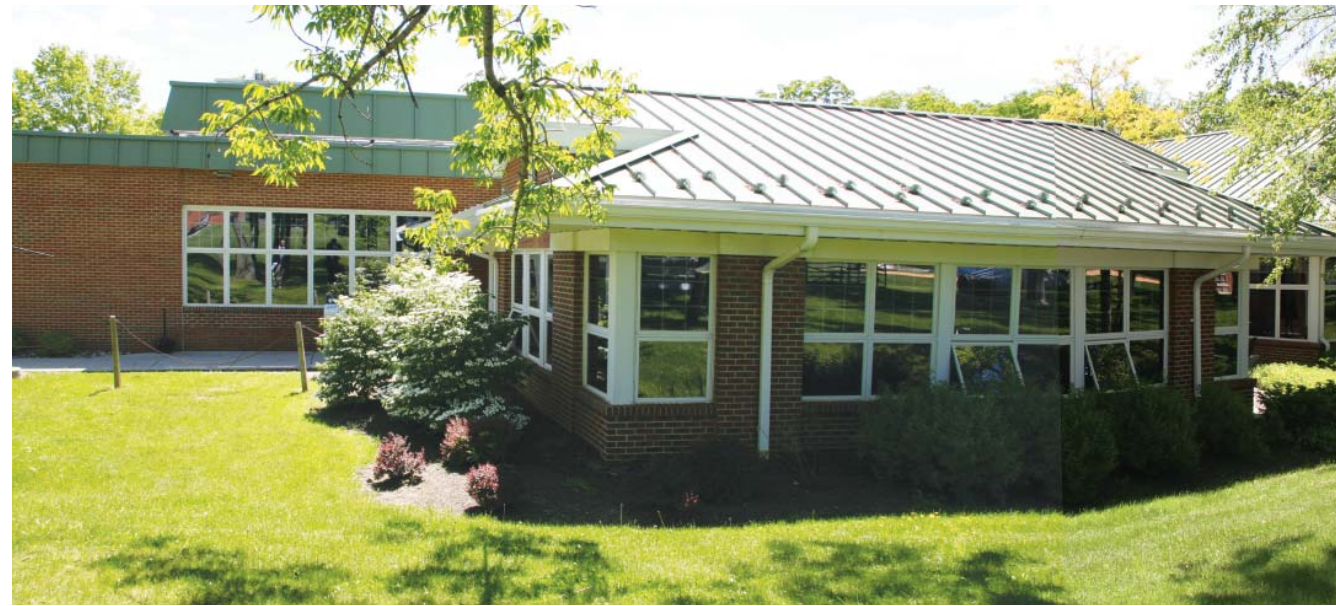
Existing under utilized area at cafe' entrance

The existing outdoor patio at the Port Sky Cafe is too small to serve a campus community of this size. An expansion is recommended as is a sidewalk connection to the existing barbeque pavilion. A new adjoining patio is proposed for the north entrance. Surrounding landscaping would provide shade and enclosure and help to direct pedestrian traffic to sidewalks. The existing post and chain can be removed.

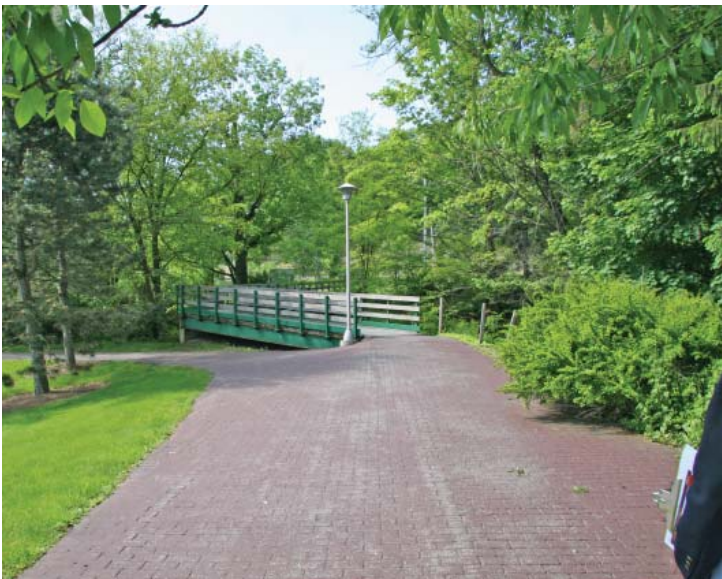
5A

Overabundance of pavement contributes to excess water runoff and solar heat island effect. Green space is more visually pleasing than paved surfaces.

The opportunity exists to reduce pavement. Primary campus walkways should not exceed 10 feet in width. Minor walkways should be 8 feet in width to facilitate snow removal. It is also recommended that stamped and painted asphalt be removed and replaced with concrete.

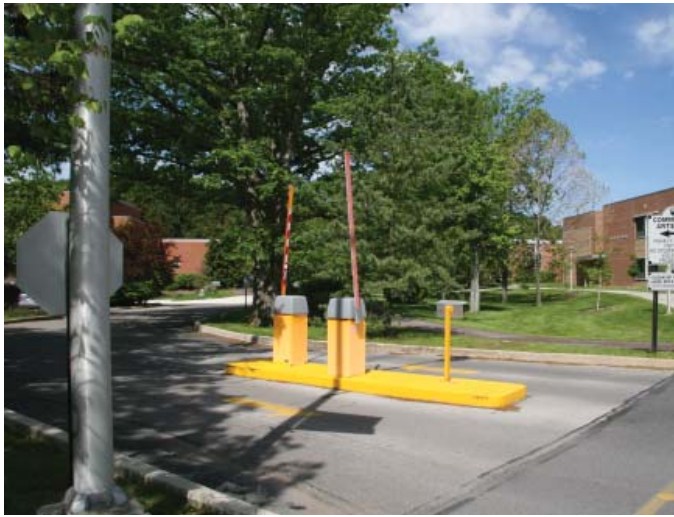
5B Paint / Repair Parking Gates

Penn State wishes to project a student centered and welcoming image to all who visit or use the campus. In lieu of removal and alternative parking control the entrance gates should be tempered by a more subtle paint scheme.

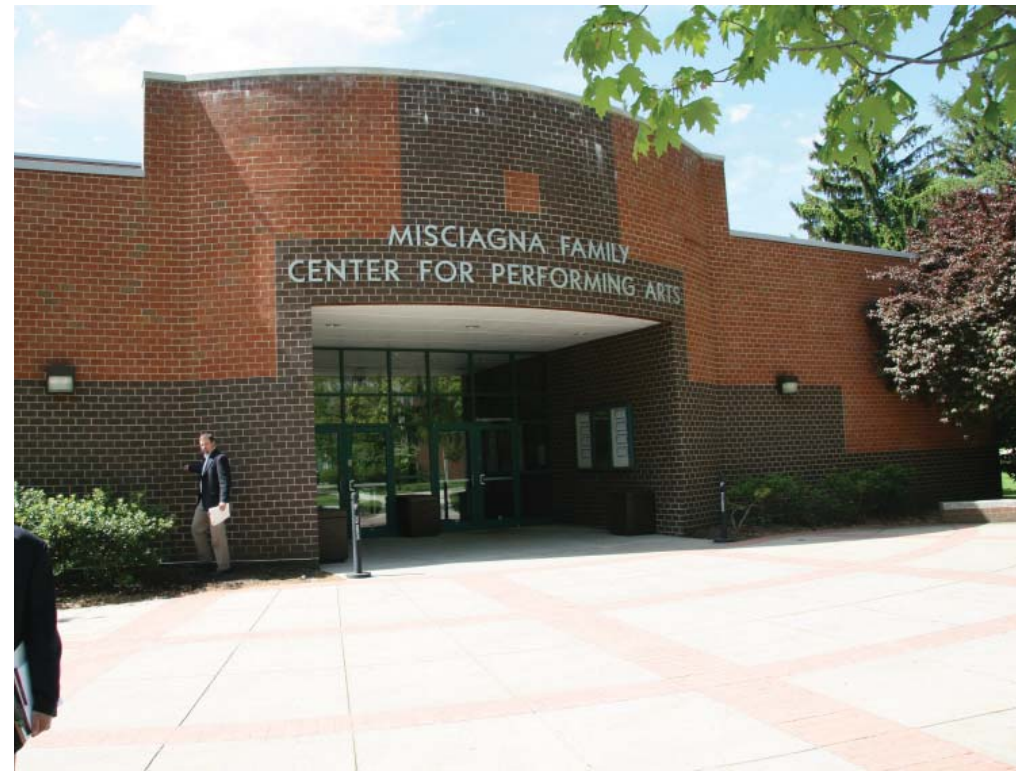
Existing Plaza and Building Sign

The plaza space at the main entrance to the performing arts center is in need of repair and enhancement. This highly visible public space is important to conveying a sense of quality and care to all University users.

The wall capstones and incised masonry sign are deteriorating due to age and possibly vandalism. The shrub plantings surrounding the plaza area would benefit from a renovation. Trash receptacles and ash urns should be replaced with new fixtures consistent with a campus standard.

Signage identifying the building does not comply with University standards. The identification sign should be redesigned to consider the standards and architectural design of the building itself.

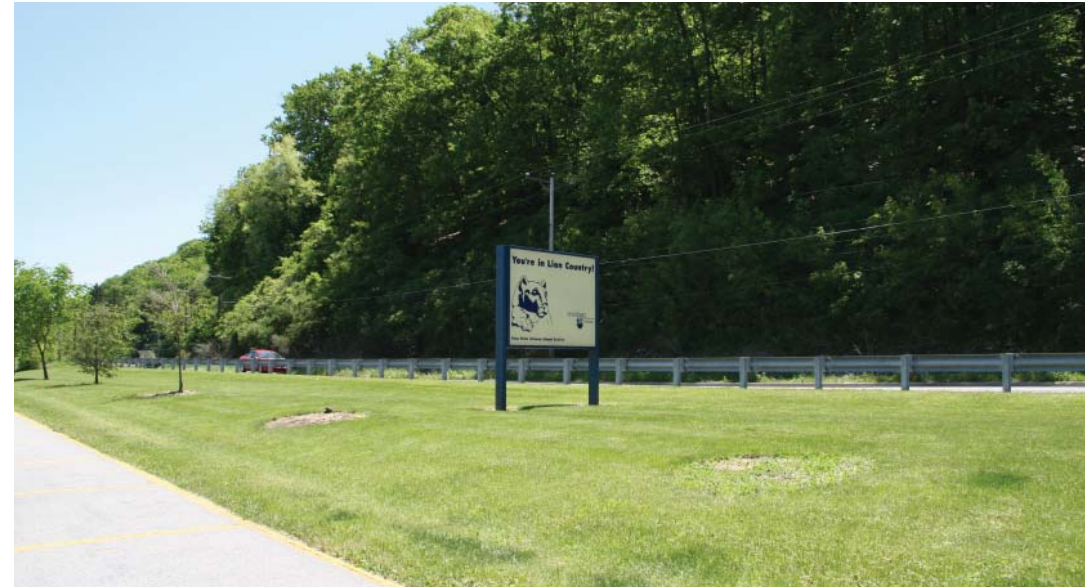
Existing sign at Juniata Gap and Rider Road intersection

An existing panel sign occupies the green space adjacent to Juniata Gap Road at the south west corner of the campus.

Recommend removal of the existing sign and replacement with the University standard for vehicular directional signage at campus perimeter locations. The size, materials and graphics of the proposed sign integrate with other newly implemented signage to create a cohesive visual identity.

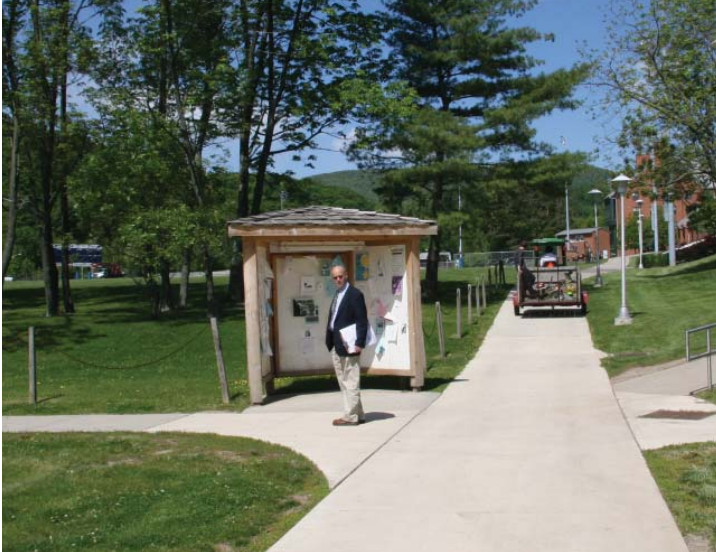
7^A Post Boards

The rustic character of lumber and shingle style exterior post boards is not compatible with the image of quality and permanence of a Penn State campus. Management of content is often irregular or inconsistent.

It is recommended that the existing exterior wooden post boards be removed from campus.

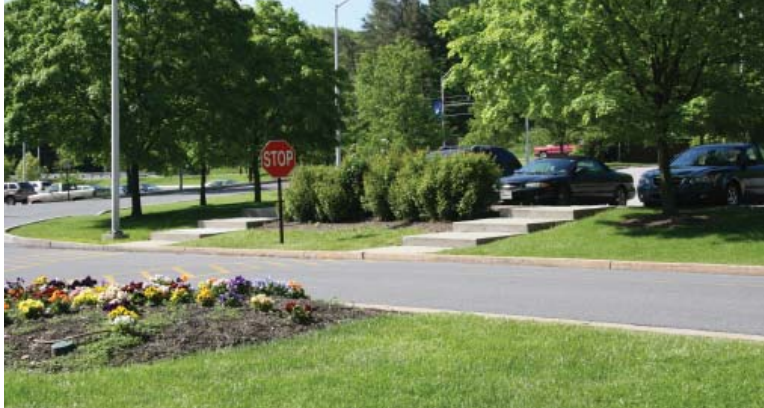
7D Handrail

The existing site steps in the south parking lot next to the main entrance do not have code required handrails in place. It is recommended that this deficiency be corrected.
