Penn State
Erie
The Behrend College

Campus Exterior Architectural Plan
January 2008

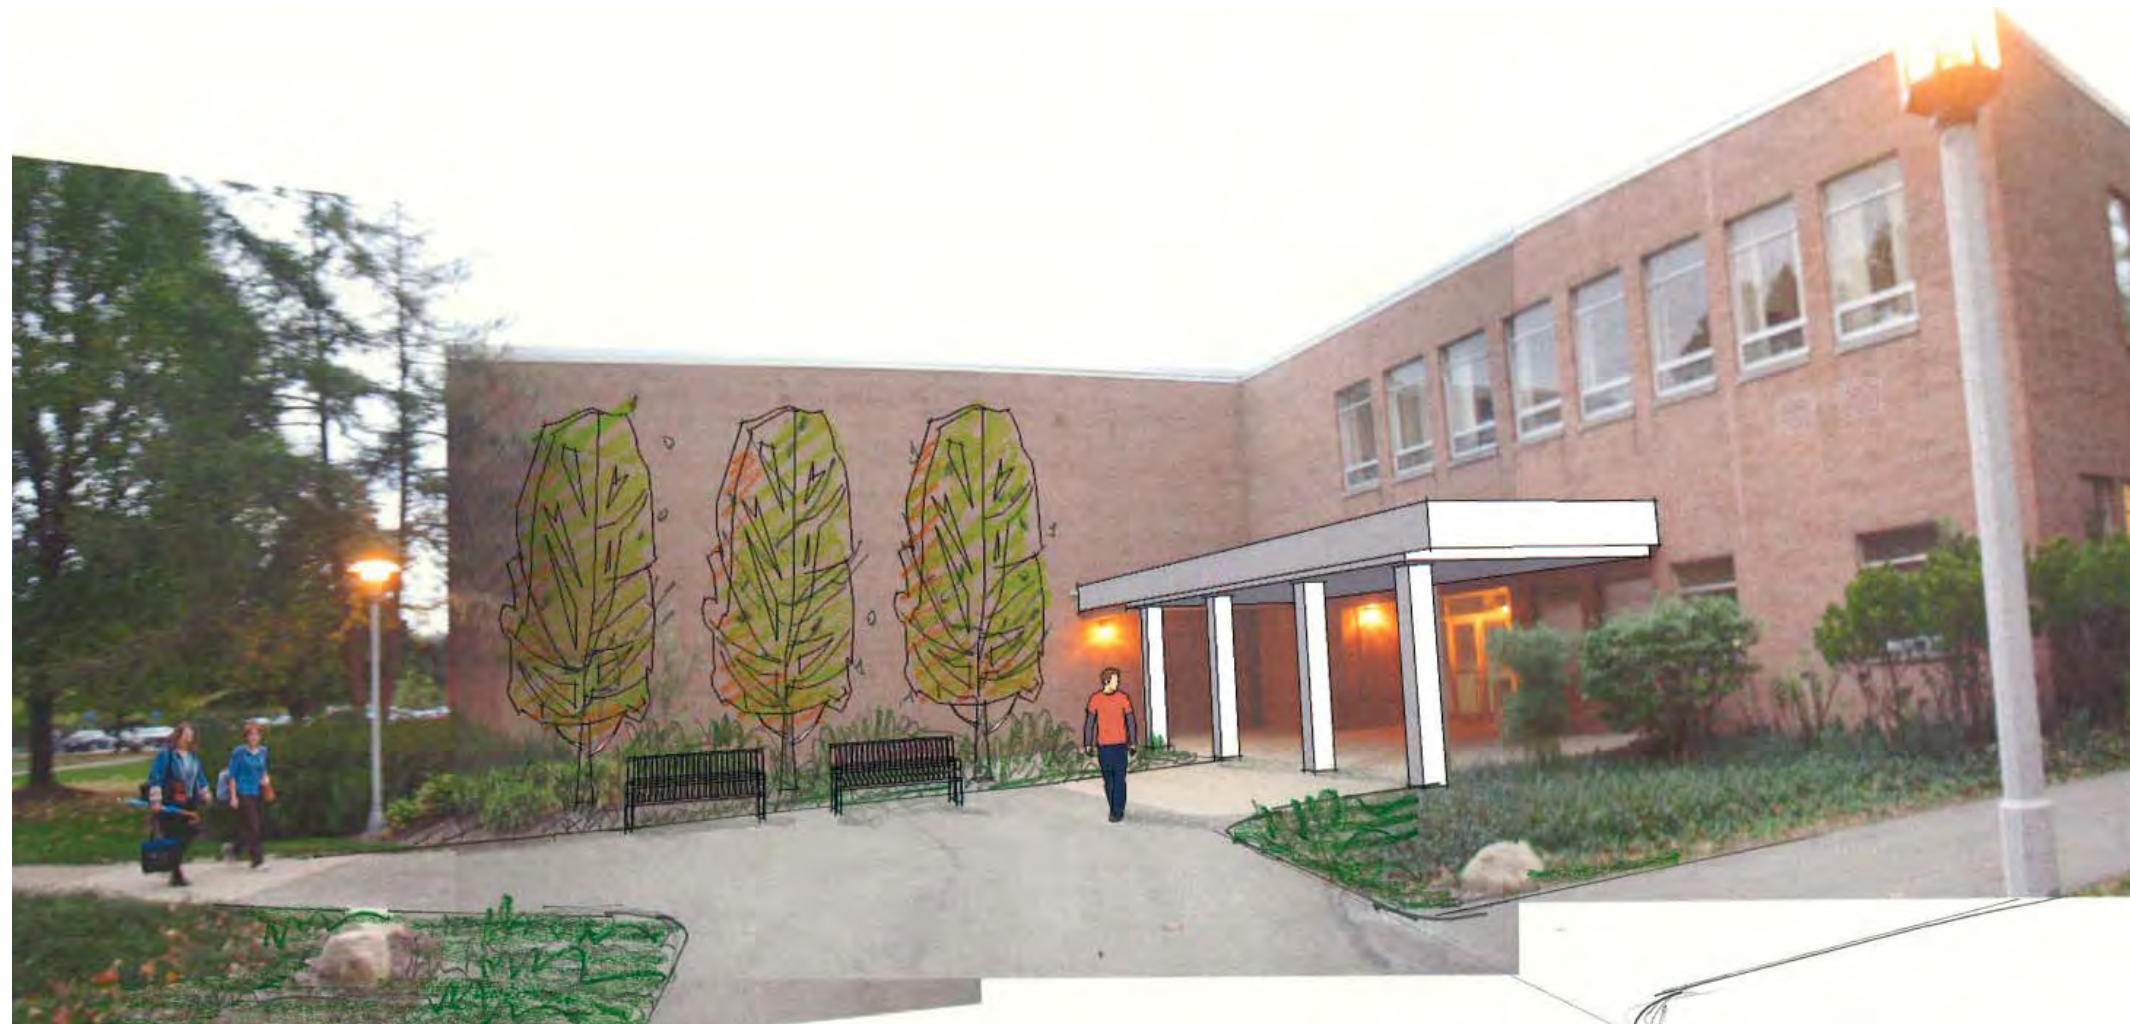
Reed NW Entrance 1a

The northwest entrance to Reed Building is severely austere and does not visually represent the significance of the entrance.

Recommend that the existing roof structure and support posts be modified/enhanced to strengthen the visual character of the entrance.

In addition to the architectural modification, it is recommended that excessive paved areas at the entrance be reduced and landscape planting increased.

The opportunity exists for the placement of site furnishings to support the use.

Site lighting in the area should be upgraded to the campus standard.

Additional signage is also recommended to identify the name and use of the building.

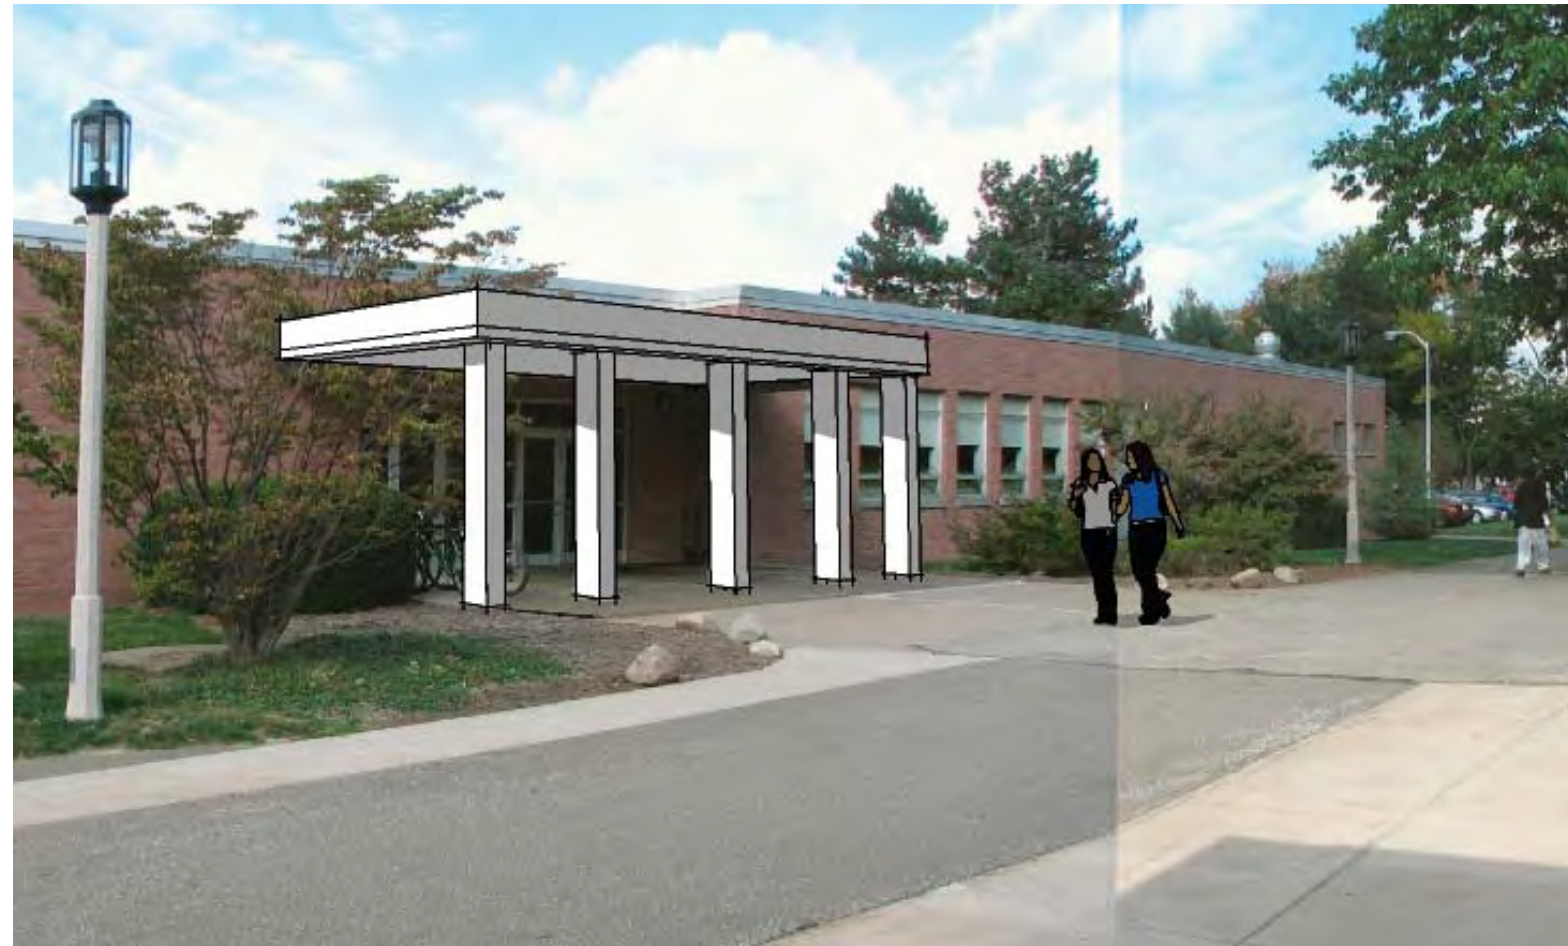
1b

As with the northwest entrance to Reed Building (see 1a), this entrance is also severely austere and does not visually communicate the significance of the entrance.

Recommend that the existing roof structure and support posts be modified/enhanced to strengthen the visual character of the entrance. The design and detail of the modification should be consistent with modifications to the northwest entrance. Design cues may be borrowed from the existing north entrance to the building.

Paved areas at the entrance should be integrated into proposed improvement to the open space adjacent to the building. The opportunity exists to provide seating for outdoor dining (see 2h).

Campus standard site furnishings should be integrated into this heavily trafficed area.

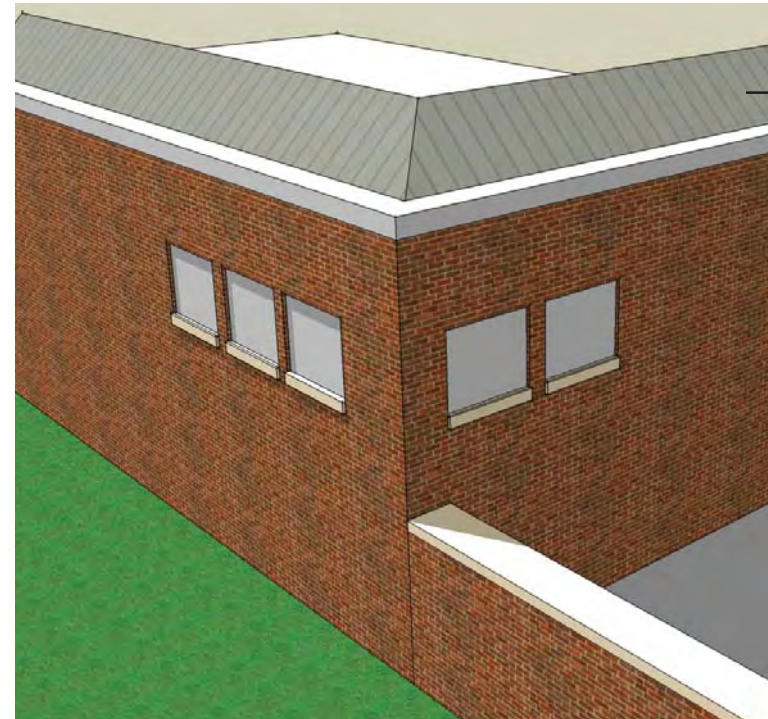
Reed Roof Improvement Recommendation

The roof of Reed Building is visible from many vantage points to the south. The roof is occupied by a variety of unsightly though necessary mechanical and communications infrastructure.

Standing seam metal is a predominant roofing material campus wide. It is recommended that a modified mansard type roof screen be placed at the perimeter of the building to screen unsightly equipment from view.

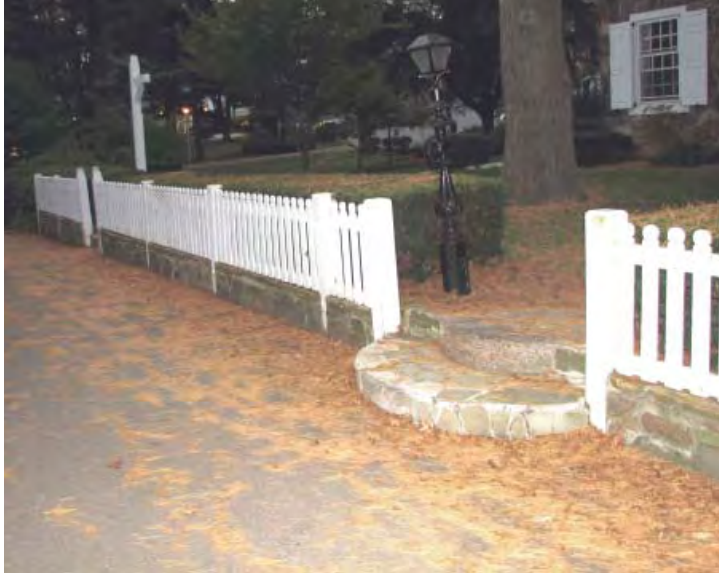
Pavement Reduction 2a

The paved area along the east/west walk/drive is excessive in width. The transition to the Glenhill Farmhouse is abrupt and unceremonious.

It is recommended that pavement be removed adjacent to the existing stone wall to be replaced by a seasonal planting bed of annual flowers.

Stoop thresholds to the walkways at Glenhill Farmhouse should be improved as well.

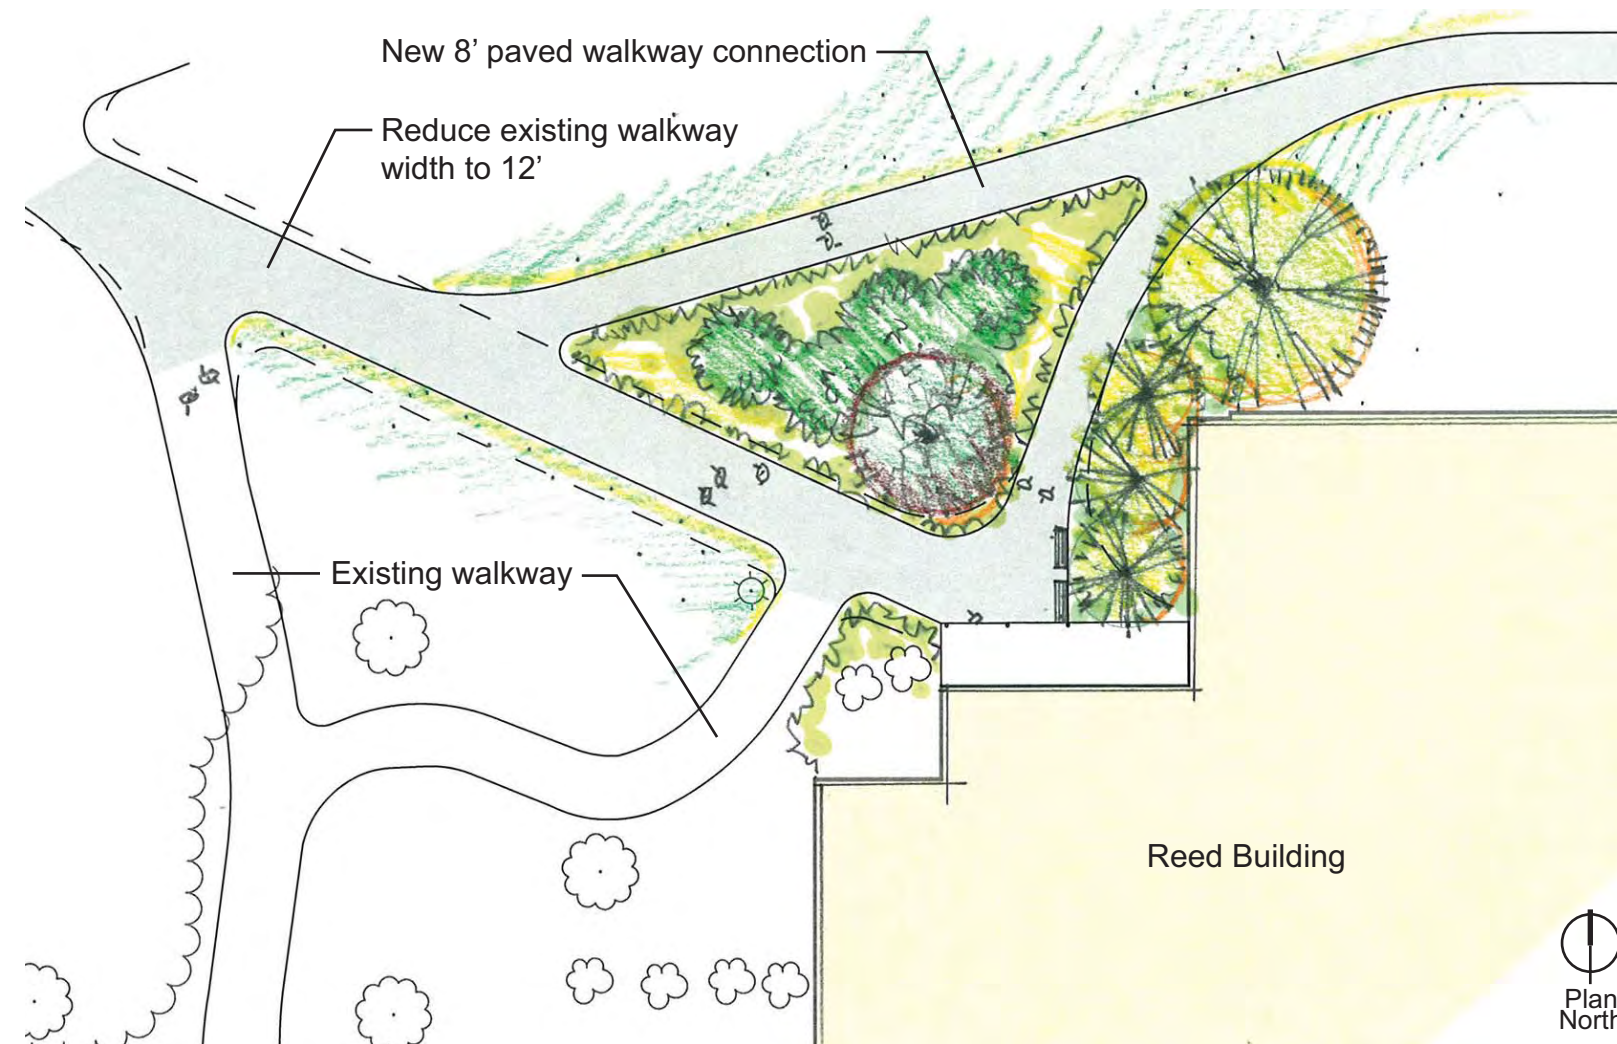
Reed NW Entrance ^{2b}

As indicated in concept recommendation 1a, the walkways and paved areas at the northwest entrance to Reed Building should be reduced to allow for enhanced landscape plantings and give the entrance a more significant aesthetic appeal.

The presence of a long-standing unimproved pedestrian route across the lawn should be remediated by installing a paved surface. The need for additional site lighting along this new segment of walkway should be assessed.

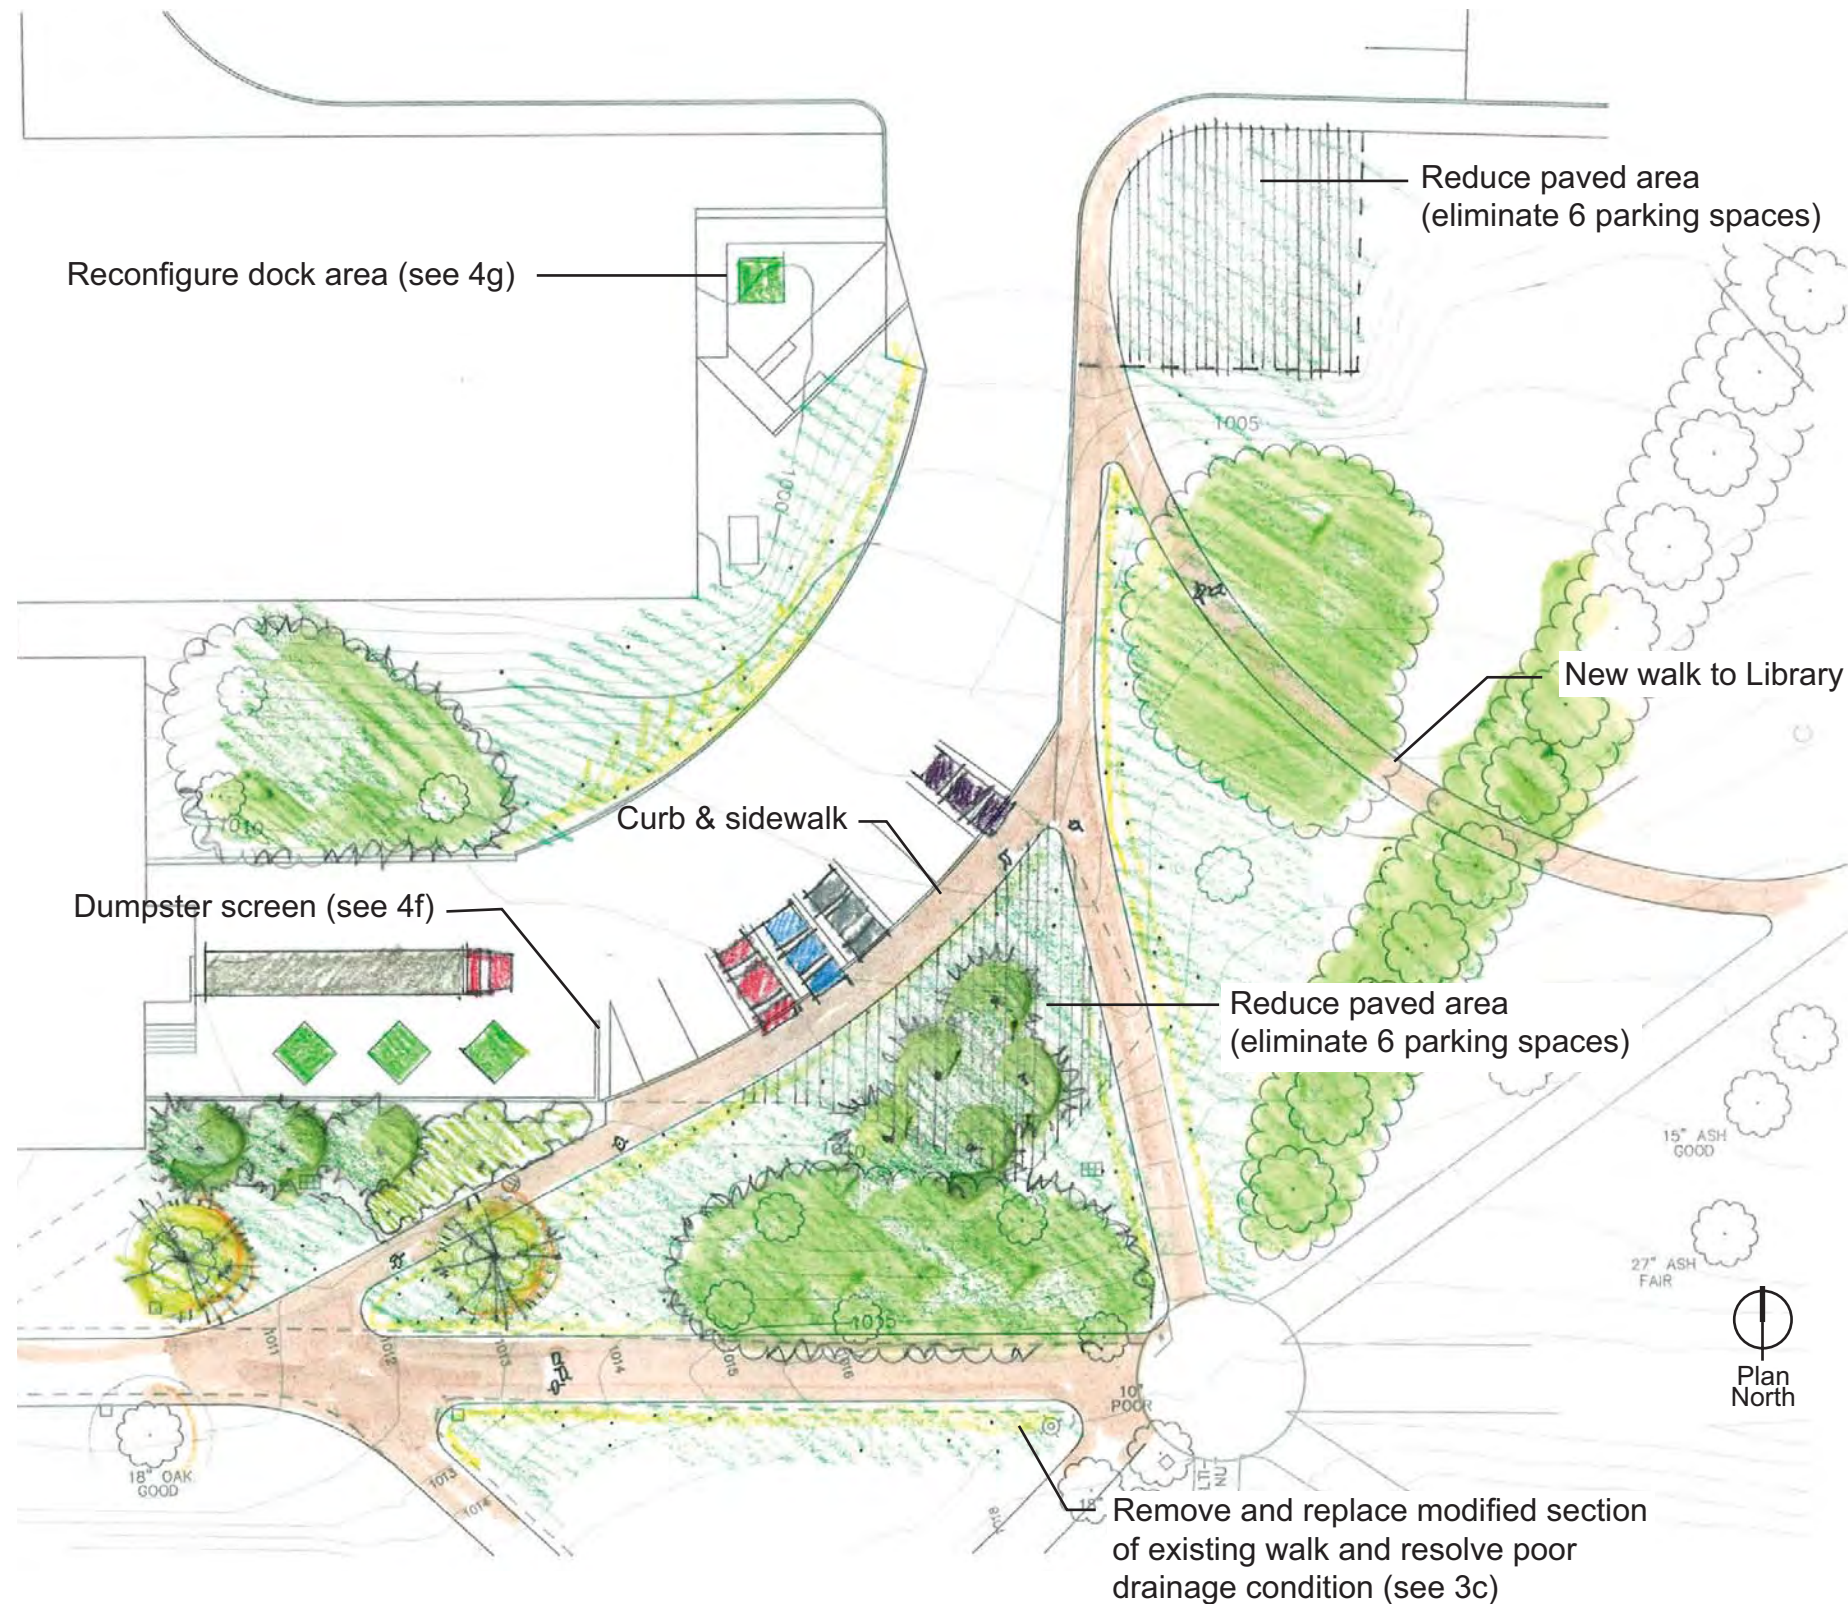
Reed Service Area 2c

This concept diagram illustrates several recommended improvements to the east end of Reed Building.

- Projects include:
- Reduce excess paving and create pedestrian circulation separated from vehicular circulation areas
 - Consolidate and screen loading dock/service area (see 4f for additional recommendation)
 - Reconfigure lift dock at Bookstore (see 4g for additional recommendation)
 - Create new walk to Library.
 - Supplement landscape planting.
 - Replace existing east/west walkway and resolve drainage issues

Note that the proposed reduction in paved areas will result in the loss of 12 existing parking spaces.

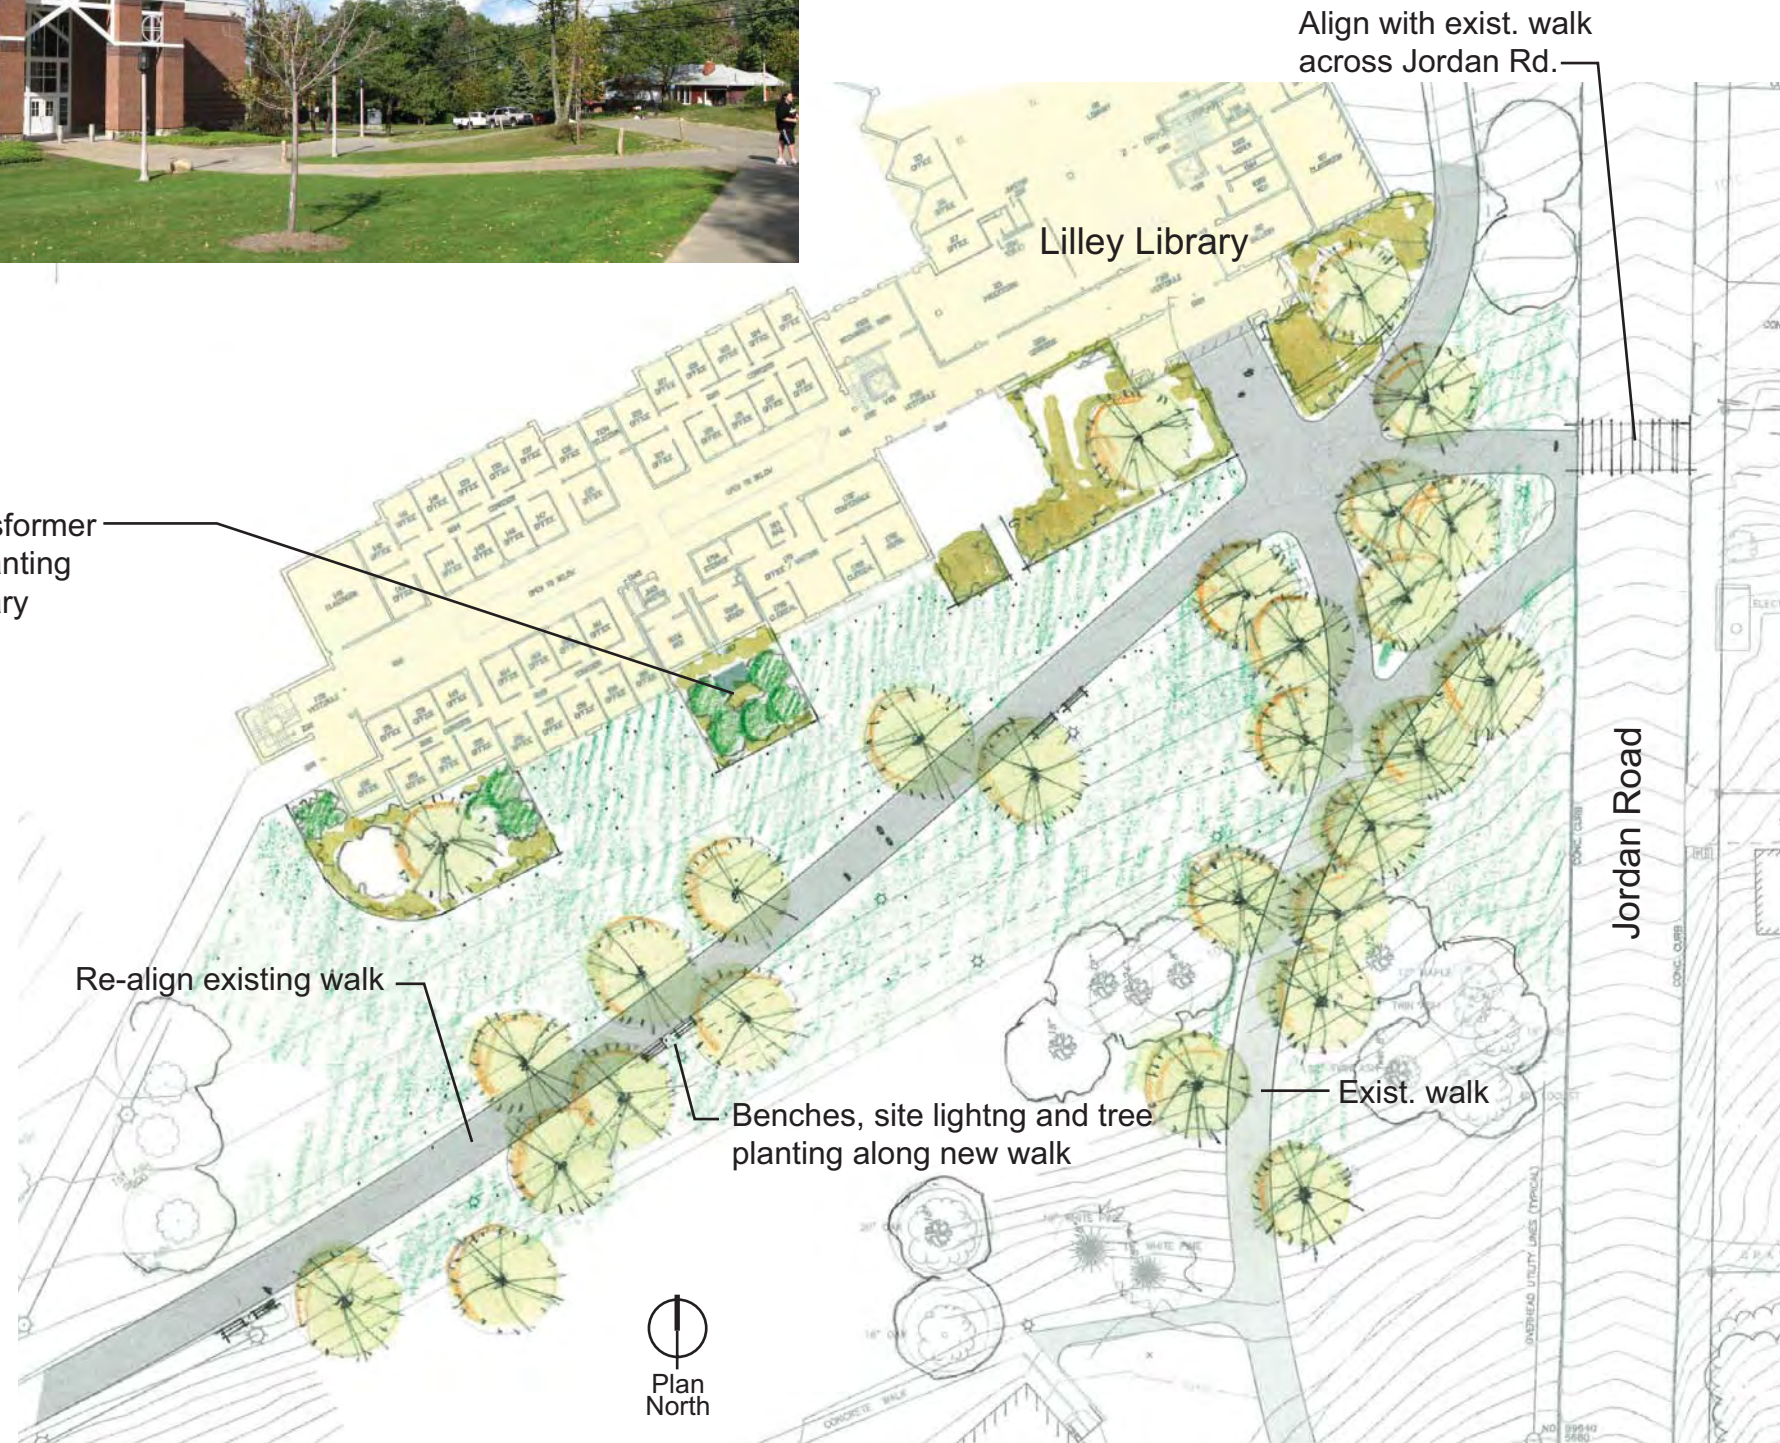
Library Entrance 2d

The existing east/west walkway south of the Library does not align with the newly installed pedestrian walk on the east side of Jordan Road. Present walkway alignments do not promote a fluid movement from one side of campus to the other along this major route.

Recommend the re-alignment of existing walks to eliminate awkward angles. Bollards placed to direct pedestrian movement can be eliminated as a result of the improved flow.

Recommend supplemental landscape planting to enhance the library entrance.

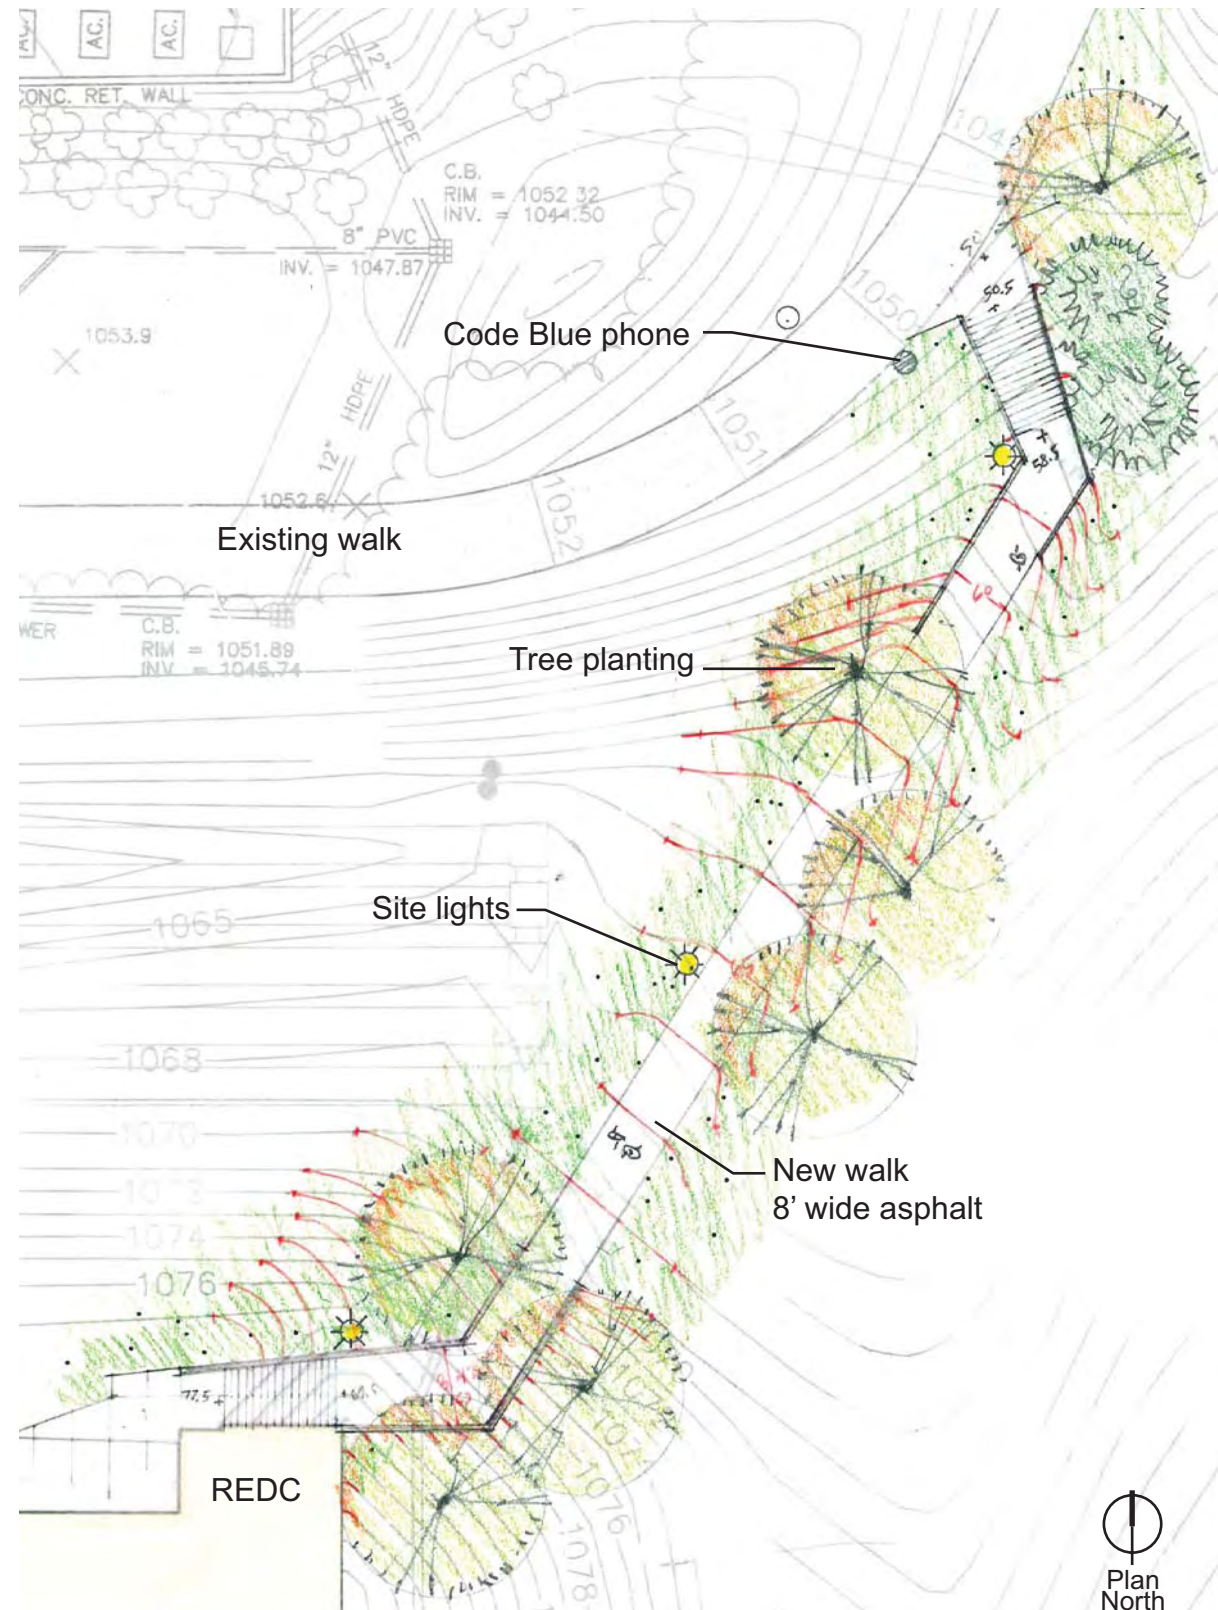
REDC Walk Access 2e

Pedestrian access to and from the REDC in a north south direction is circuitous resulting in the formation of an unimproved path.

Recommend the installation of a walkway and stair system with required site lighting to accommodate the inevitable traffic this route will receive.

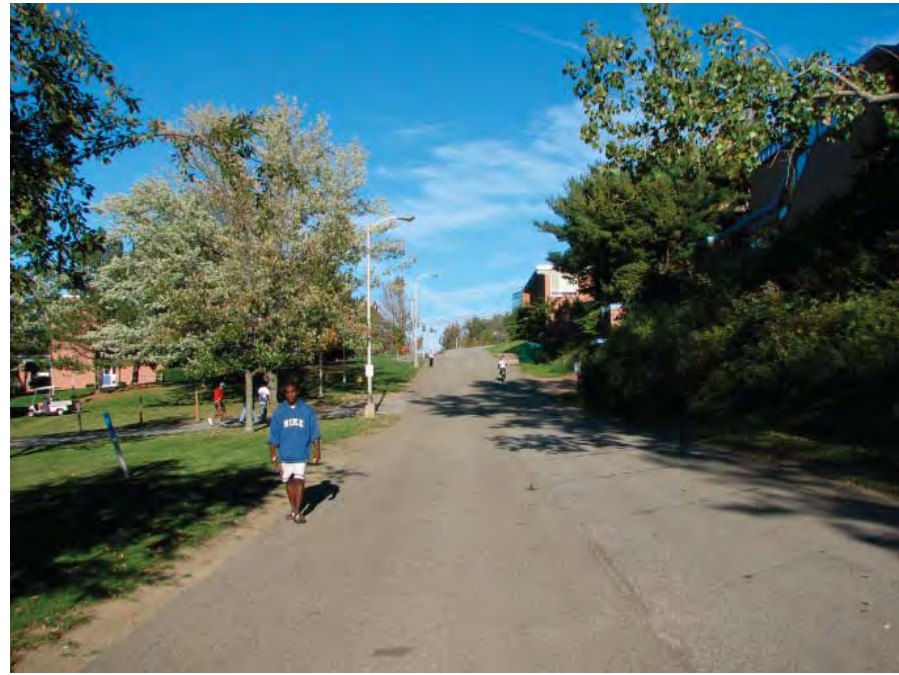
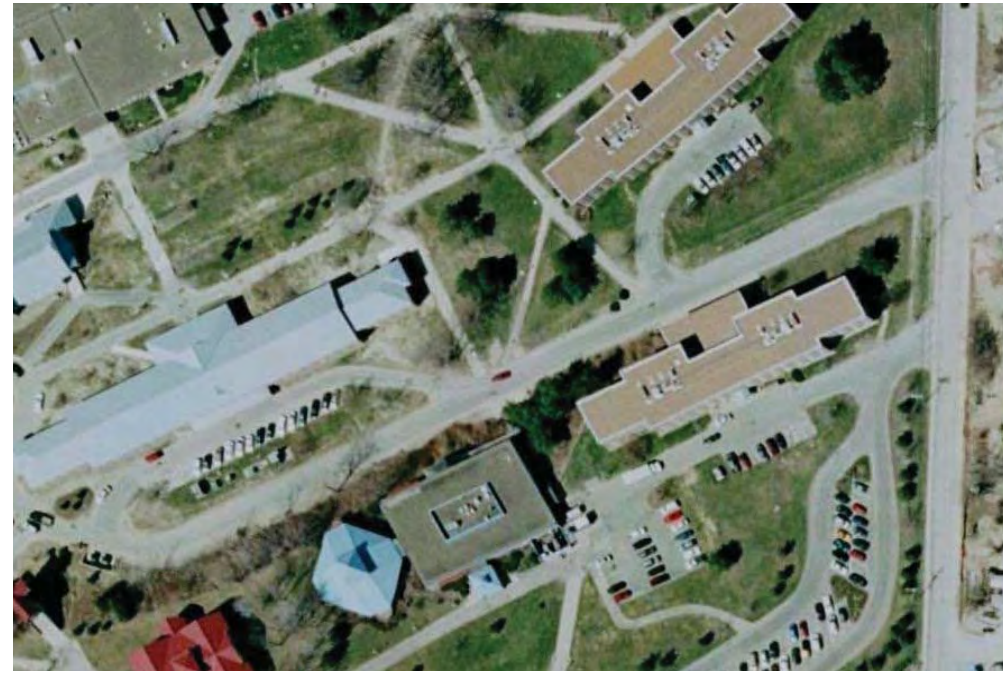
Aquarius Drive Pavement Reduction ^{2f}

Aquarius Drive cartway width is excessive. With the recent installation of parallel walk at Niagra Hall the redundancy is more evident.

Recommend that existing paved area be reduced per the sketch below. New curb and storm inlet relocations will be necessary to manage water run-off. To accommodate pedestrian users, a new section of 8' walk should be placed west of the Niagra Hall parking lot entrance. Lighting along the corridor should be evaluated and supplemented as necessary. Turf ground cover should replace pavement reduction areas. Tree planting along the drive is also recommended.

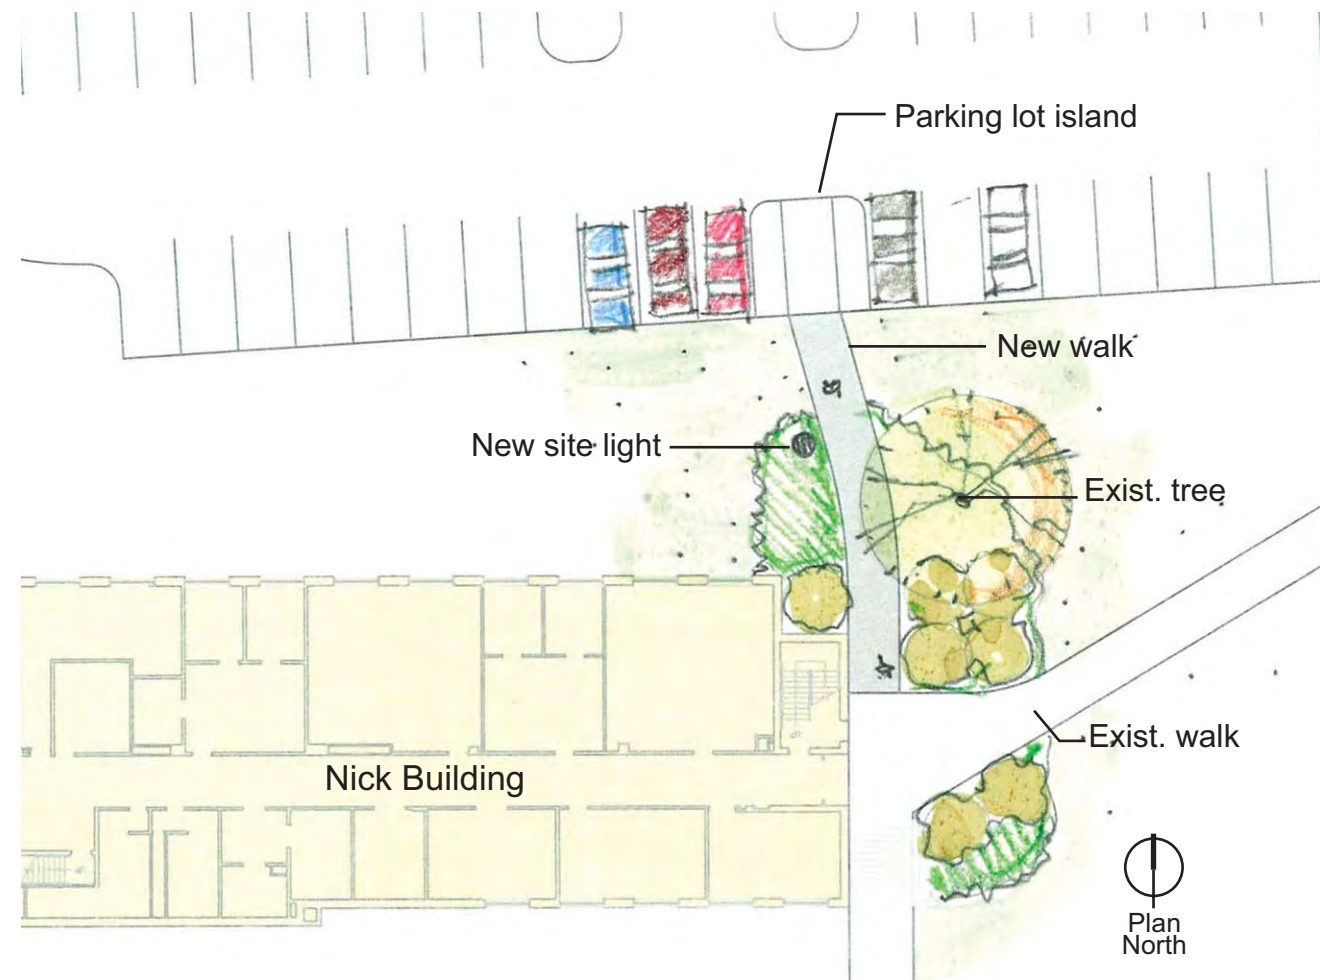
Nick Walk/Stair

The unimproved pedestrian path connecting the east end of the Nick Building with existing commuter parking to the north is a logical and inevitable route. Recommend that a permanent, maintainable surface be installed. A landing area in the parking lot should also be incorporated into the design to signal the walk location from the parking lot side. Additional analysis is needed to determine if gradient of proposed walk is excessive. If it's deemed to be too steep there will be a need for stairs to transition grade.

Additional landscaping and site lighting should be incorporated into the improvement.

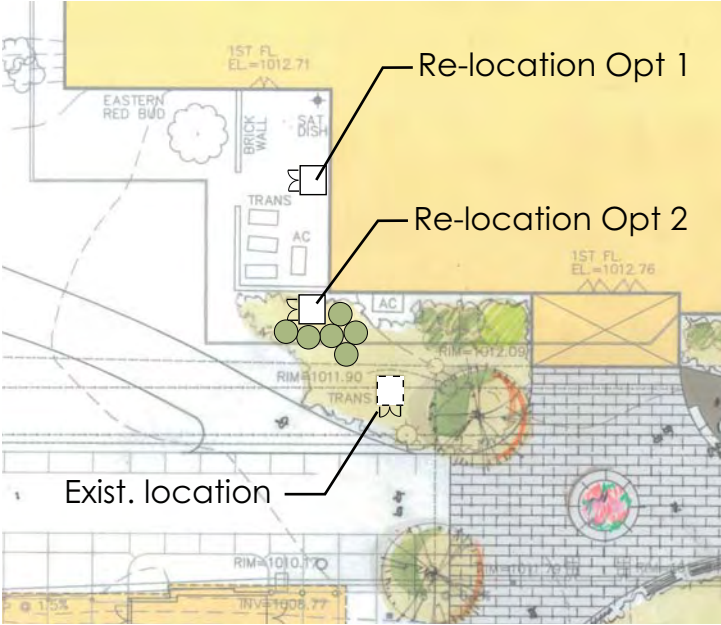
Utility Relocate 3a

The existing electrical transformer adjacent to the south entrance to Reed Building occupies a highly visible location.

Options for mitigating this “ugly” are limited due to the critical utilitarian need for the equipment.

Recommend that the transformer be re-located to a less prominent position and be screened with landscaping.

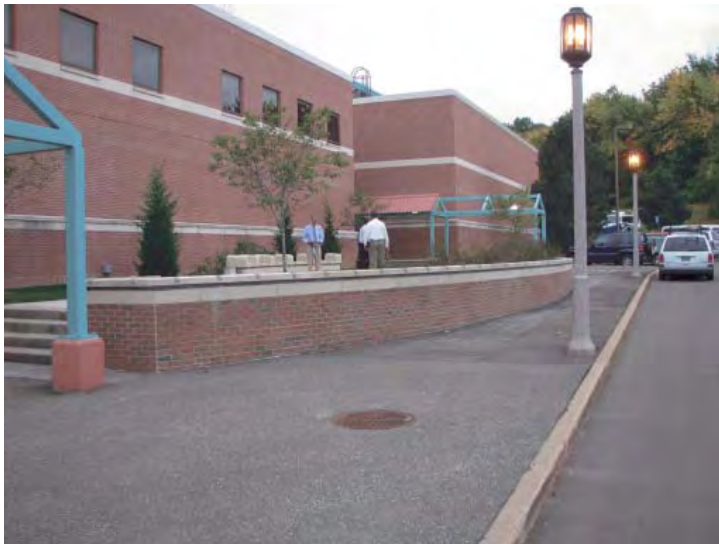
Landscape Improvement ^{3d}

Considerable effort and expense has gone into the existing patio area west of Prischak and Witkowski Buildings. However, the aesthetic quality of the patio area is diminished by the effect of excessive paved surfaces.

Recommend the removal of unnecessary asphalt paving and replacement with lawn and trees.

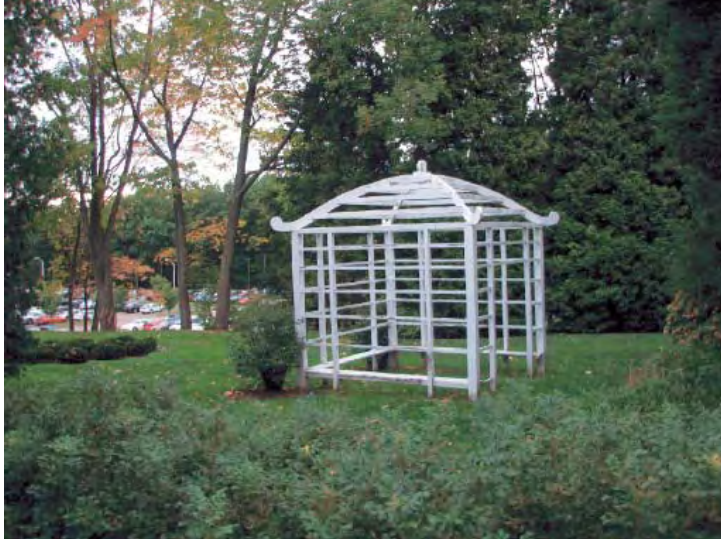
Garden Restoration ^{3e}

Only remnants remain of the manicured gardens that once flourished under the care of Ernst and Mary Behrend. The garden area remains to this day in the historic core of campus.

Recommend that a historic restoration of the gardens be undertaken.

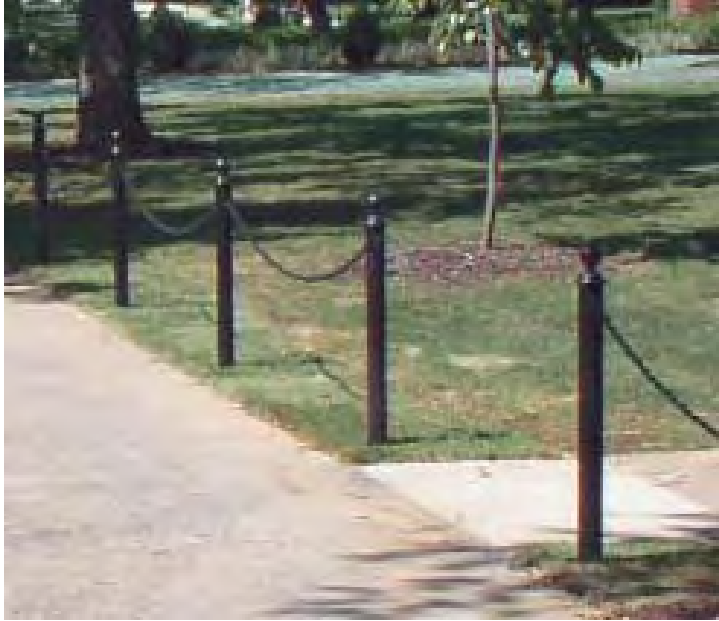
Post & Chain 4b

Bollards and post & chain barriers serve a vital function where traffic must be controlled. However, as with other site furnishings, the aesthetic appeal of this utilitarian necessity need not be sacrificed.

Existing post & chain

Propose the replacement of wooded post & chain with barriers that compliment other furnishings. The barrier(s) should be fabricated from quality, enduring materials.

As a result of changes made to campus circulation over the years, it is recommended that the need for such barriers be carefully evaluated prior to replacement or addition of barriers.

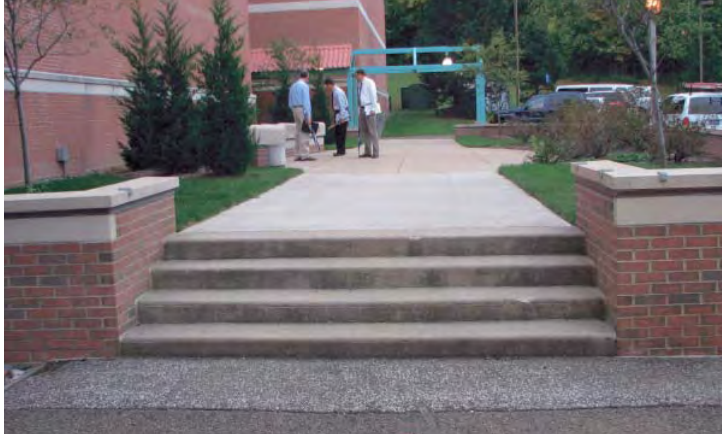
Handrail 4C

The stairs to the patio area west of Prischak and Witkowski Buidling lack the required handrail to be code compliant.

Recommend the installation of ADA compliant railing that's designed to be compatible with other railing systems on campus.

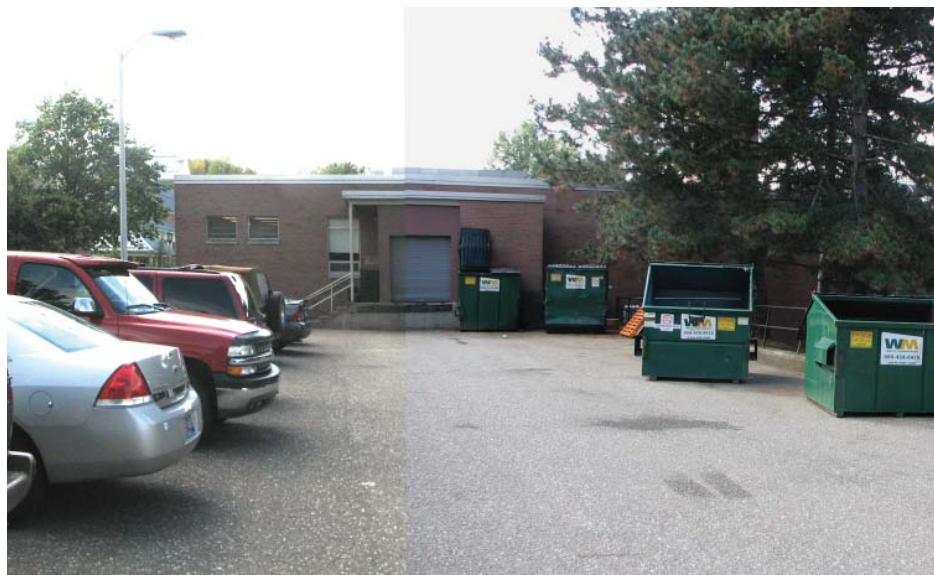
Dumpster Screen 4f

The service dock area on the east end of Reed Building is vital to operations inside the building despite its unsightly nature.

In addition to the recommended reconfiguration of paved areas (see 2c), the utilitarian aesthetic of the area can be mitigated by constructing a screen wall and re-orienting the dumpster location. Precedent for this type of screen exists at two other locations around the perimeter of this building.

This recommendation includes the establishment of a new pedestrian walkway separated from vehicular areas as well as supplemental landscape plantings to soften the appearance of the new masonry wall.

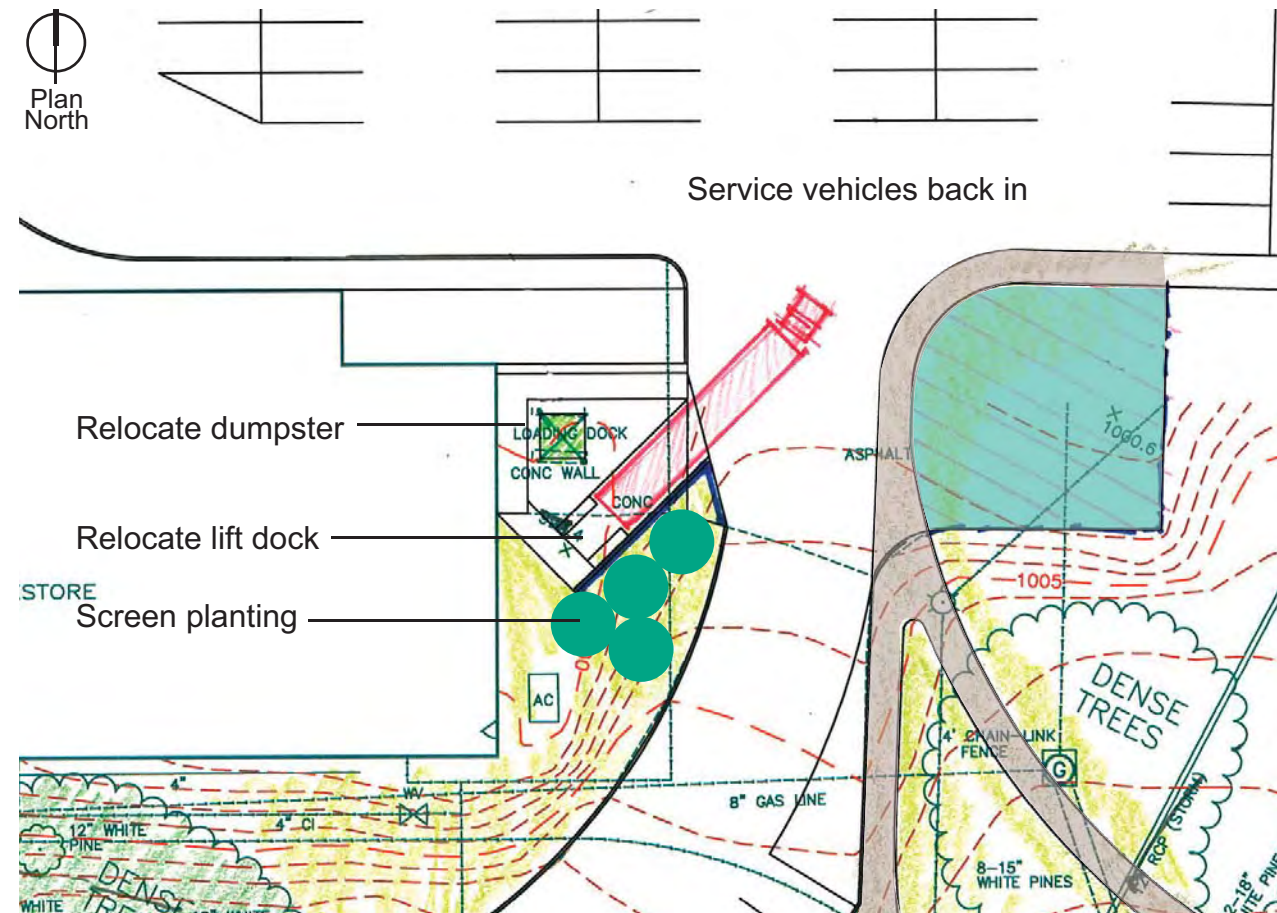
Bookstore Dock 4g

The removal of excess pavement recommended in concept 2c will necessitate modification to the Bookstore loading dock to make it accessible to delivery vehicles.

This recommendation proposes relocation of the existing lift dock to accommodate a backing maneuver by delivery trucks at an angle from the existing parking and driveway north of Reed Building. This shift will also enable the relocation of the trash dumpster to the inside corner of the enclosure effectively screening it from view. Strategic placement of vegetative screening on the south side of the reconfigured dock area will screen the view from the north.

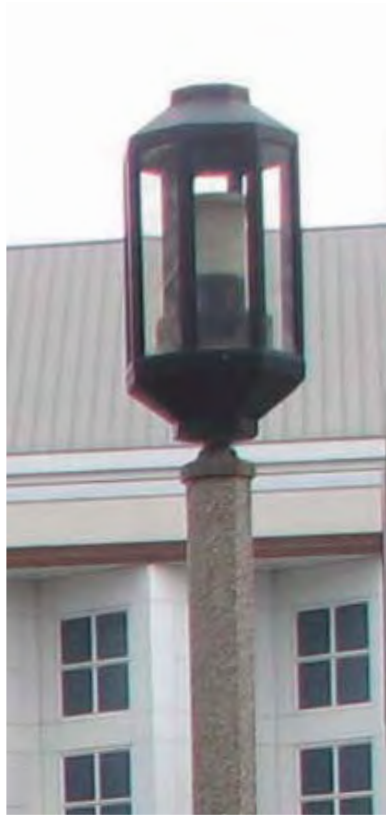
Site Lights ^{4h}

Existing site lights at the campus are stylistically uniform and most are in good working order.

However, the type of luminaire does not provide a cut-off refractor to prevent light pollution and excess glare.

If and when the manufacturer produces a retrofit that will provide cut-off illumination it is recommended that the existing fixtures on campus be modified. Metal halide lamping is also advised due to the quality of the light produced.
