# Fayette

The Eberly Campus

Campus Exterior Architectural Plan

Penn State Office of Physical Plant | August 2017

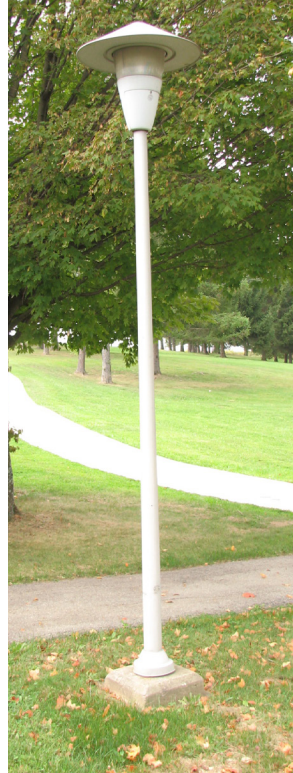
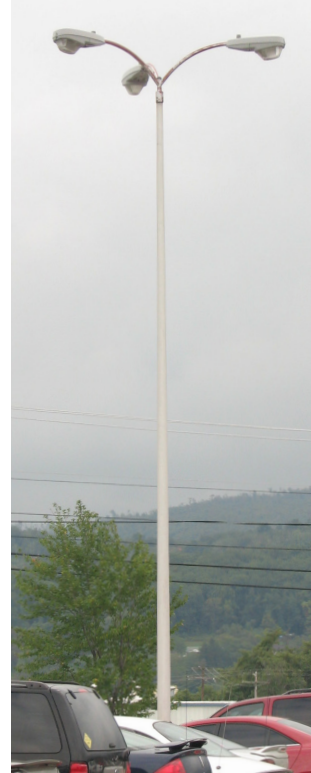
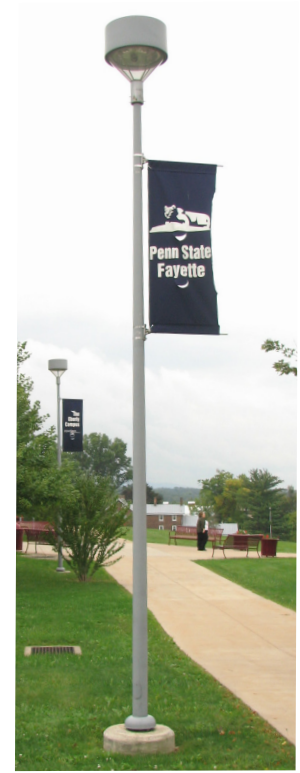
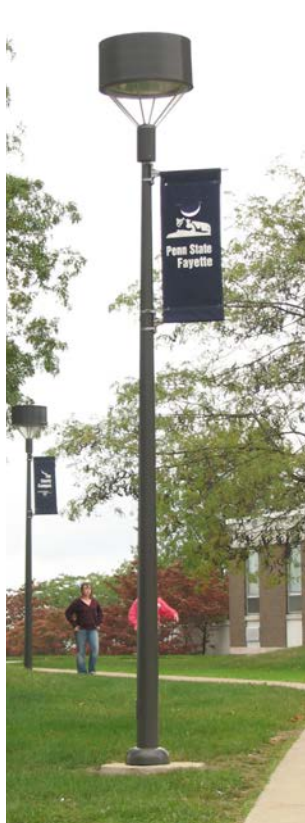
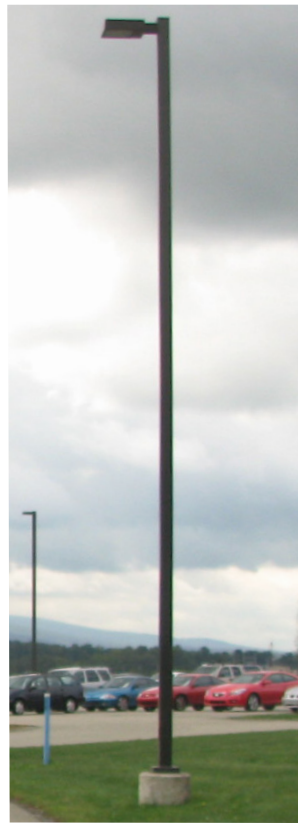
Lighting fixtures remain antiquated and there is no established standard. Five different types of fixtures are found throughout campus. This project has already been undertaken by the campus and is currently in progress.

These two fixtures (left) are the most attractive of the fixtures found throughout the campus and are the same color. Update all light fixtures to modern, LED lights; however, retrofitting these lights already in place (left) with LEDs may be a cost effective option. That being said, the other light fixtures (above), must be replaced entirely to match the new campus standard that will be established.

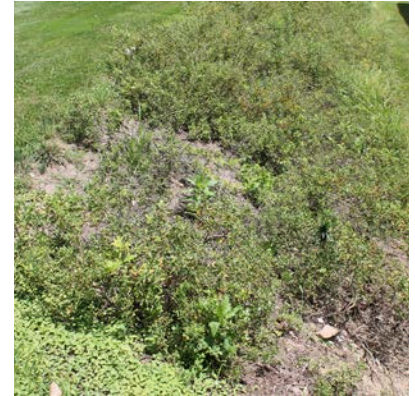
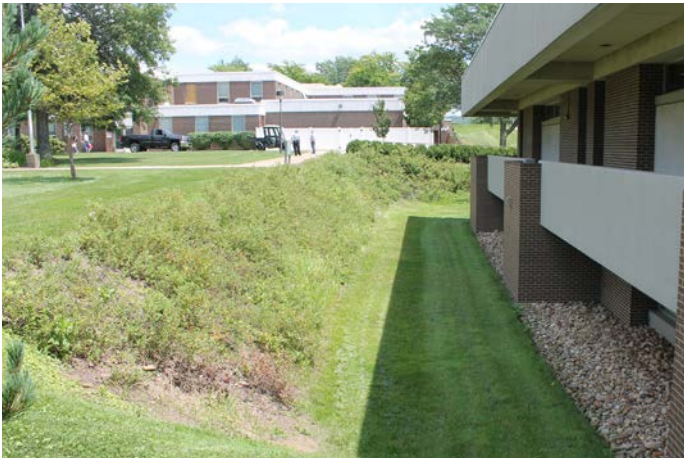
Existing

The embankment around the library continues to look ragged and unkempt. Weeds have overtaken; some areas are sparse or barren, leaving exposed soil.

Recommend planting Gro-Low Sumac as a stabilizing ground-cover. The sumac is hearty and effective and will provide good coverage. Proper and regular maintenance to ensure weeds stay out and soil stays covered must be set in place.

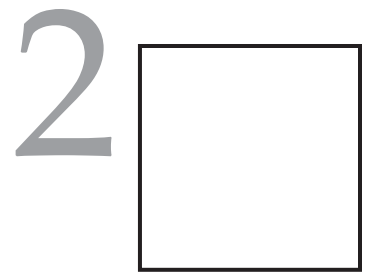
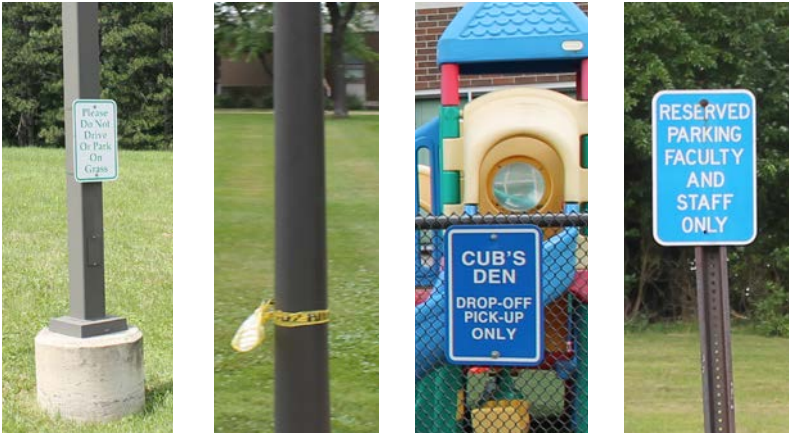
The Eberly Campus has many examples of non-standard signage. Non-standard signage looks out-of-place and as though it does not belong to the campus. Some signs or banners look informal and unsightly.

Recommend removing and replacing non-standard signage with Penn State standard signage.

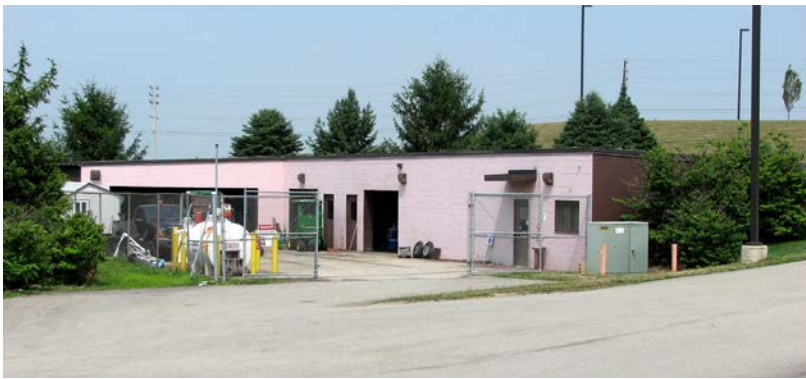
Existing

The Maintenance Building remains open to the campus, even though the majority of the campus does not use this building. Since the last CEAP recommendations, it seems that the building has actually become more noticeable. There are fewer upright evergreens screening the building and the new paint is brighter and higher contrast than before. The chain-link fence physically separates the service yard, but does not visually separate the unpleasant view.

Recommend replacing chain-link fence with an opaque paneled fence. Plant more upright evergreens around the northeast corner to screen the maintenance building.

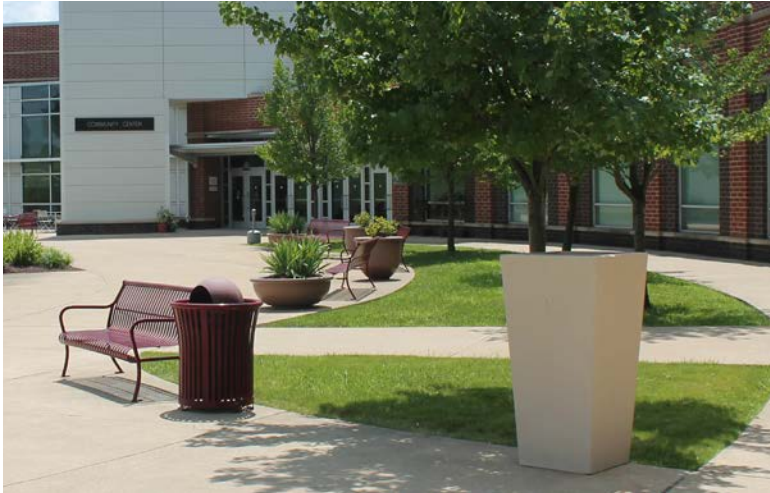
Planter is too large for the site and without any plants

Planters can add visual impact to a space, but they must be at an appropriate scale with their surroundings. Planters either too big or too small look out of place.

Recommend that existing planters be moved to sites more appropriate to their size. Similarly, larger plants should go in larger planters and smaller plants in smaller planters.

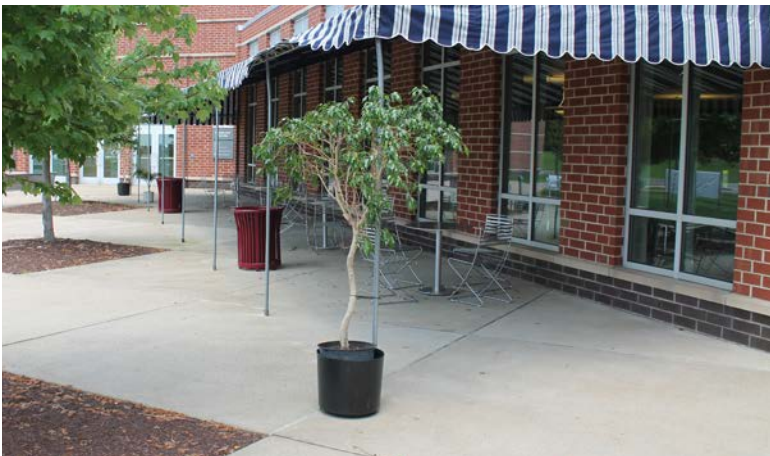
Planter is too small for the site, and the plant too large for the planter

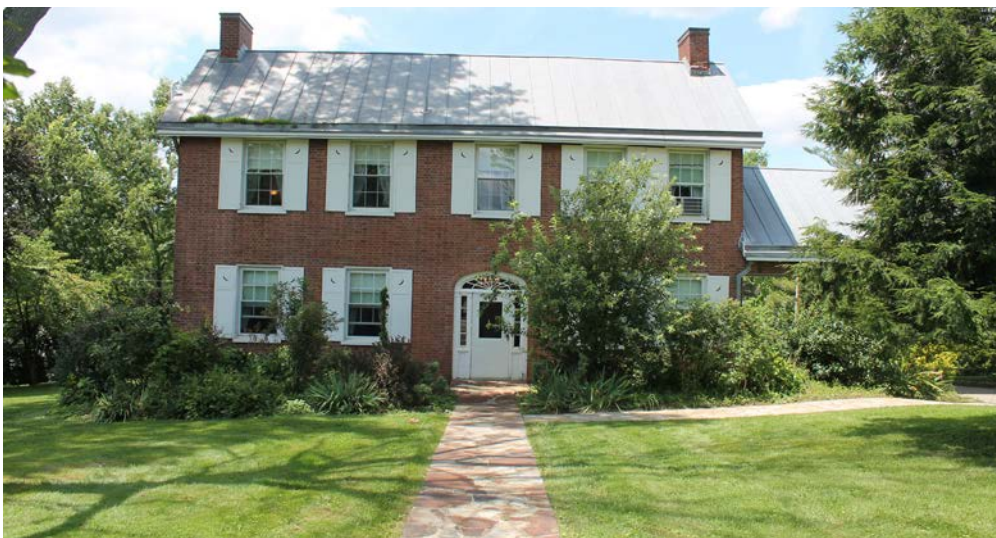
Existing landscaping is messy and hides the house from view. The house feels separated from the rest of the campus and inaccessible. Recommend simpler landscape design for ease of maintenance and improve aesthetics.

Prune trees and remove foreground plantings for a cleaner view of the University House

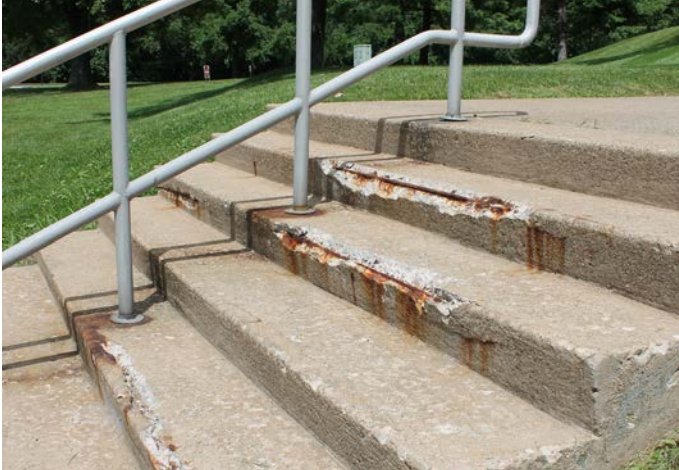
The concrete steps off the side of Eberly Building are crumbling away and must be repaired or replaced. A handrail also near Eberly is broken. Other steps with rust stains show early signs of deterioration.

Exposed rebar

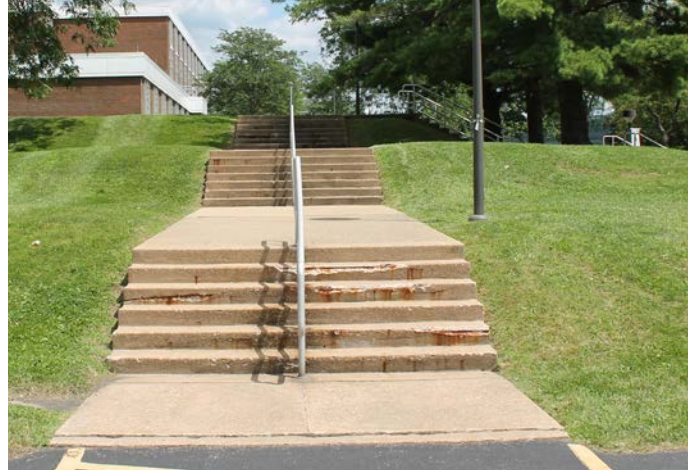
The corners of the concrete steps are chipping away, creating a major tripping hazard

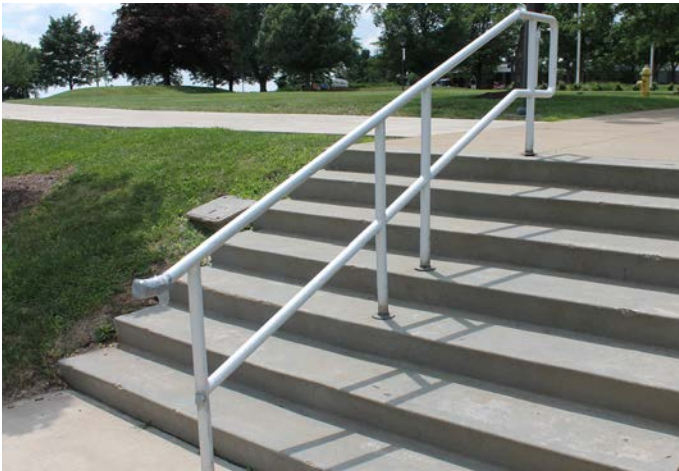
Broken handrail

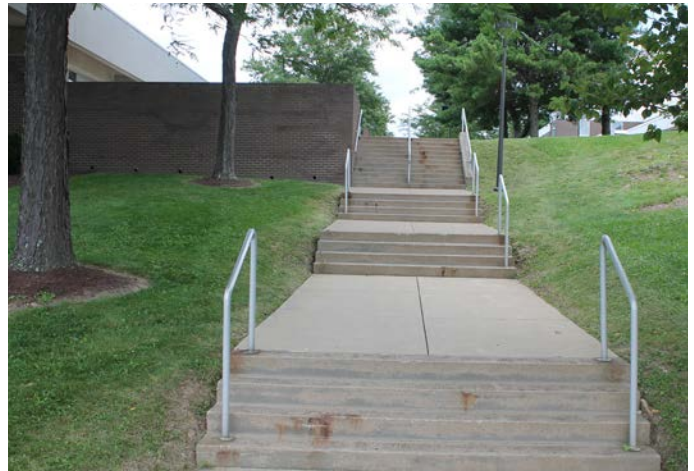
Rust-stained steps early indicator of deterioration

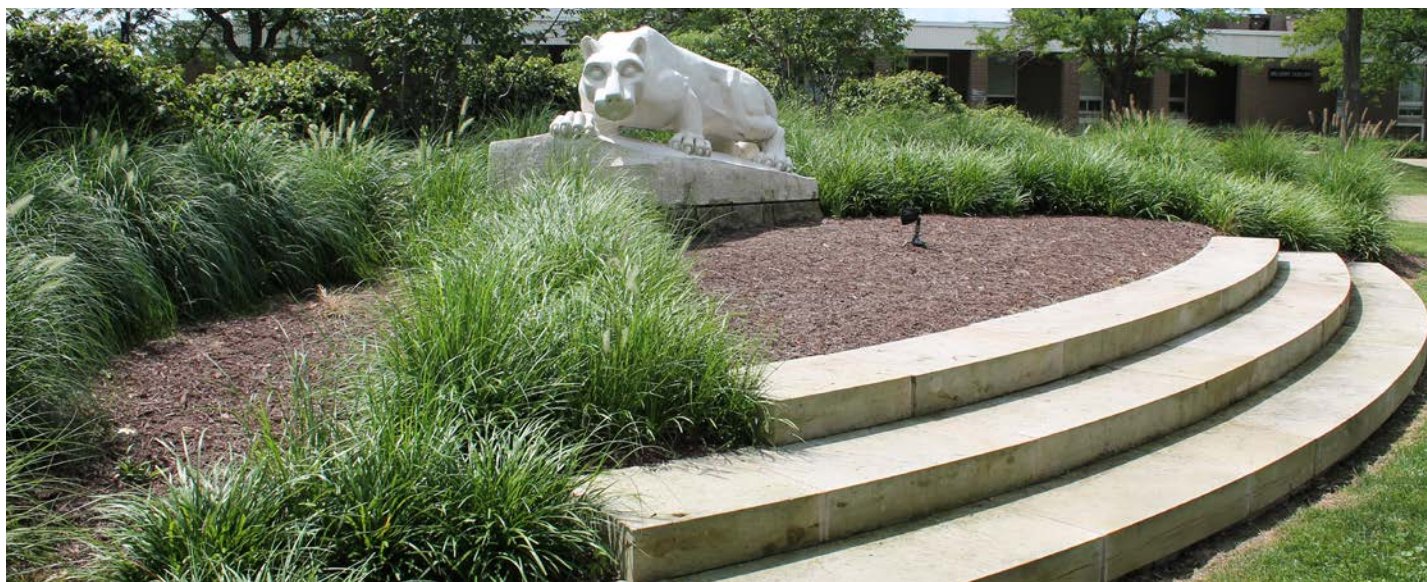
Plantings have large gaps between rows
