Penn State  
**Lehigh Valley**

Campus Exterior Architectural Plan  
January 2008

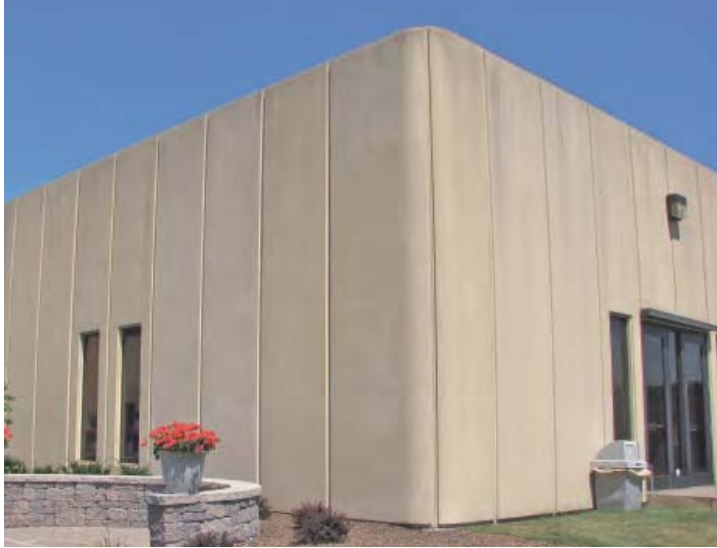
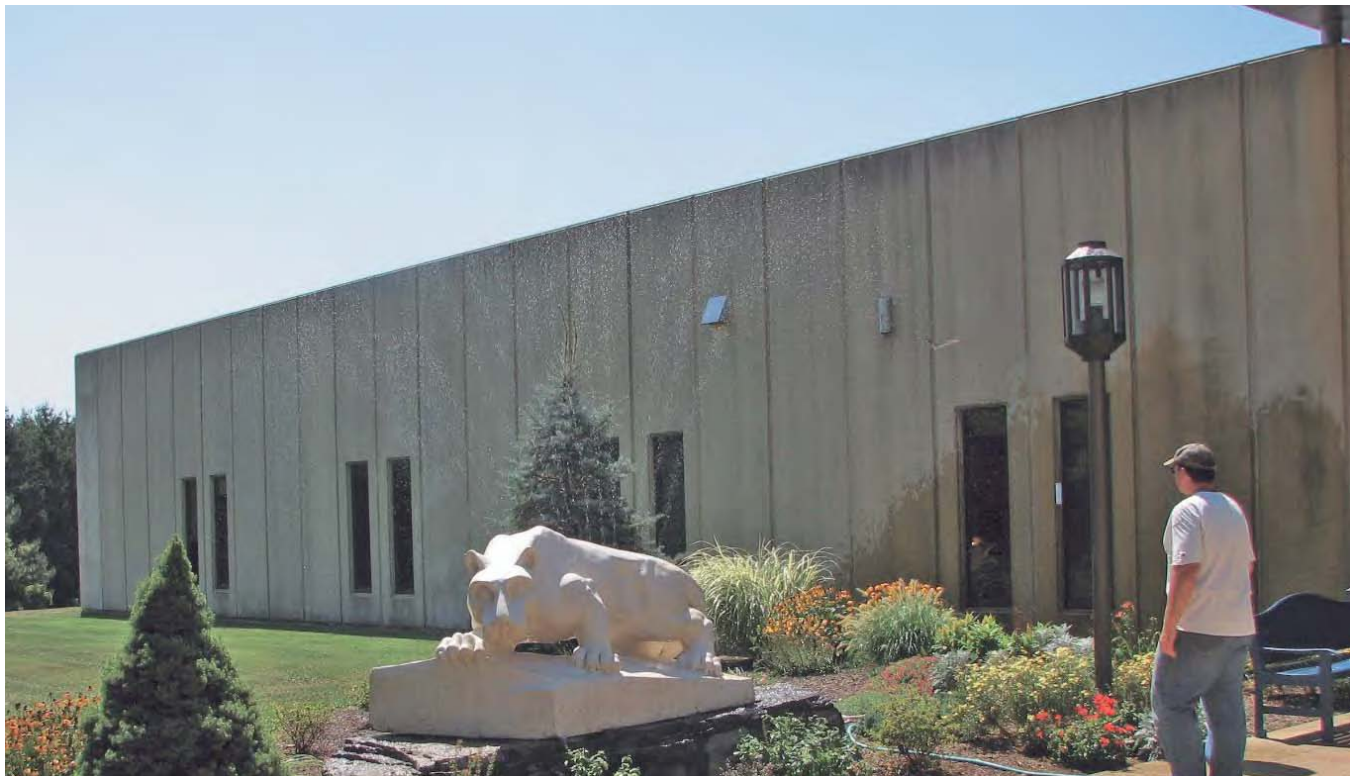
# 1a

Airborne dirt accumulates on building surfaces over time. Discoloration is particularly noticeable on light colored surfaces.

Recommend that all masonry building facades be pressure washed to remove discolorations

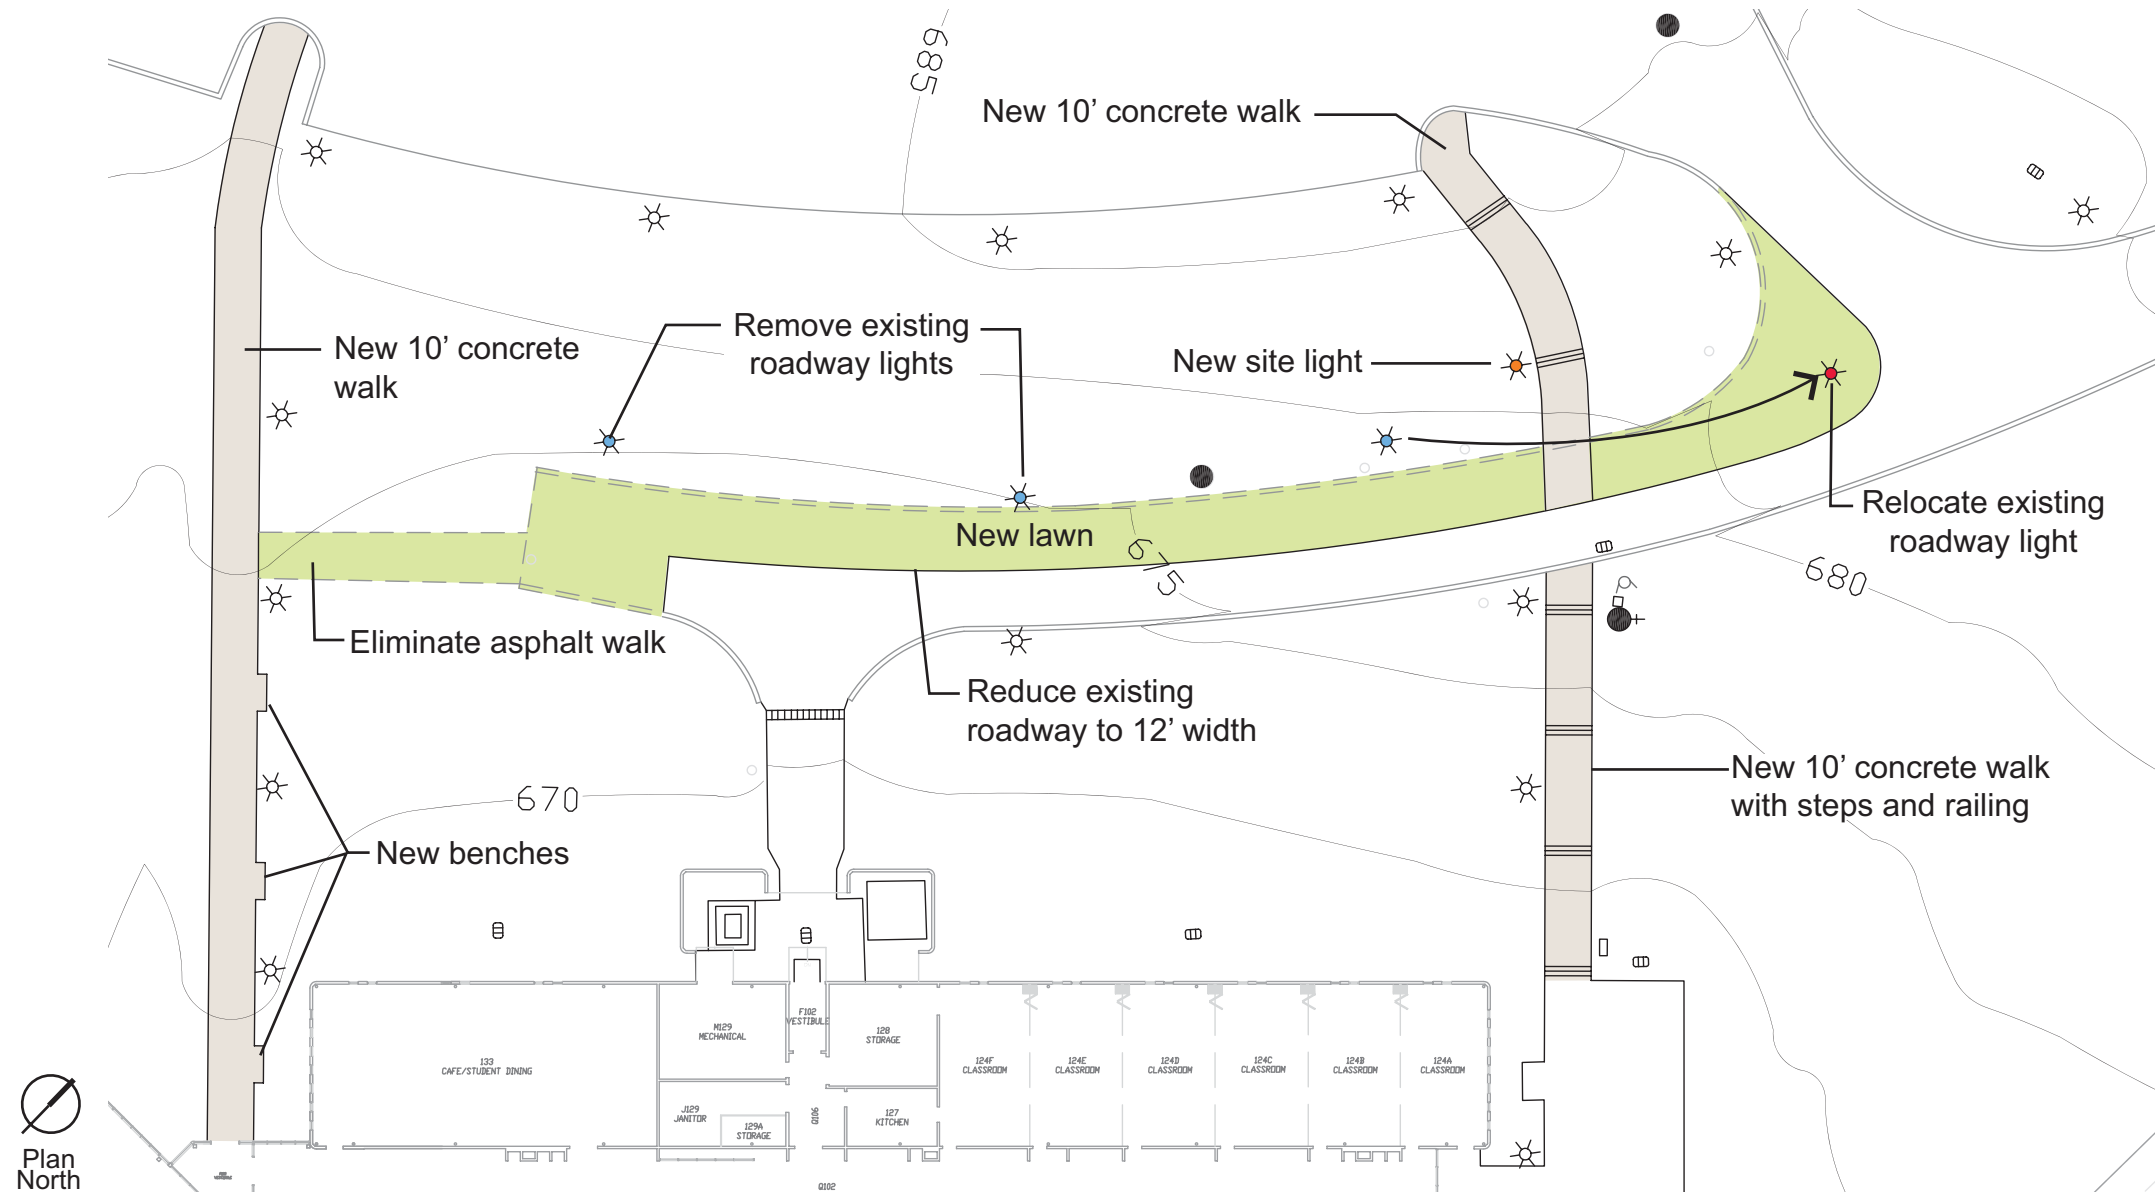
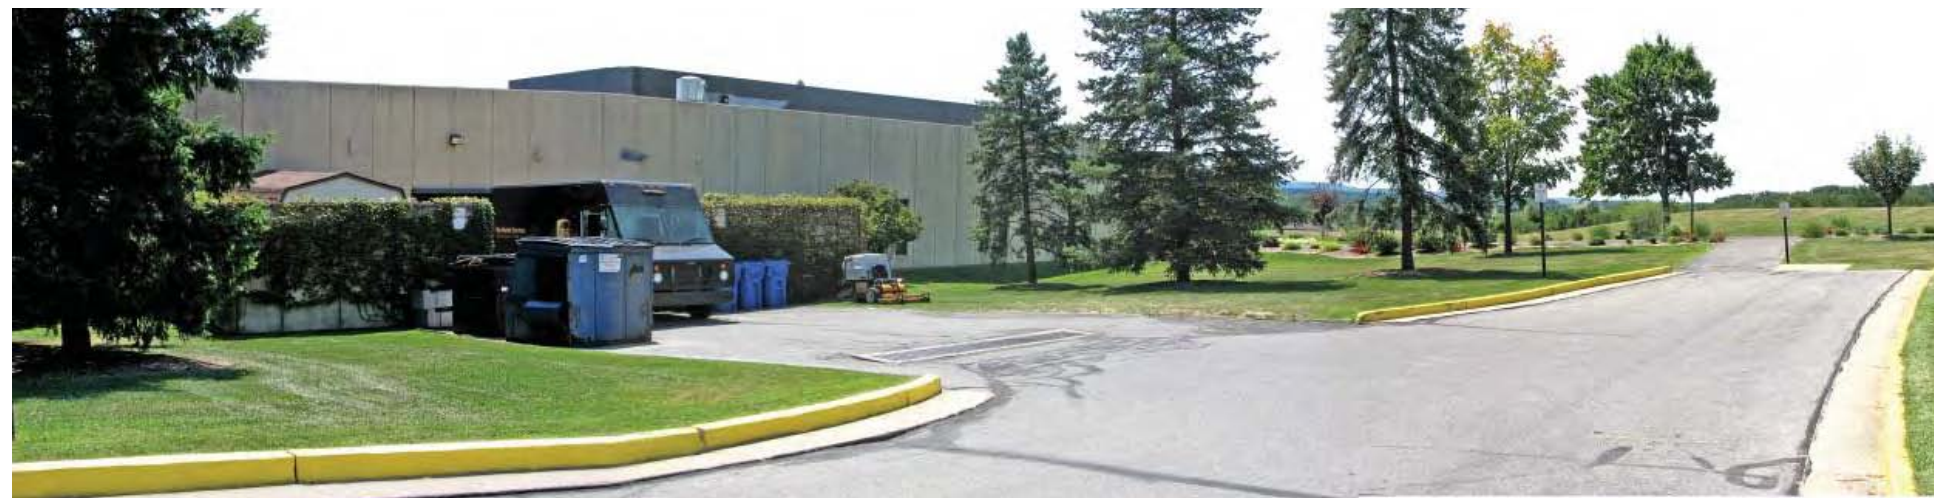
# Pavement Modifications 2a

Various pavement modification opportunities exist that will enhance the visual quality of campus as well as reduce excess impervious surfaces.

Paved access to the service area at the Academic Building must be maintained. However the width of the drive could easily be reduced by 50%. The head of the island separating the parking lot from the service drive can be expanded to provide a "greener" view to users entering the campus from Mohr Lane. This modification will also facilitate the removal and/ or relocation of several light fixtures.

This figure also illustrates in plan view, the replacement of asphalt walk surfaces with concrete and stairs as required. These projects are also illustrated on Figures 2b & 2c.

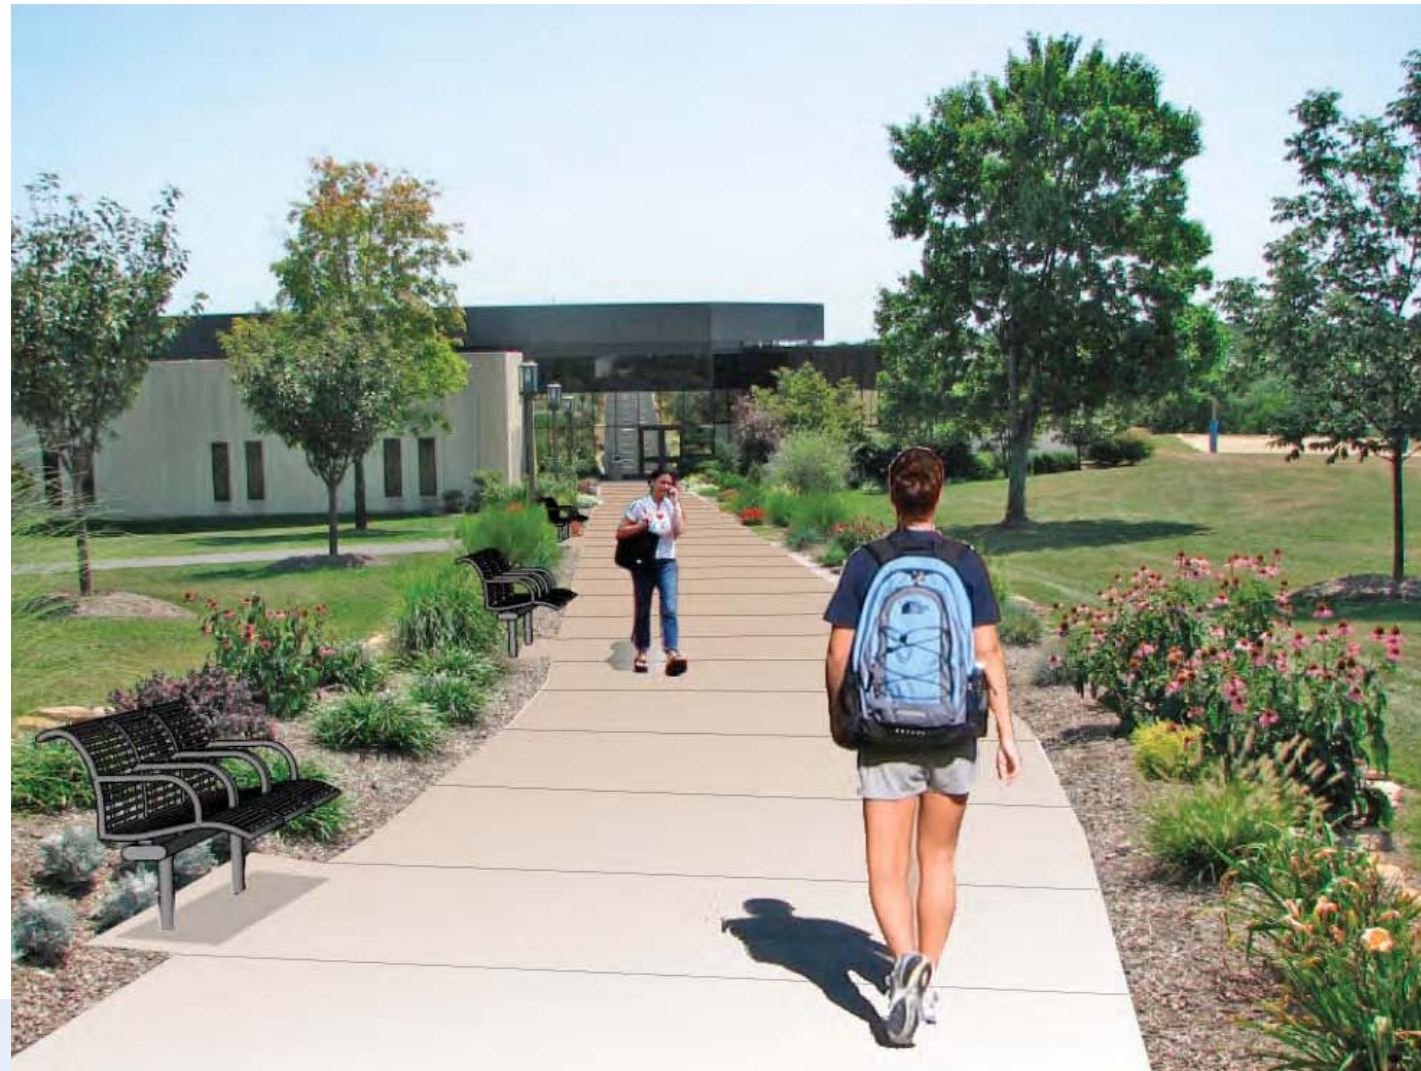
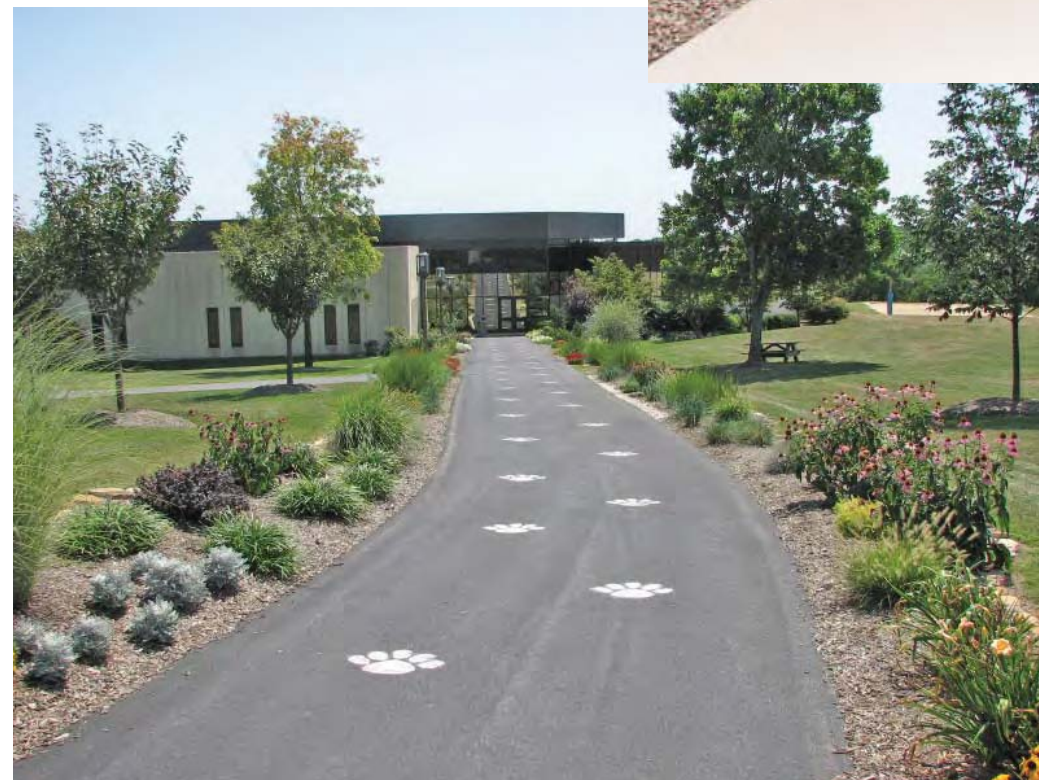
# South Entrance Walk <sup>2b</sup>

The existing walkway to the south entrance of the Academic Building should mimic the north entrance walk. Due to a gentler slope there is no need for stairs or railings.

Recommend the replacement of the asphalt surface with concrete, a more refined and clean looking material. Placement of benches along the walk is also recommended.

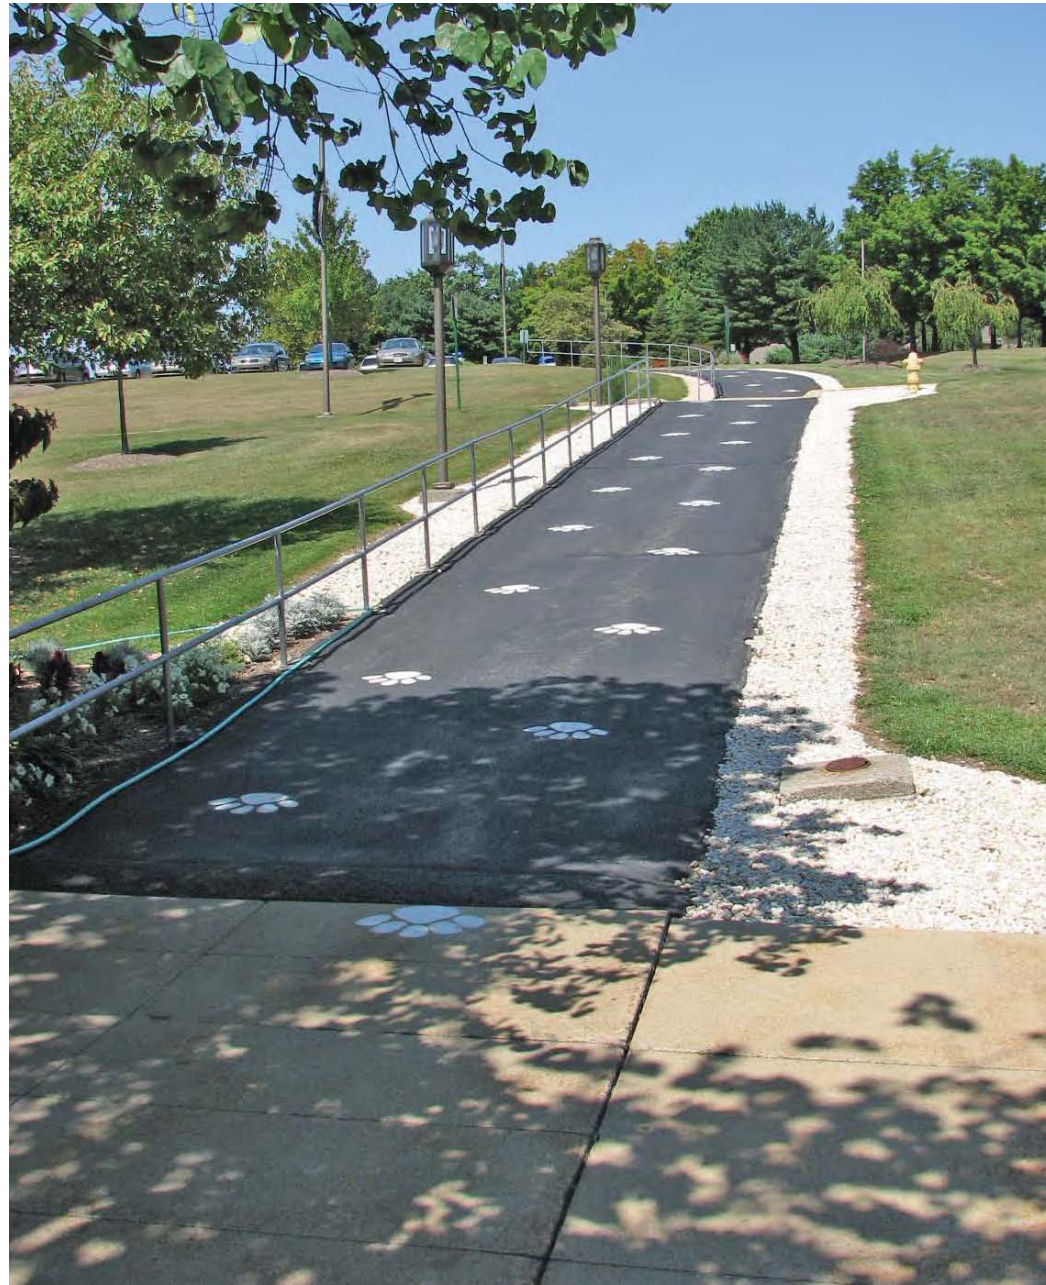
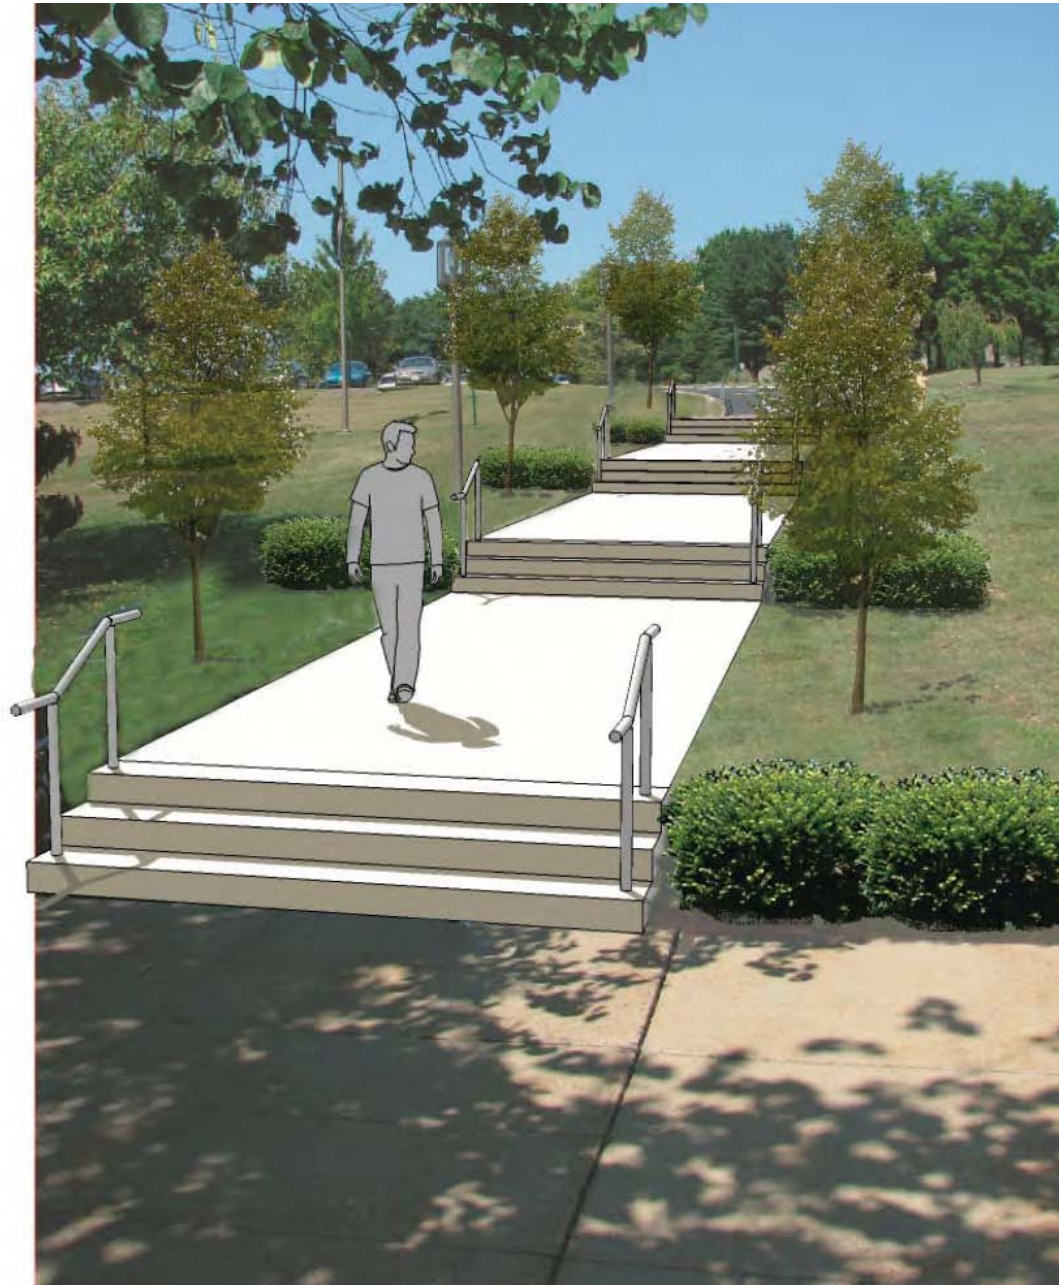
# North Entrance Walk <sup>2c</sup>

The asphalt walkway that leads campus users to the Academic Building is sloped in excess of 10% necessitating the placement of a continuous handrail the length of the walk. The excessive slope makes the walk uncomfortable as well as hazardous.

Recommend the replacement of the existing walk with concrete and a series of stairs to more gently transition the grade. The existing continuous handrail can be removed.

Supplemental landscaping along the walk will strengthen the sense of entry.

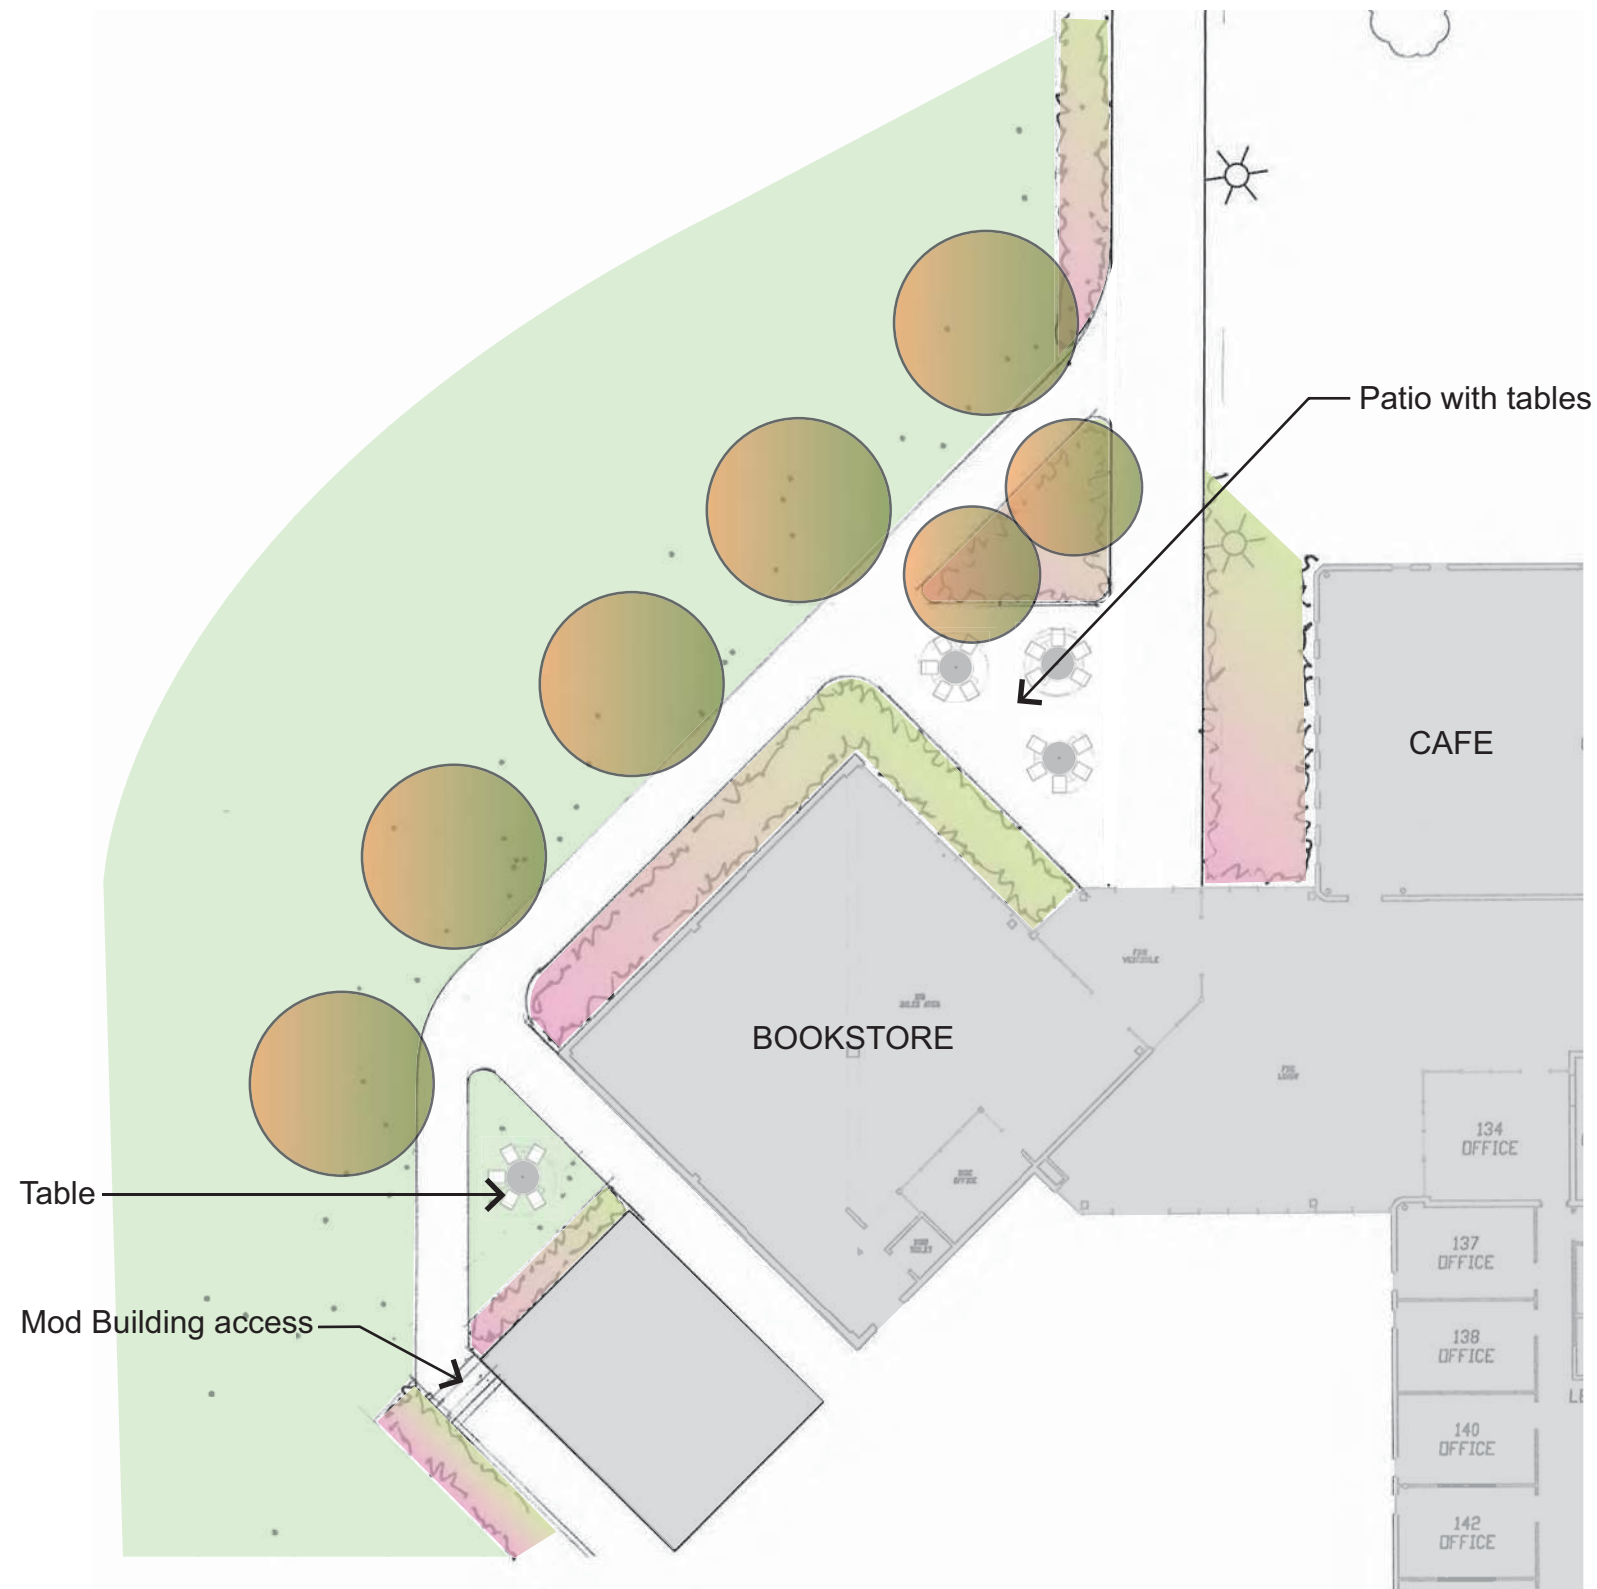
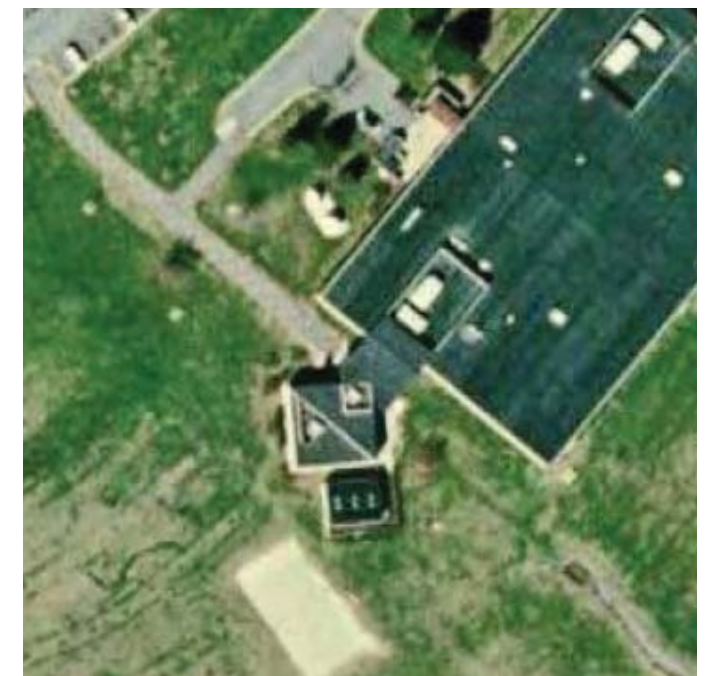
# South Patio 2d

There is a shortage of outdoor seating areas at the campus. The opportunity exists to provide a patio furnished with tables adjacent to the south entrance of the Academic Building. This location is in close proximity to the cafe and bookstore.

An alternate pedestrian route to the Mod/Pictel Building is also proposed.

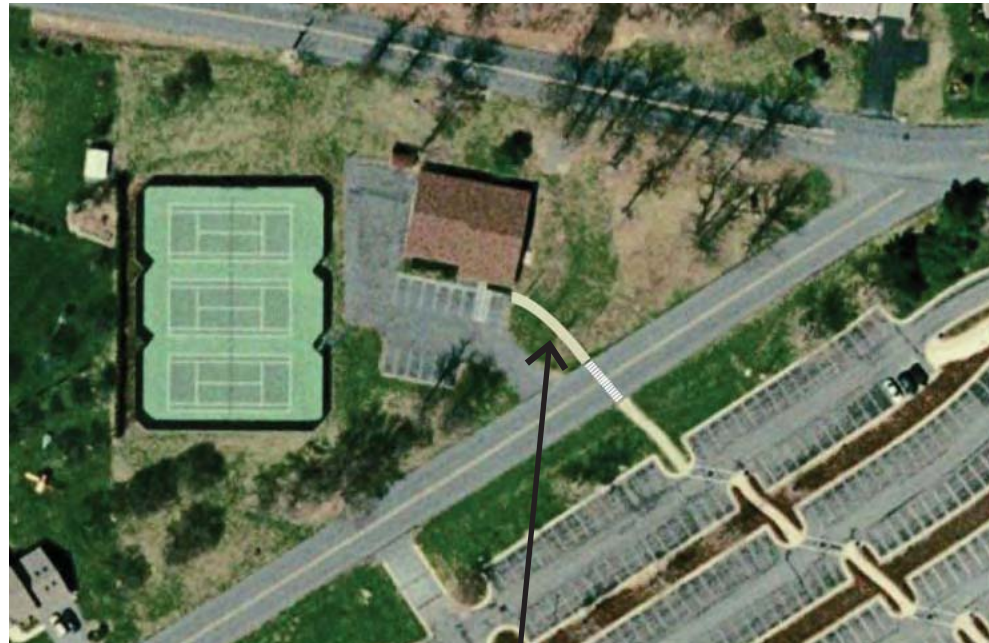
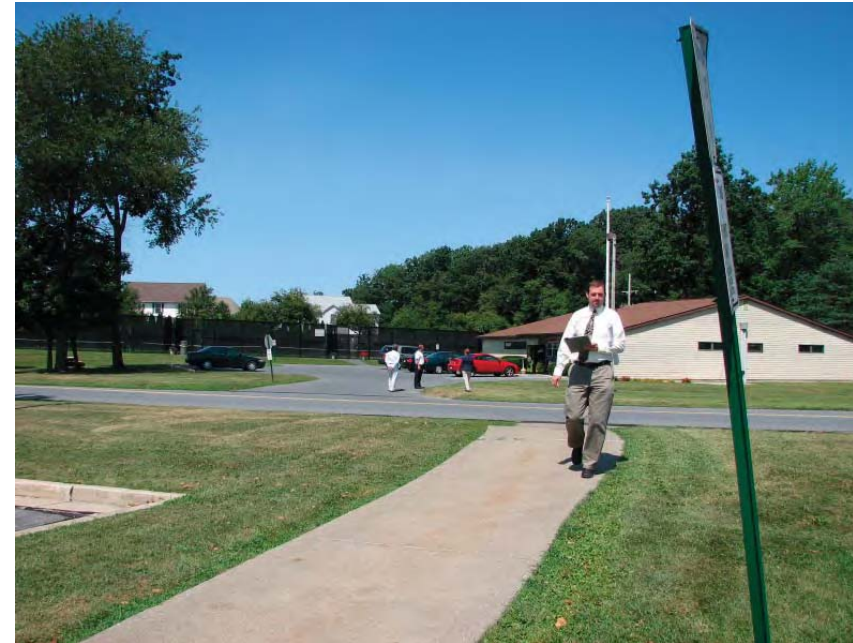
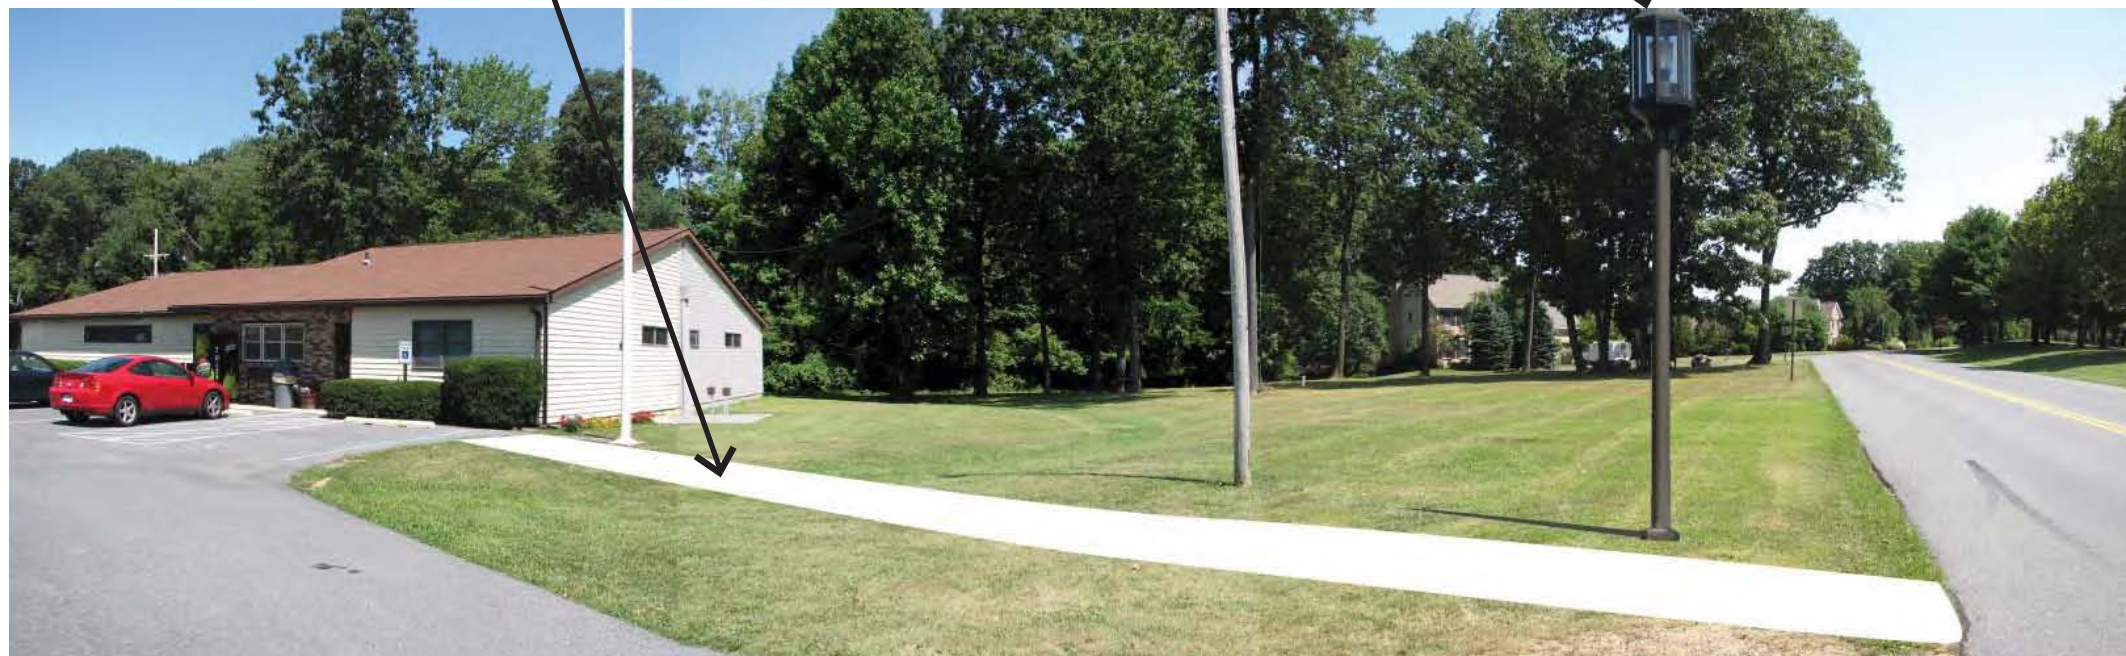
# Fitness Center Walkway 2e

Pedestrian access to the Fitness Center and tennis courts from the main campus south of Mohr Lane is incomplete.

Recommend the installation of a concrete sidewalk to complete the pedestrian connection. Additional improvements include replacement of the existing flood light with a new walkway light and striped crosswalk on Mohr Lane.

Install new concrete sidewalk and stripe crosswalk

Replace existing floodlight with campus standard walkway light

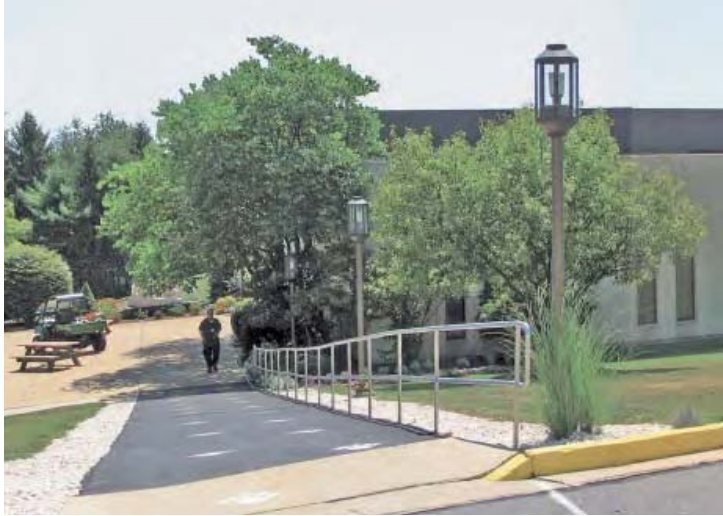
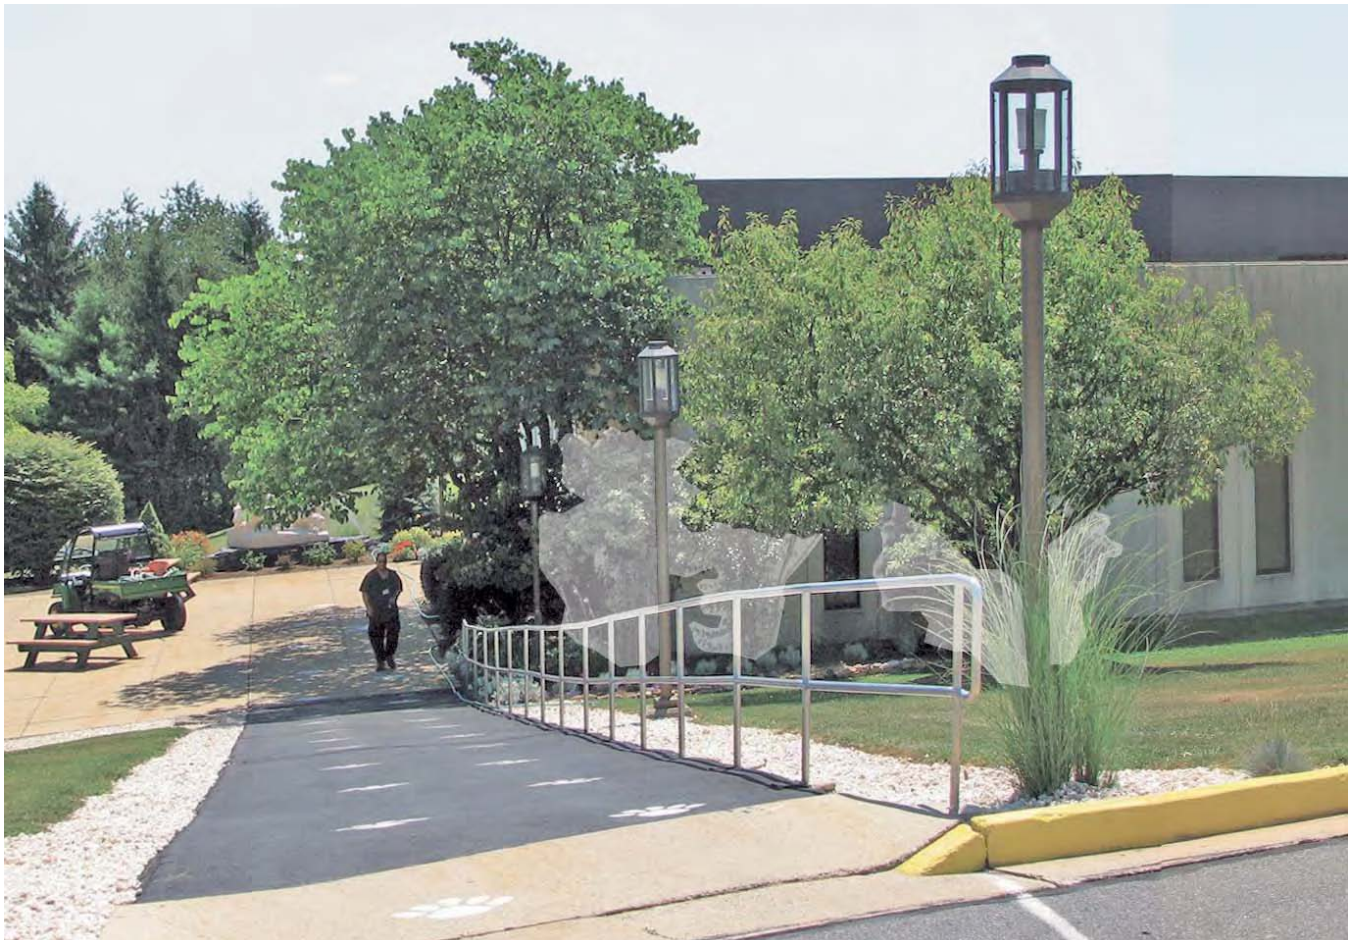
# Shrub Removal 3a

Existing shrub plantings at the corner of the Academic Building no longer possess the ornamental value they once had.

Recommend removal of overgrown plants to improve visibility to building. Continued pruning/maintenance of trees in this area is recommended.

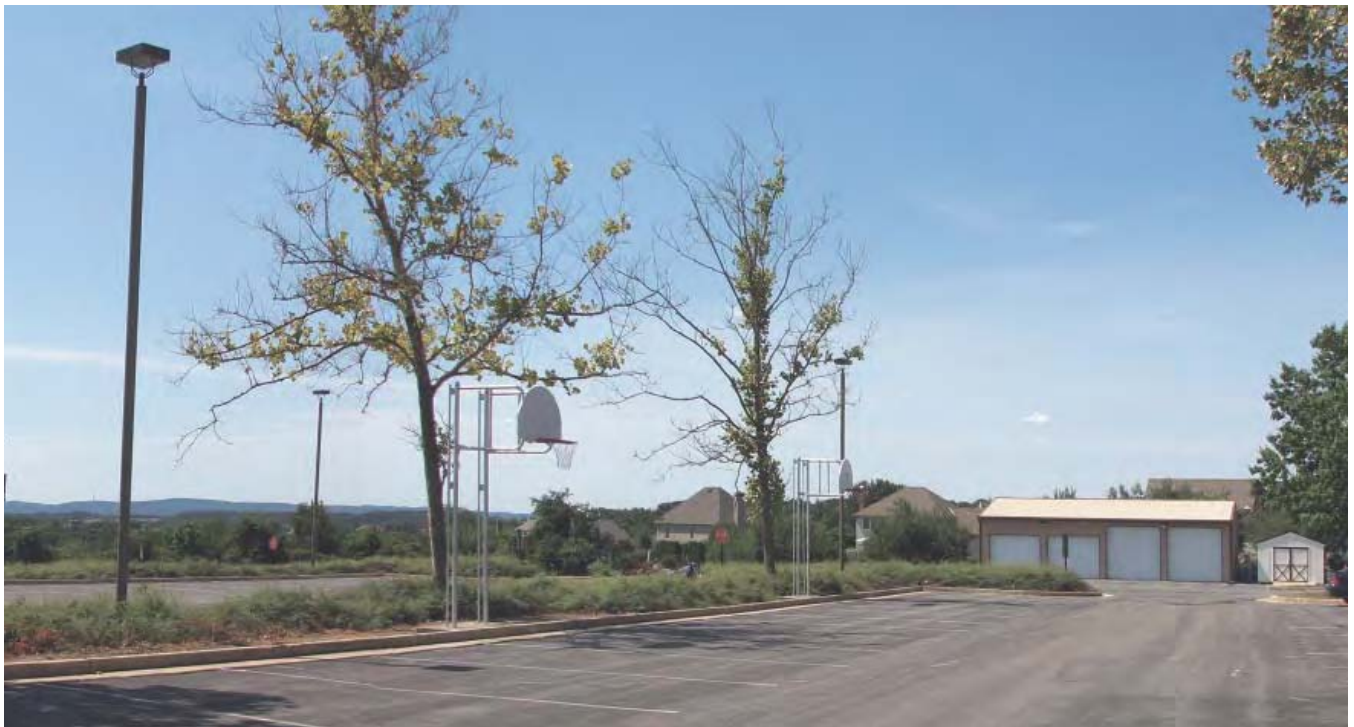
# Tree Removal 3b

Existing Sycamore trees in parking lot island exhibit severe die-back condition compromising the value of the specimens.

Recommend removal and replacement. Prior to re-planting it is recommended that the soil condition be assessed to determine suitability as growing medium.

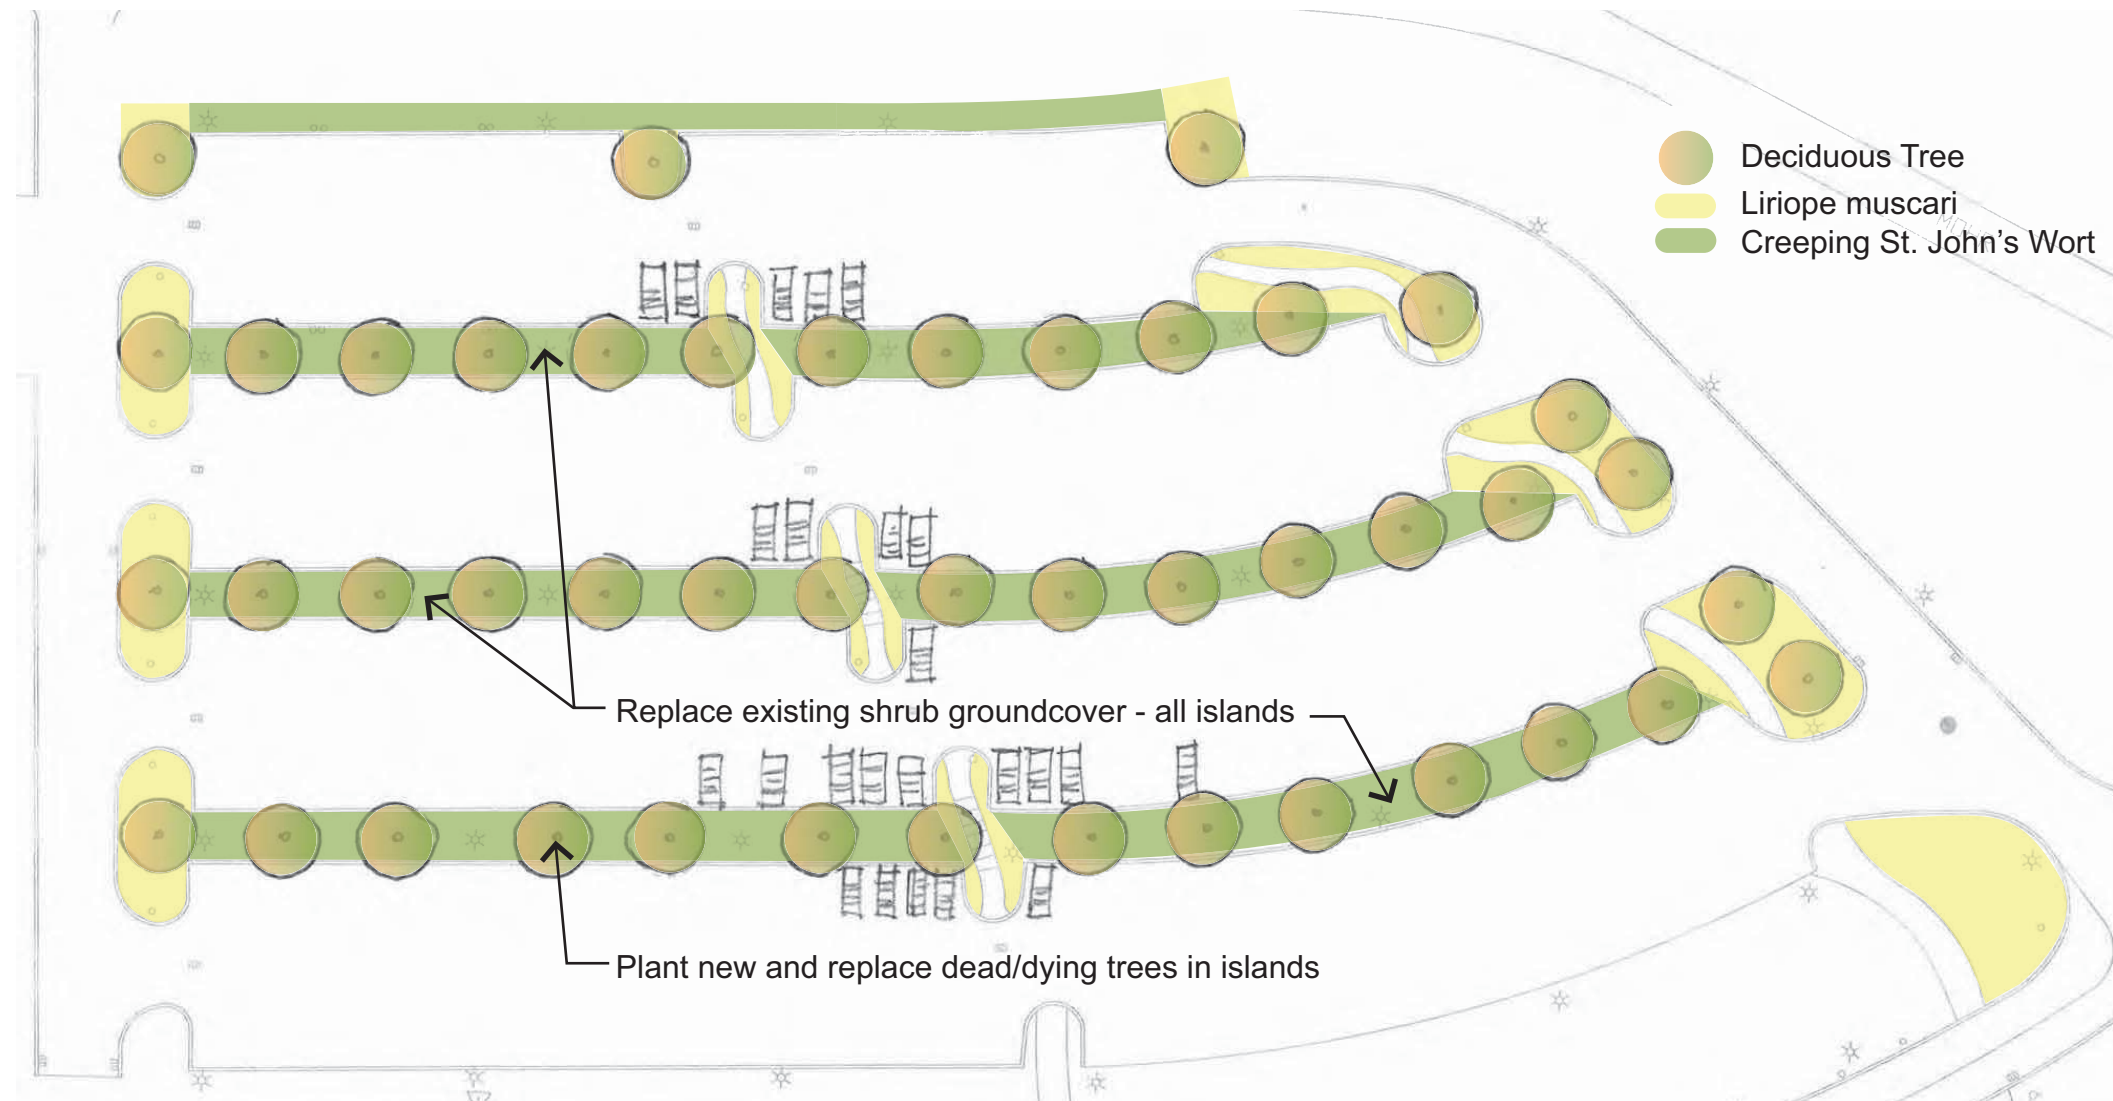
# Island Landscaping 3C

Existing groundcover vegetation in the parking lot islands traps debris and attracts bees. In addition, there's an absence of tree planting within the islands.

Recommend the replacement of existing vegetation with varieties described on the plan. Prior to any new landscape installations it will be necessary to conduct soils testing to determine suitability for sustaining new plantings.
