Penn State  
**Lehigh Valley**

Campus Exterior Architectural Plan  
January 2008

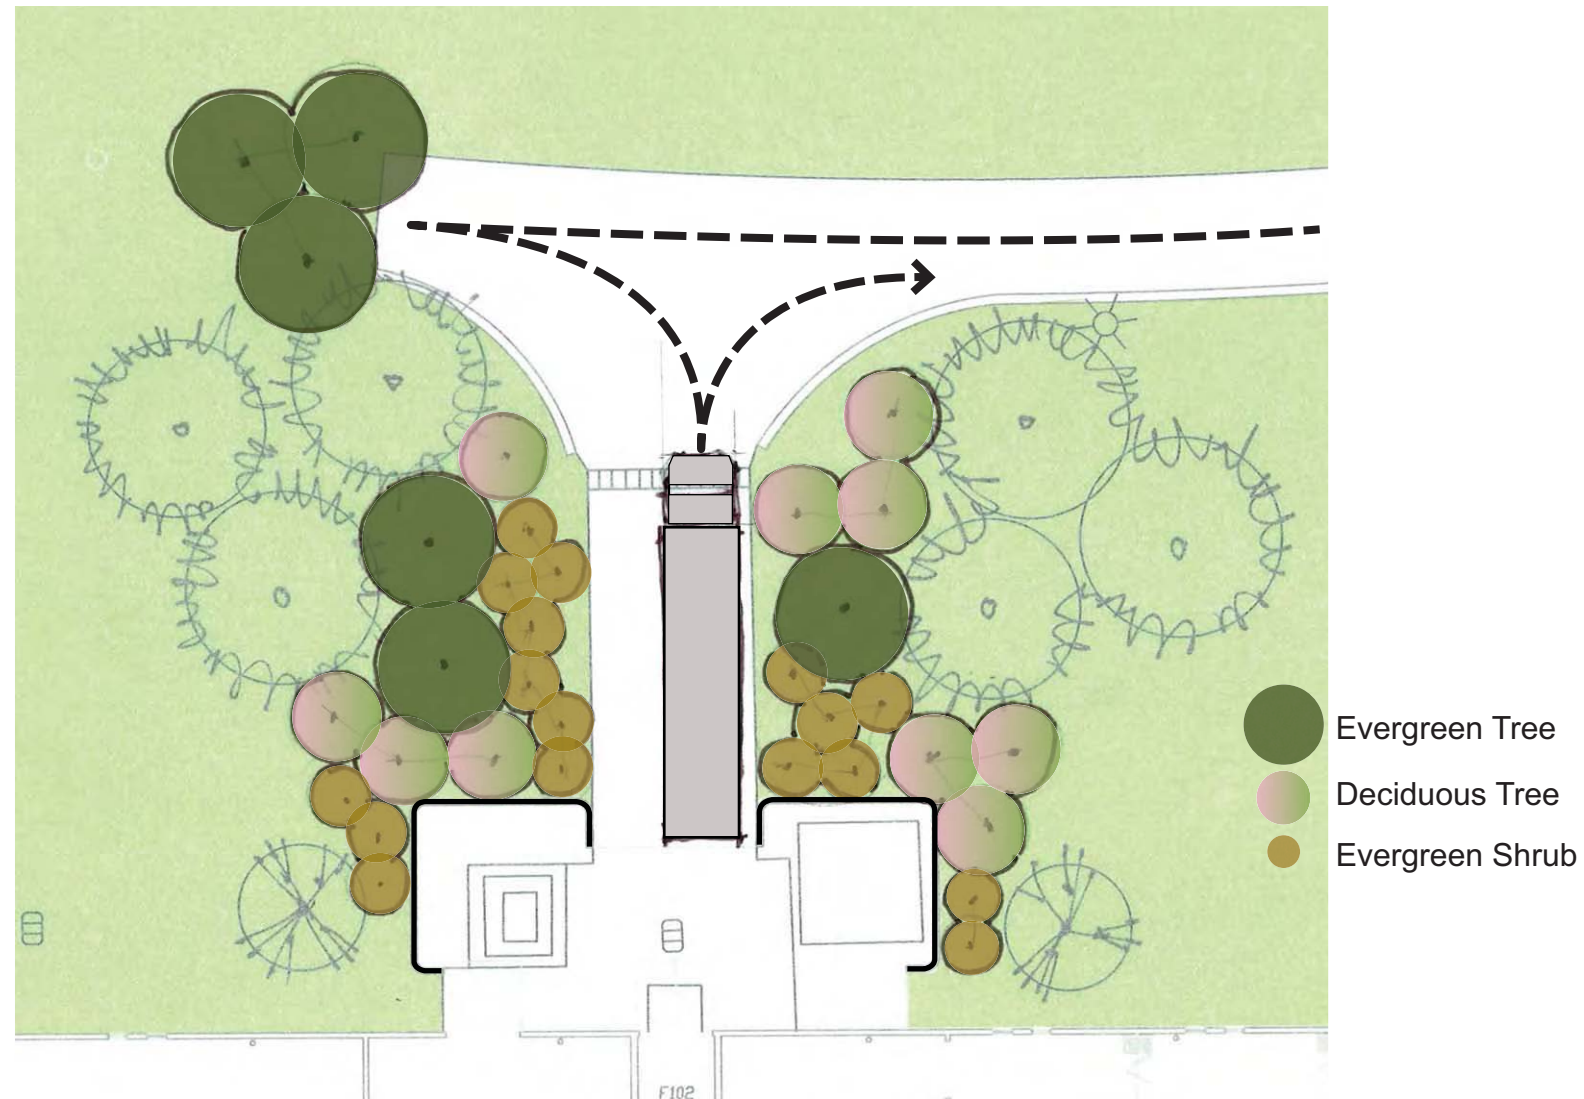
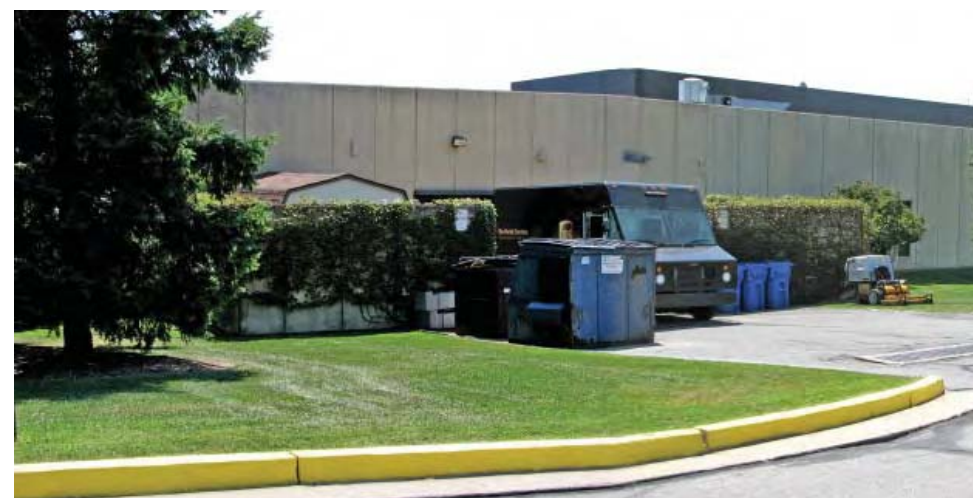
# Service Dock Screening 3d

The functionality of this service area must be maintained. Delivery trucks and waste handling equipment pose challenges to the aesthetic quality of the space.

The improvement of this area involves the relocation of dumpsters (see Fig. 3e) and reduction of asphalt paving. The screening effect of the existing masonry walls surrounding the dock can be enhanced by additional planting.

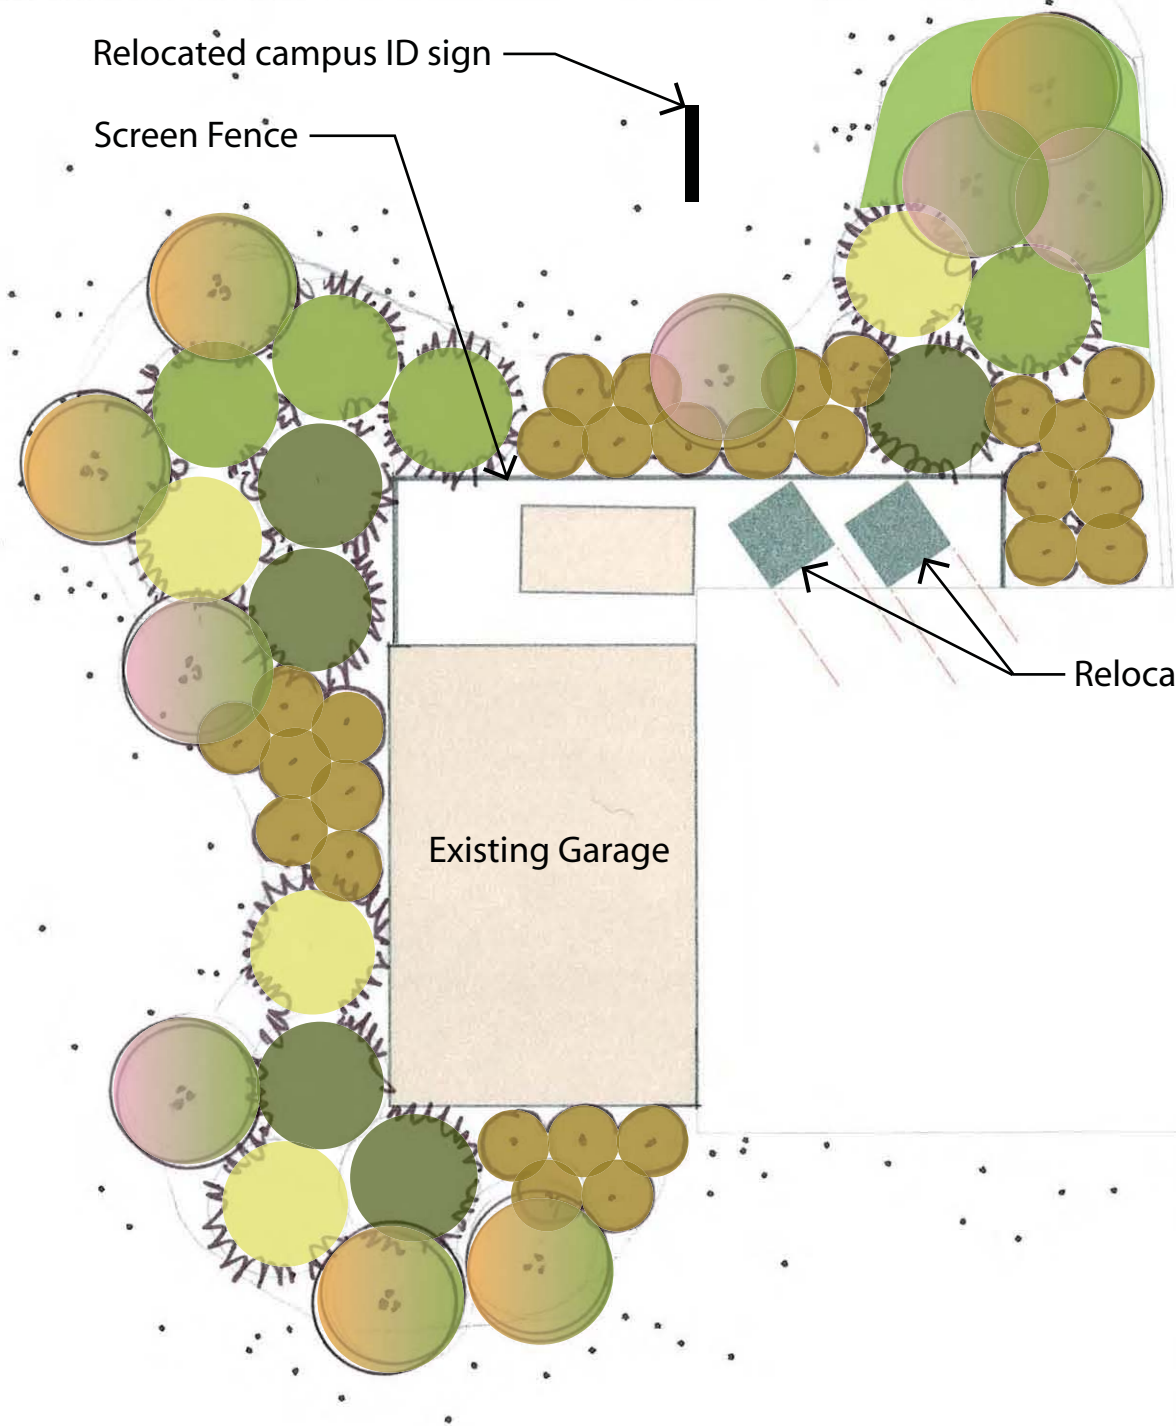
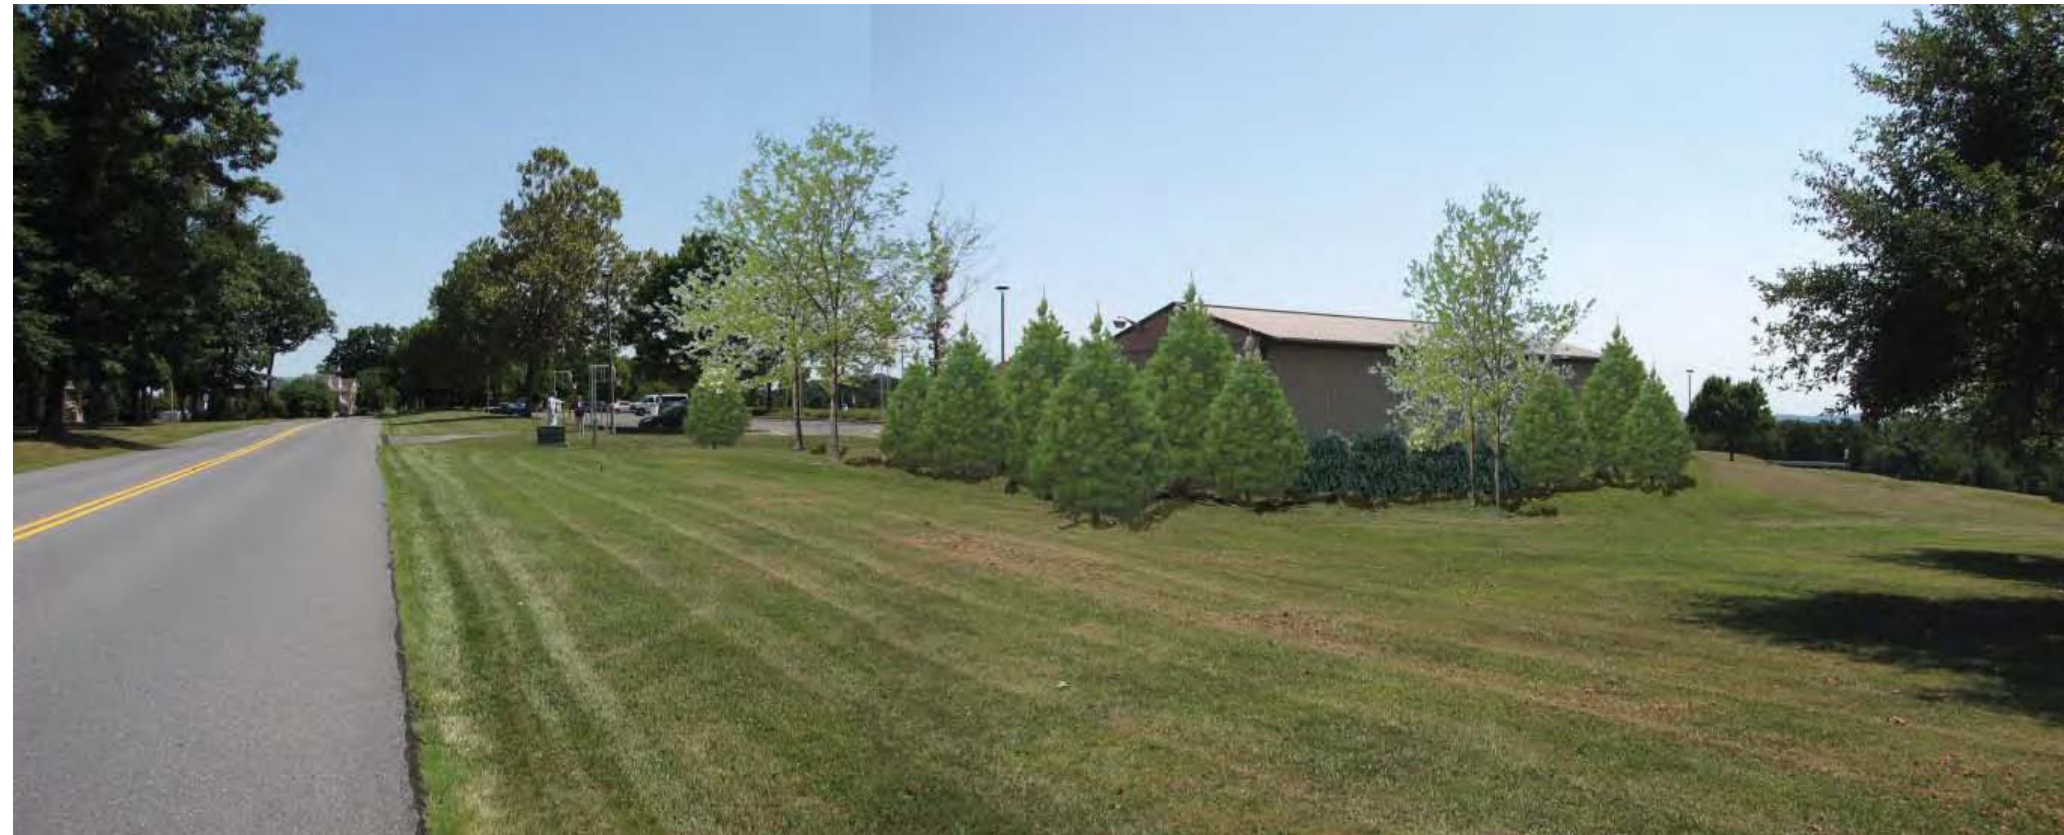
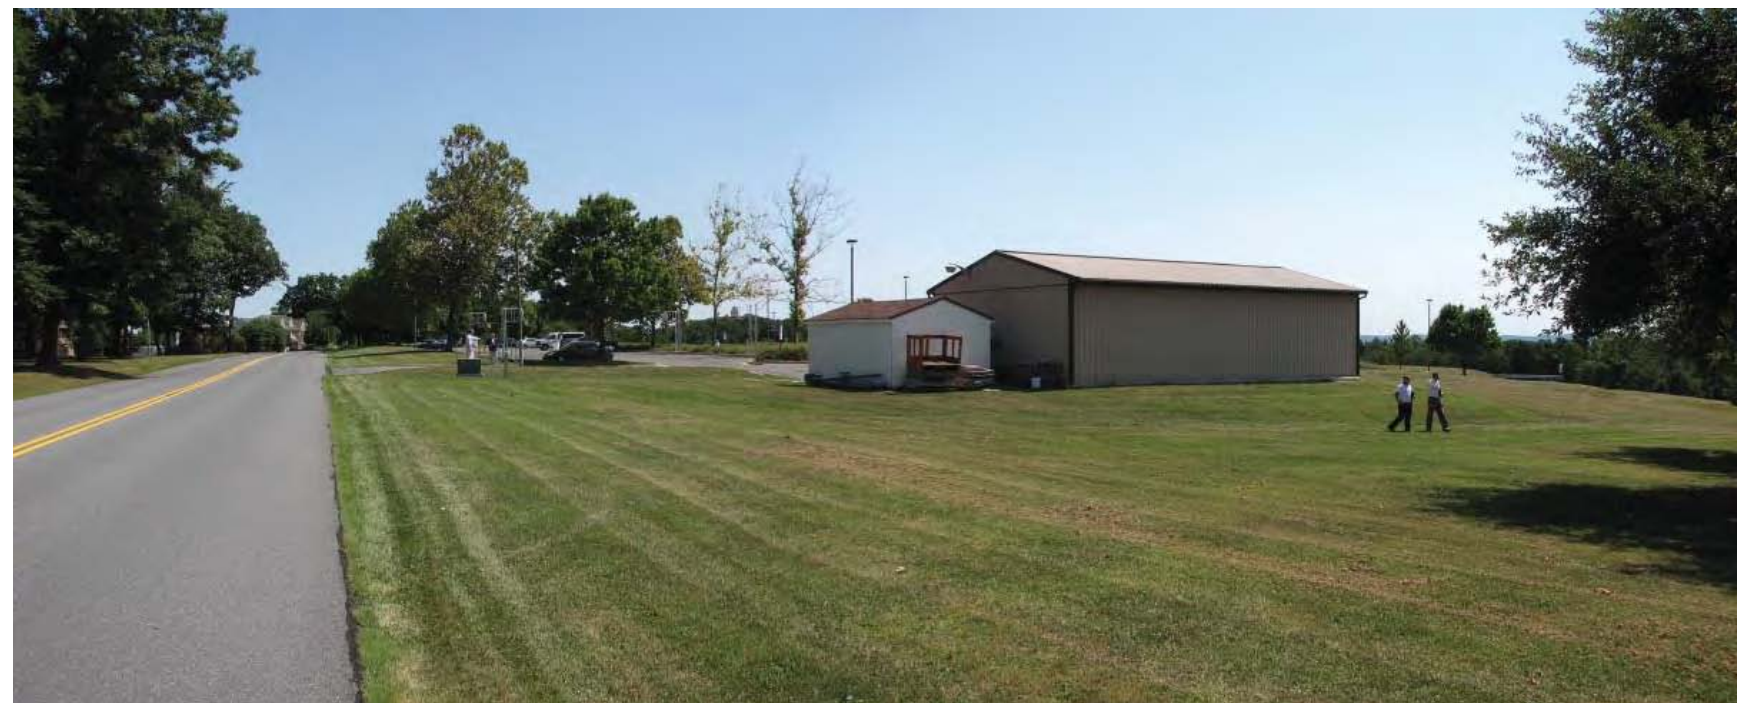
# Garage Screening 3e

The view of campus from the eastbound approach along Twp. Rd. 609 is dominated by the maintenance garage and storage shed. This vantage point may be the initial impression of campus to visitors.

Recommend that trash dumpsters be relocated to this area from the front of the Academic Building.

All structures should be densely screened with fence, evergreen trees and shrubs and accented with deciduous trees.

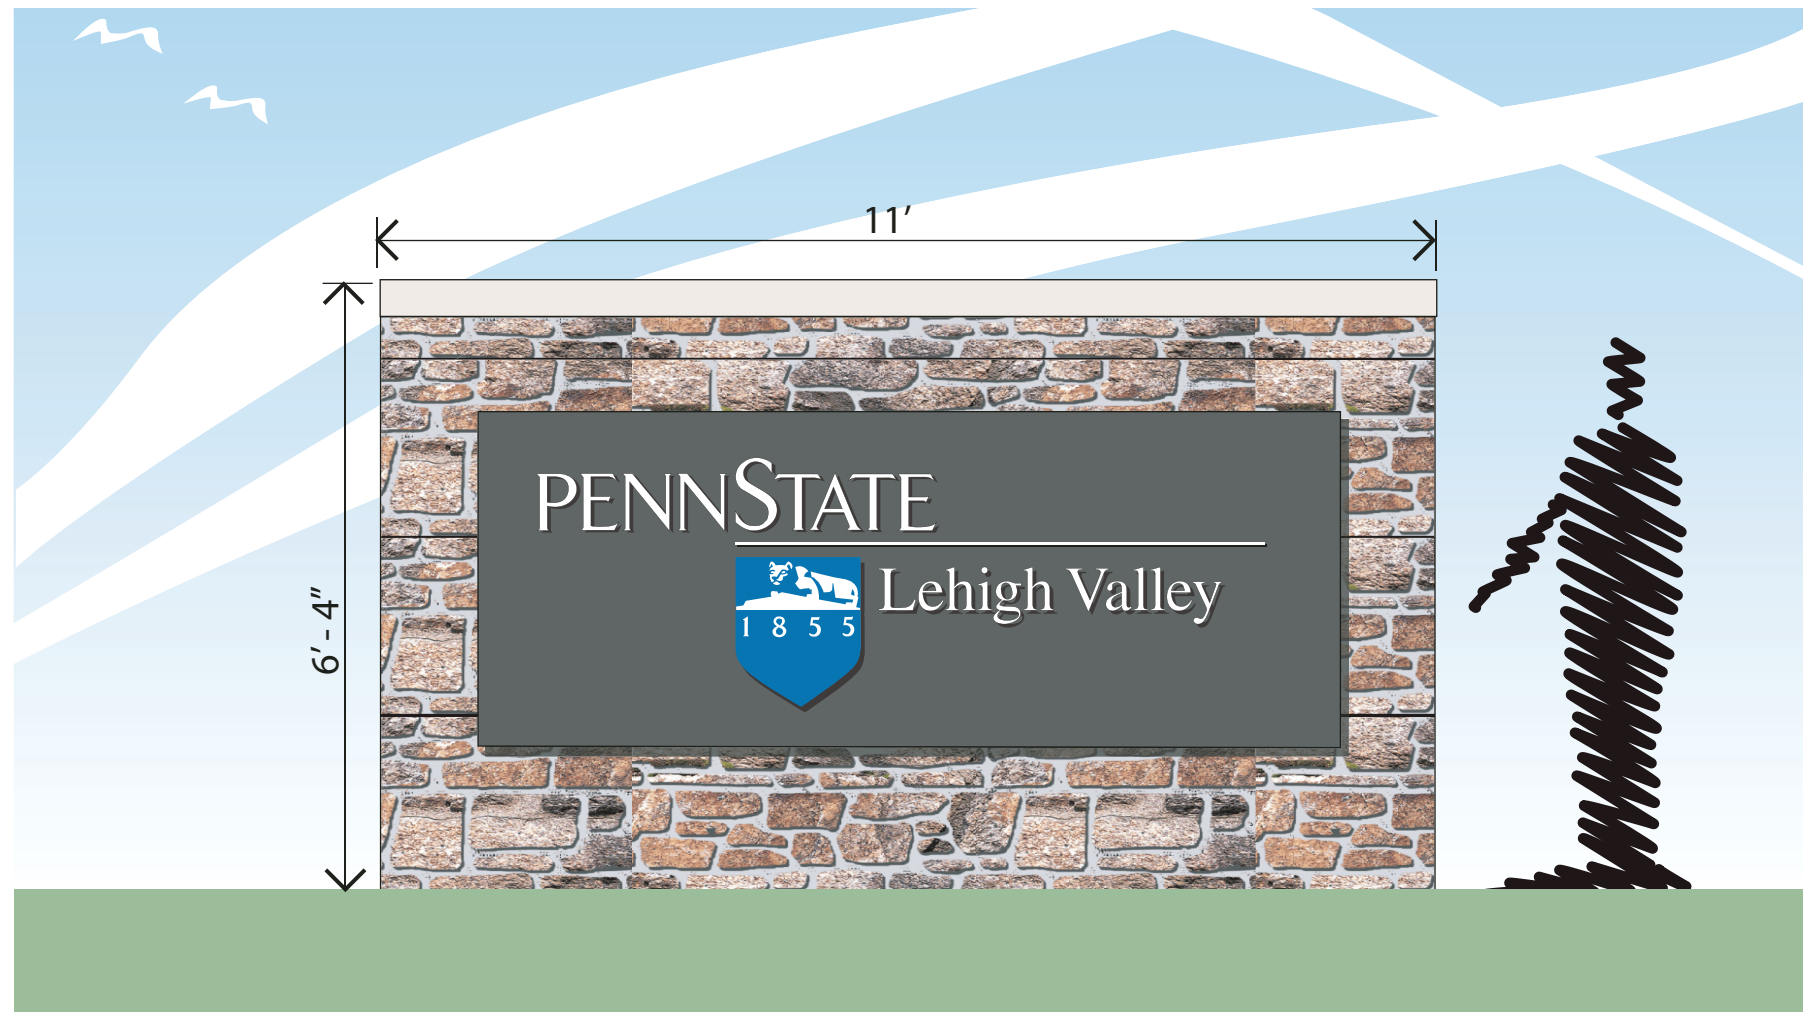
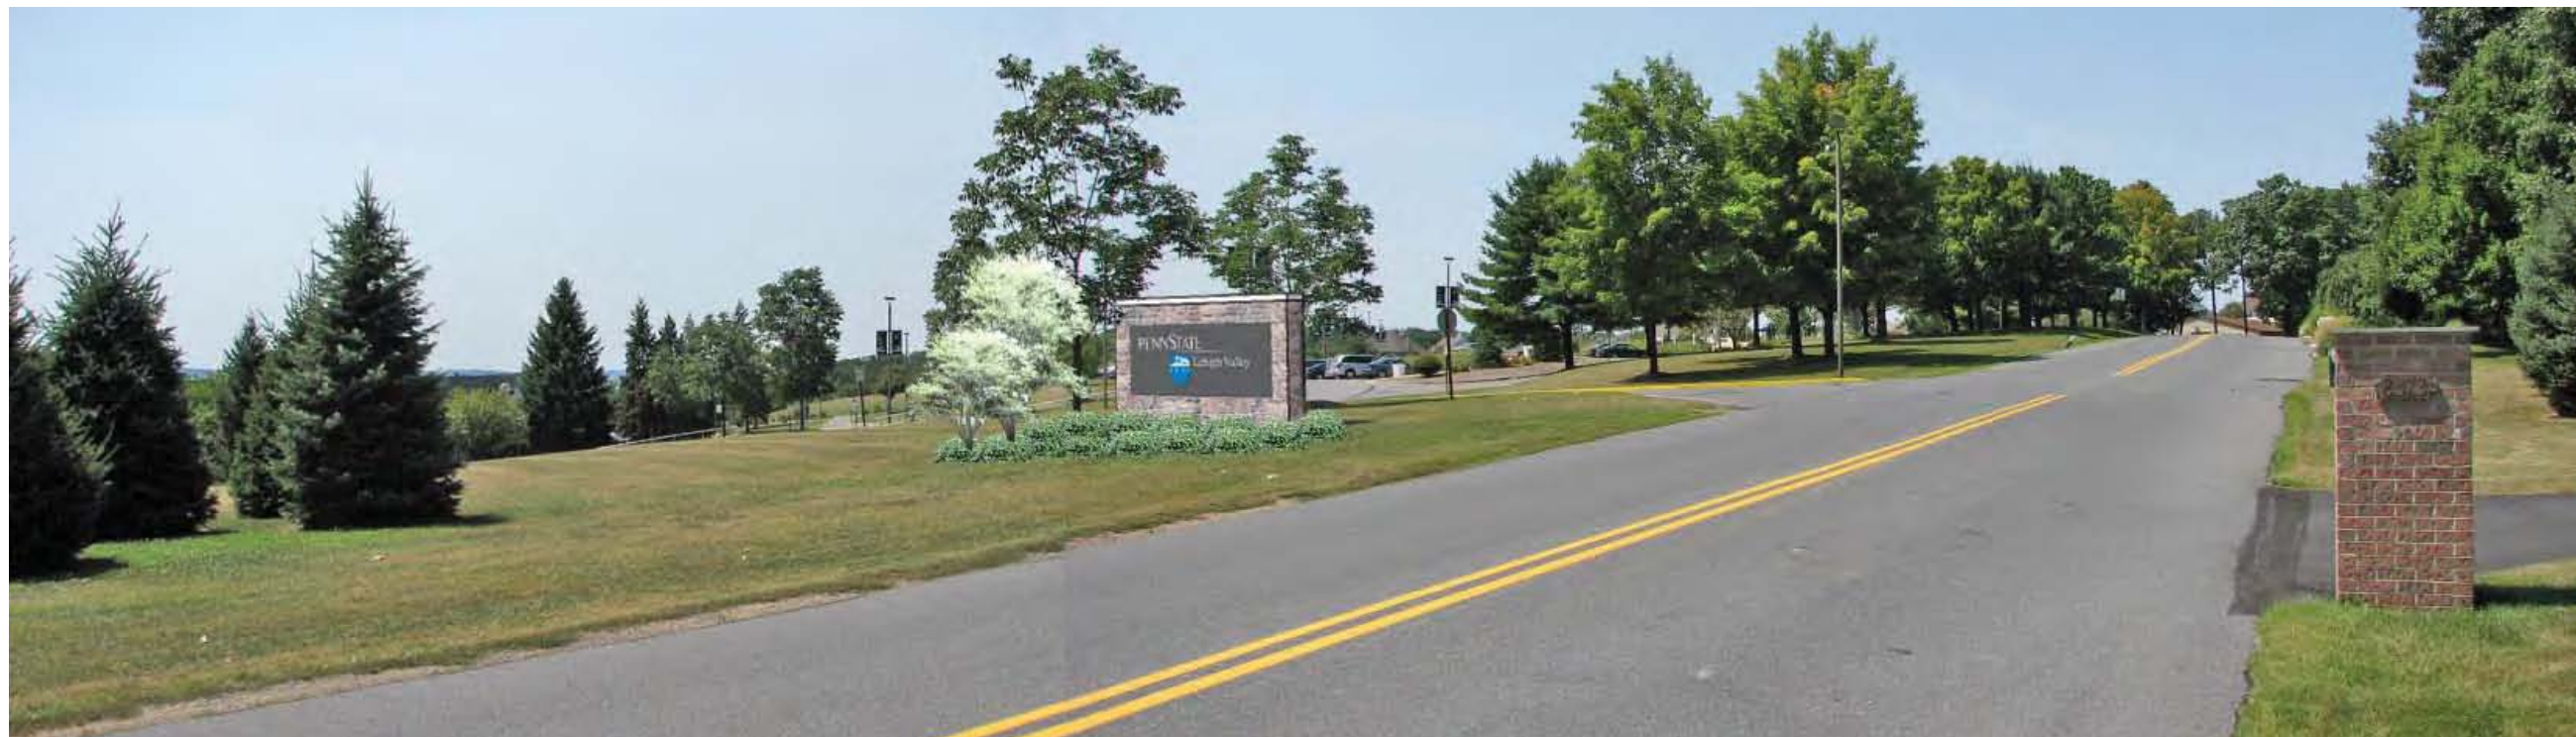
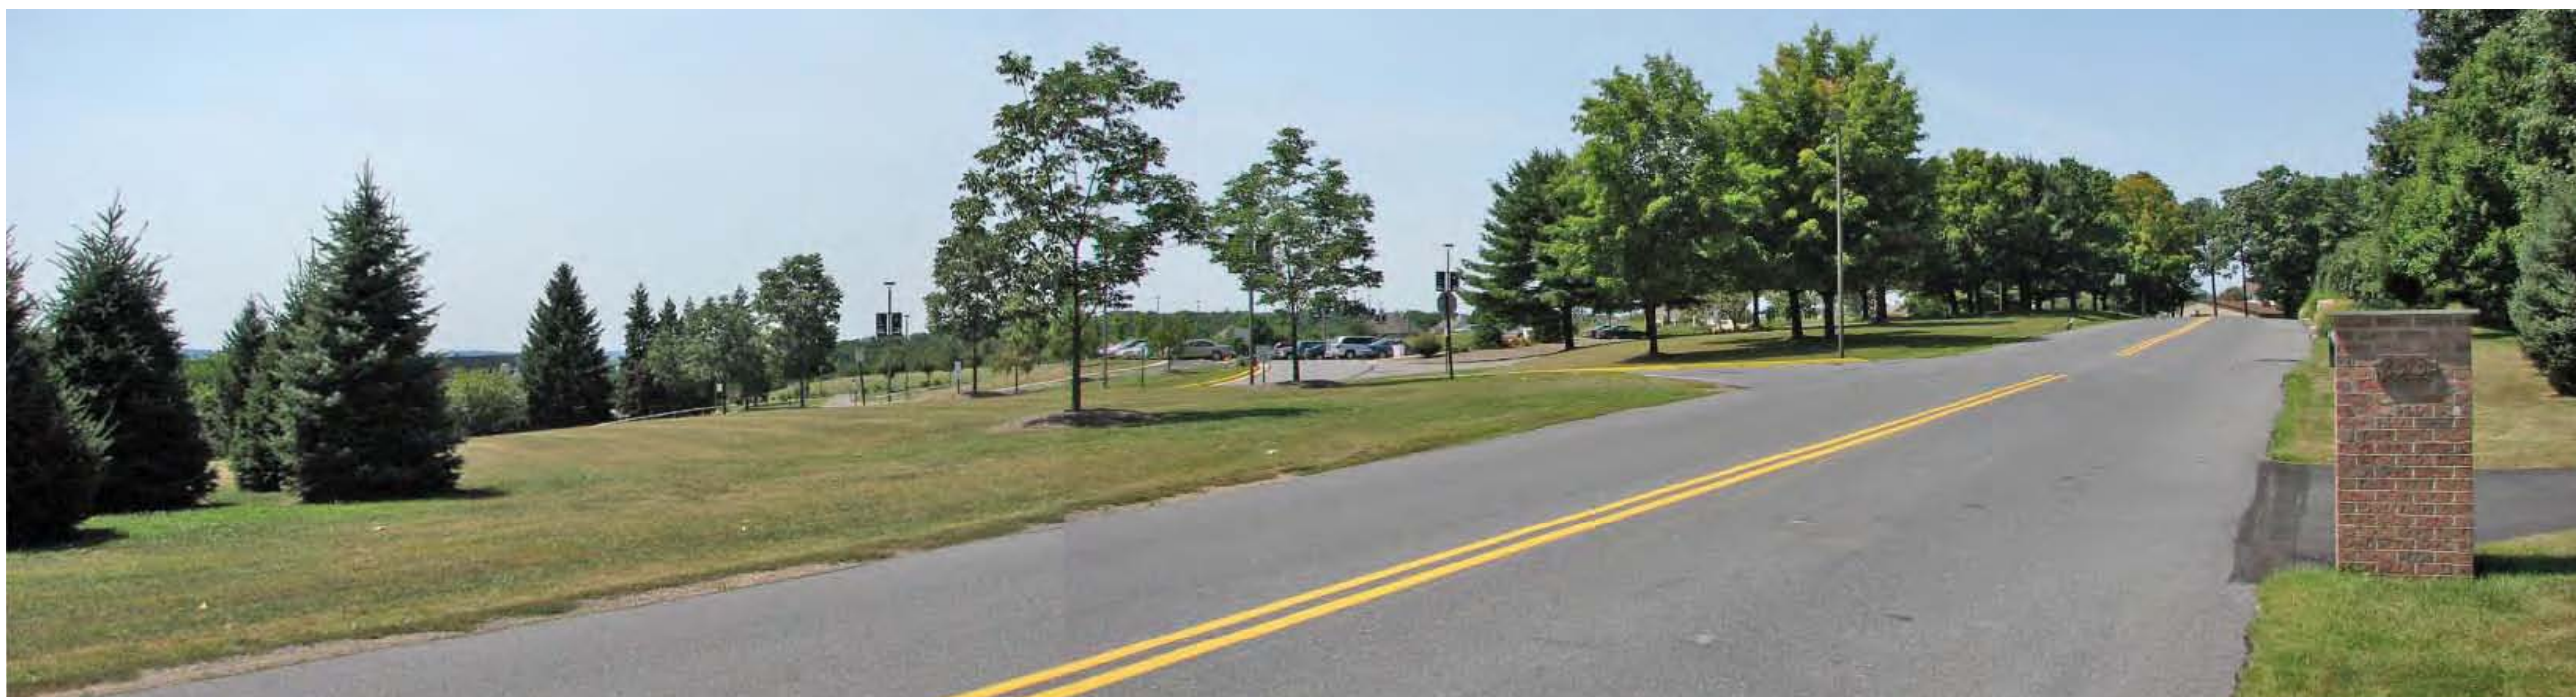
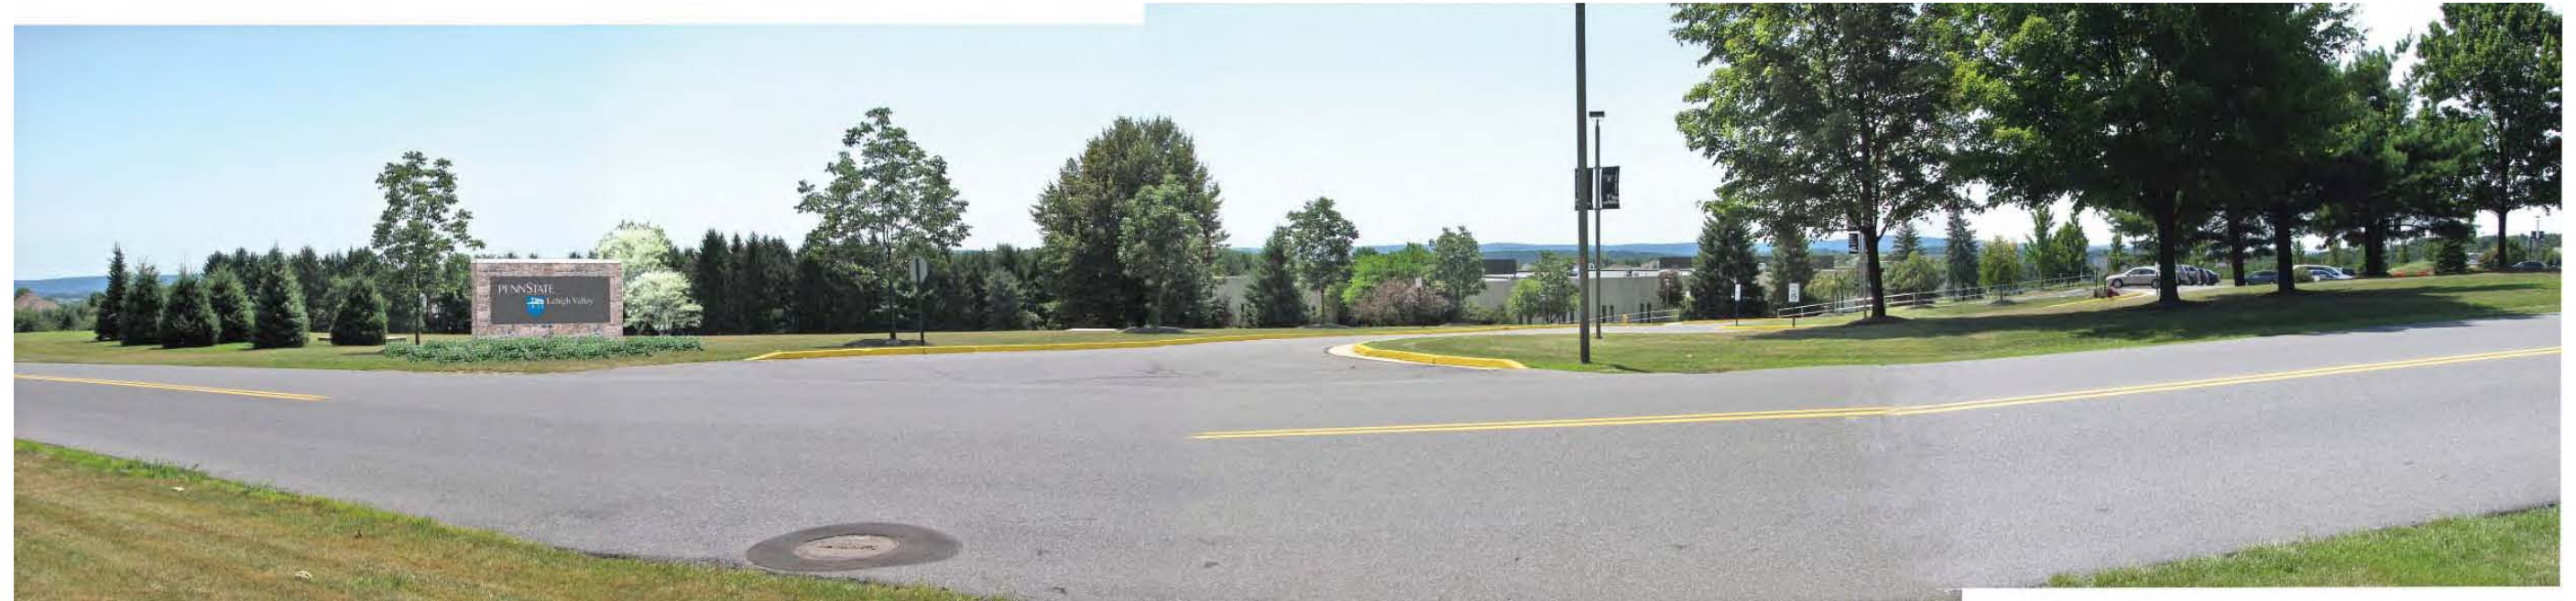
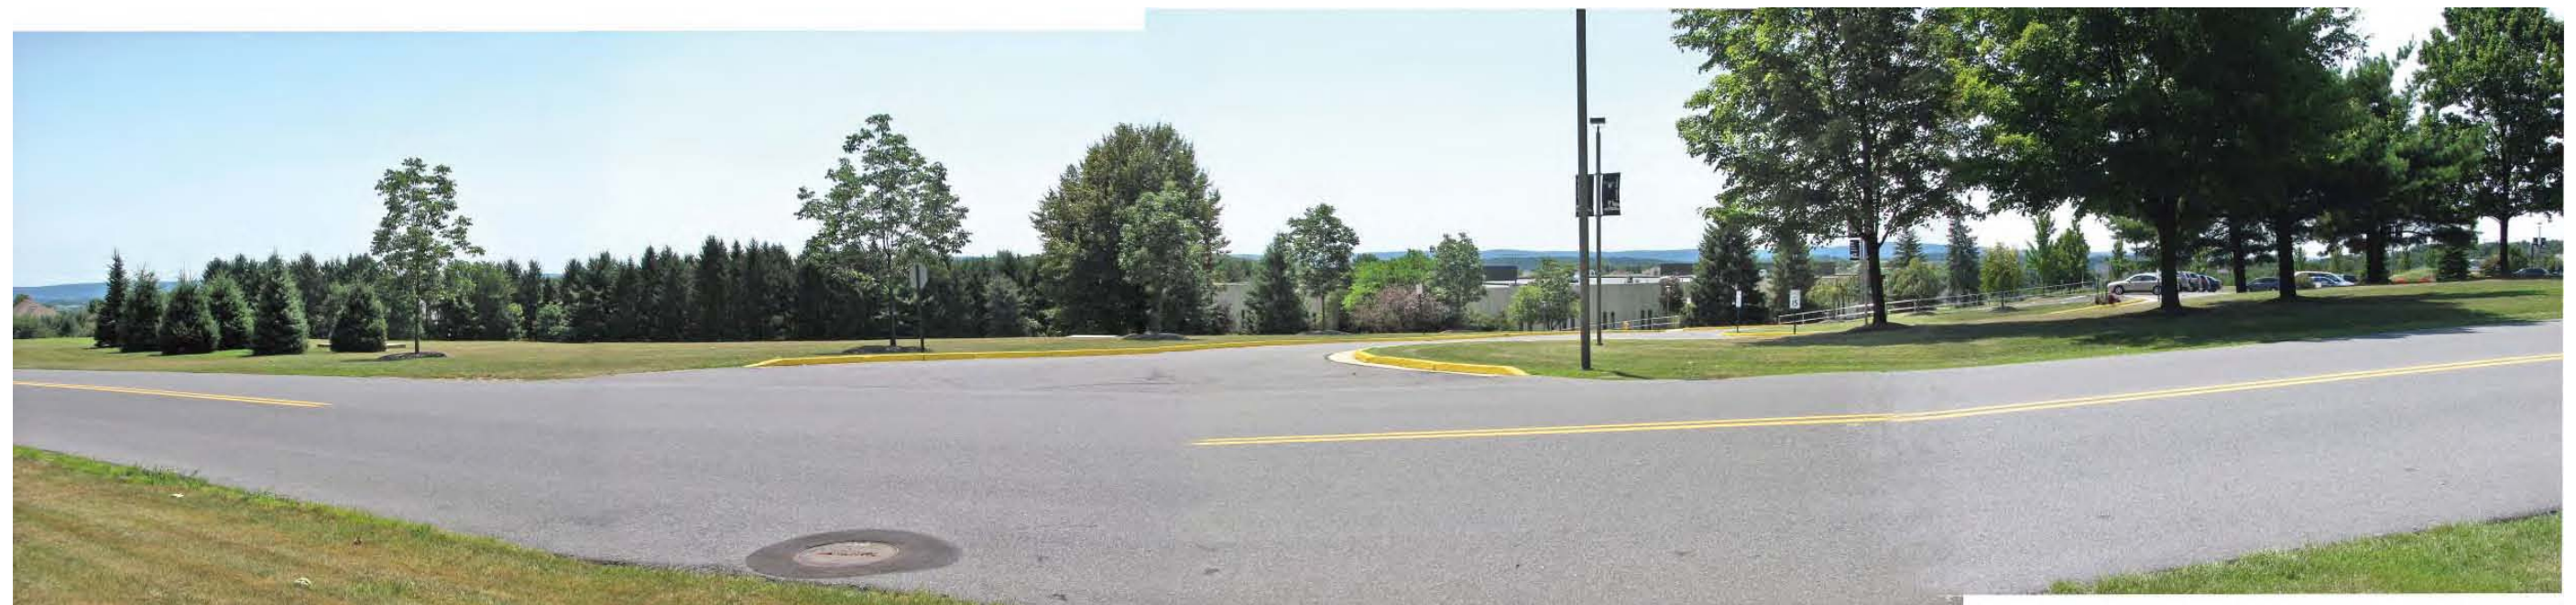
# Campus Identification Sign 4a

One objective of the CEAP program is to unify the Penn State “brand” across the state. The signature mark of the campus should be displayed using standard colors and typeface. The main entrance sign is typically located near the primary campus entrance as a directional cue in addition to identifying the campus.

Recommend the installation of a new sign on a masonry structure. The illustration depicts the size, scale and proportion being recommended. The graphics on the following pages simulate the appearance of the sign from the eastbound and westbound vehicular approaches.

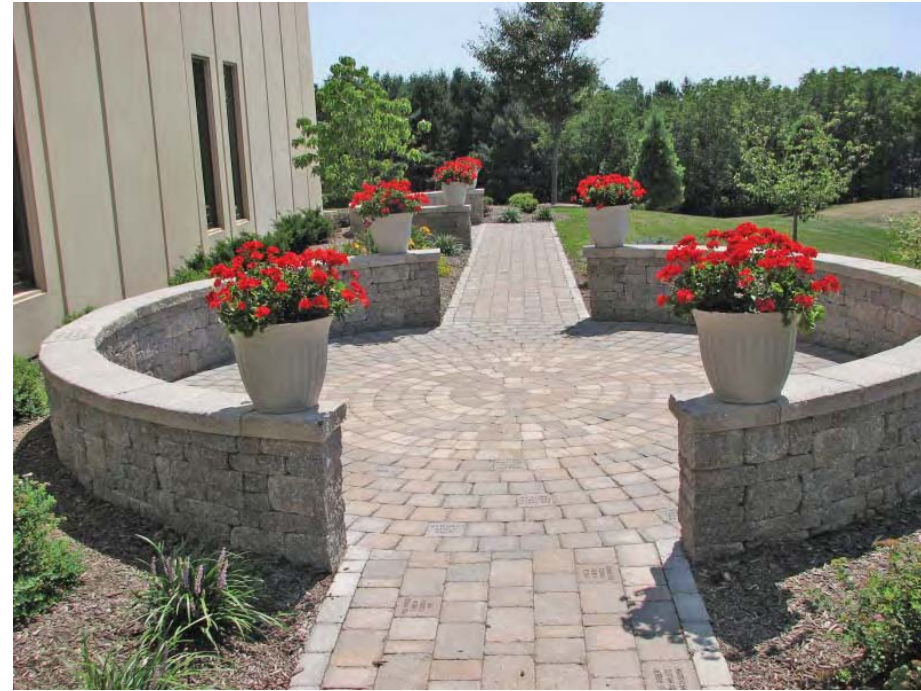
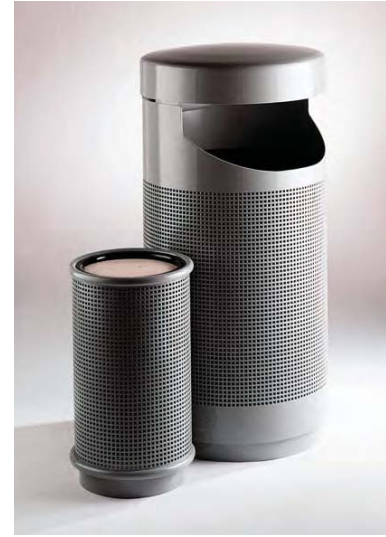
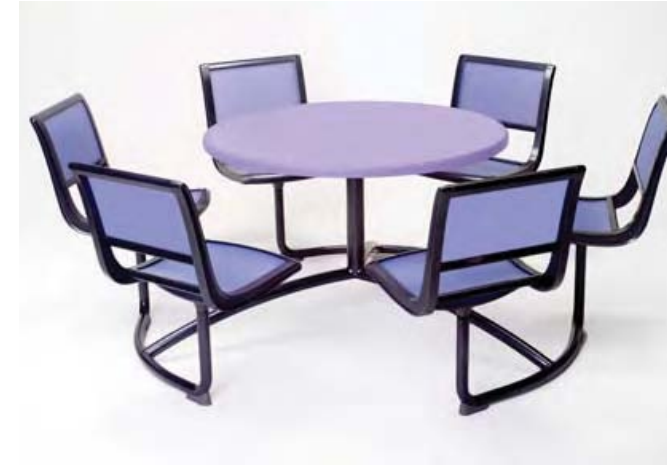
# 4c Site Furnishings Improvement Recommendation

Site furnishings surrounding the Academic Building are mismatched stylistically.

It is also noted that the garden space south of the Academic Building is not suitably furnished for seating. The bench style illustrated here is available in curved segments that can be integrated into the masonry cove walls that presently exist. The walls themselves are too high and narrow to provide comfortable seating.

Recommend the replacement of all benches, tables, trash receptacles and movable planters with appropriately scaled furnishings from a stylistic "family" to unify the aesthetics of the campus exterior.

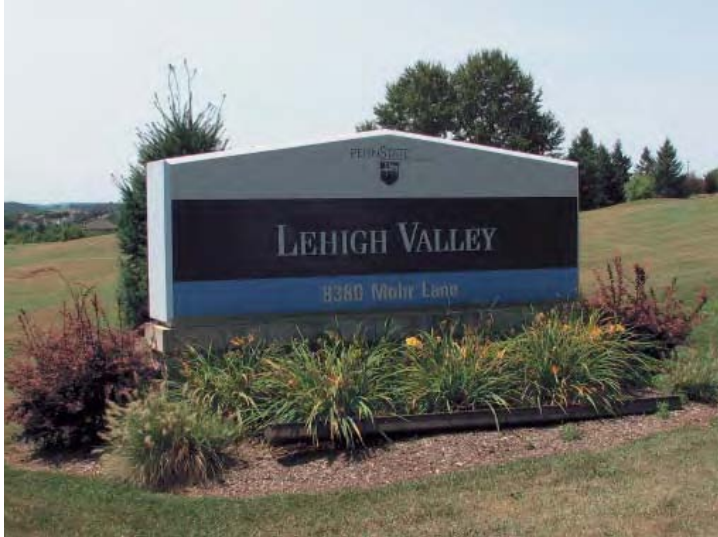
# Sign Removal 4d

Existing campus identification signs do not comply with University signage and graphic standards.

Recommend the removal of antiquated signage and replacement with new.

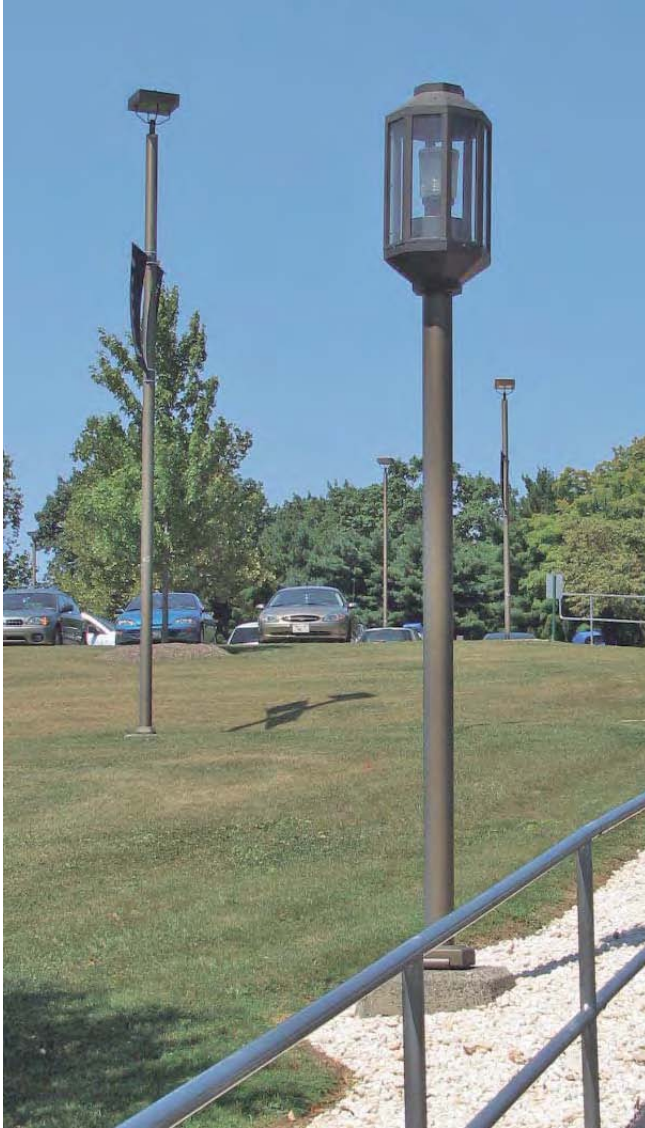
# Site Lights <sup>4e</sup>

Existing site lights at the campus are stylistically uniform and most are in good working order. However, the type of luminaire does not provide a cut-off refractor to prevent light pollution and excess glare.

If and when the manufacturer produces a retrofit that will provide illumination cut-off it is recommended that the existing fixtures on campus be modified. Metal halide lamping is also advised due to the quality of the light produced.

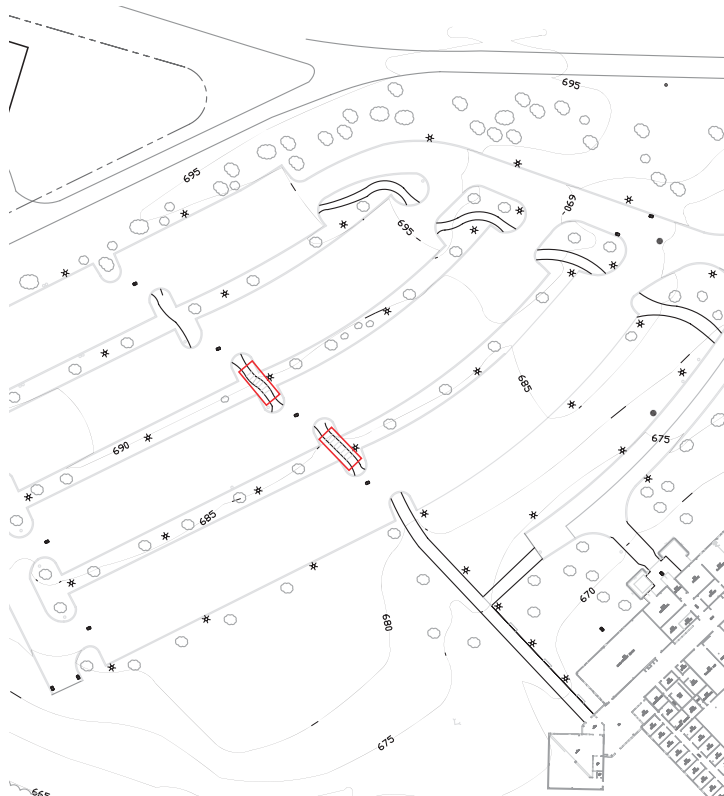
# Stair Railing 4f

Safety codes mandate the placement of handrails on the outside edges of exterior stairs.

New handrails should match existing designs on campus.

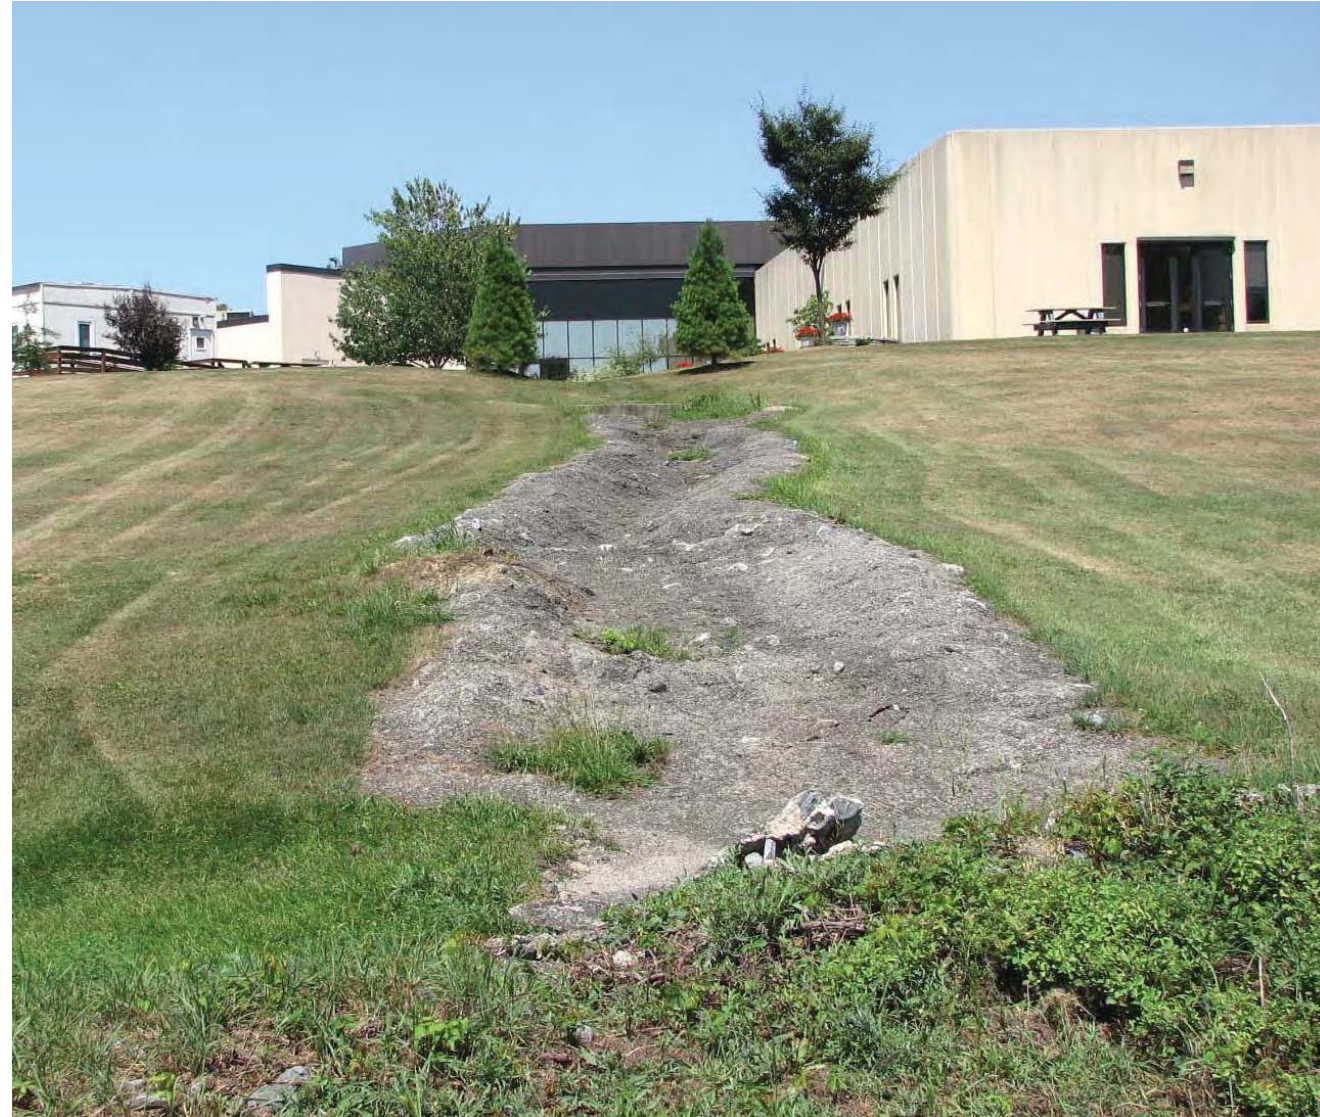
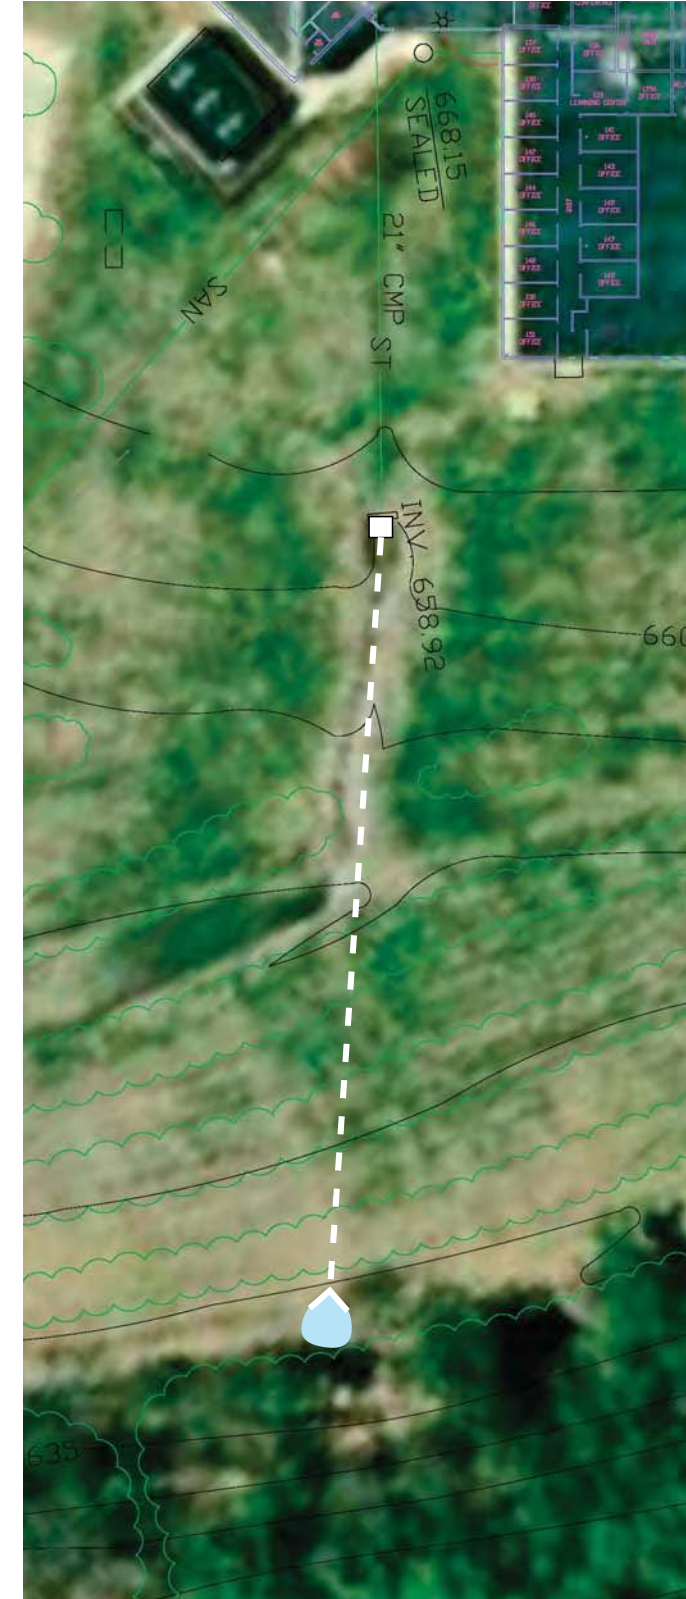
# Drainage Mitigation 4g

The existing asphalt lined swale at the discharge end of the storm sewer is problematic on several levels. In addition to being unsightly, the current condition is a maintenance problem.

The remedy to the current condition is installation of a storm sewer junction box at the end of the existing pipe and a new underground conveyance to a discharge location down slope. The outlet of the new pipe will require soil stabilization to prevent erosion at this water concentration point.
