# CAMPUS EXTERIOR ARCHITECTURAL PLAN

September 2003

Prepared by:  
Pennsylvania State University  
Office of Physical Plant  
Division of Campus Planning and Design

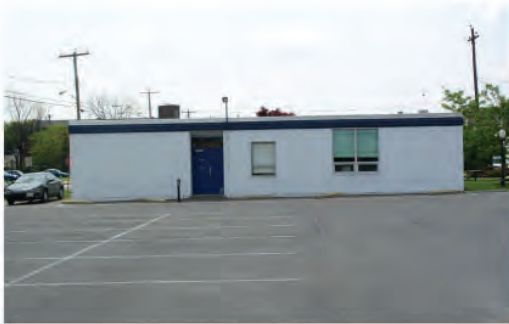
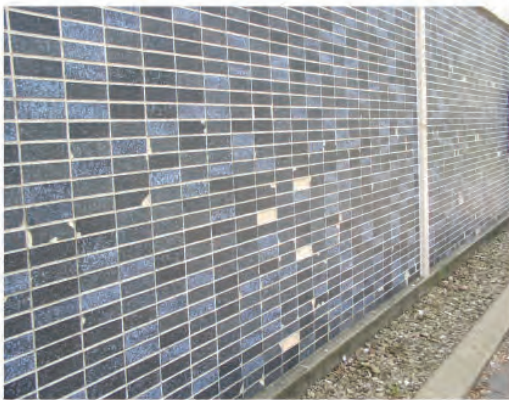
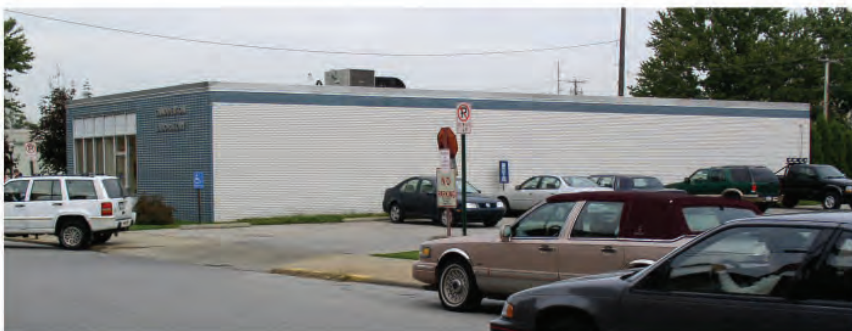
Deteriorating wall finishes and siding material are noted on Black and Bashore Building and McDowell Hall.

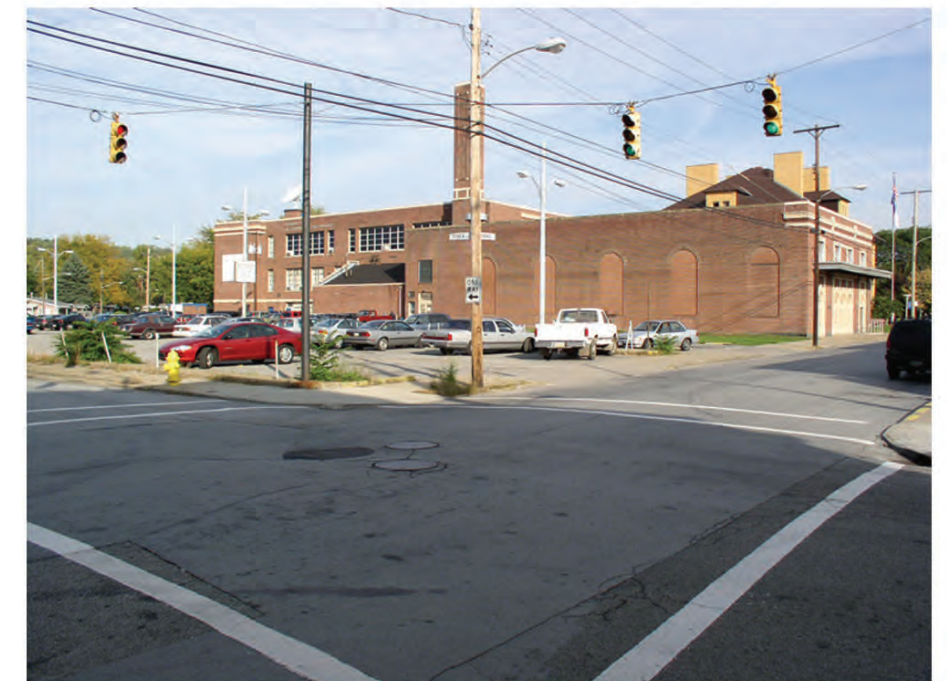
Before

The primary approach to campus is characterized by the stark facade of the south side of the auditorium wing of Sharon Hall and a deteriorated parking lot. A busy civic use occupies the opposite corner in the City of Sharon post office.

The opportunity exists to create a multi-functional parklike area. In addition to the softening effect of landscape plantings, the space can provide seating as well as an identification signage opportunity on the masonry corner wall.

Construction cost to establish the park is estimated to be in the range of \$50,000 to \$100,000.

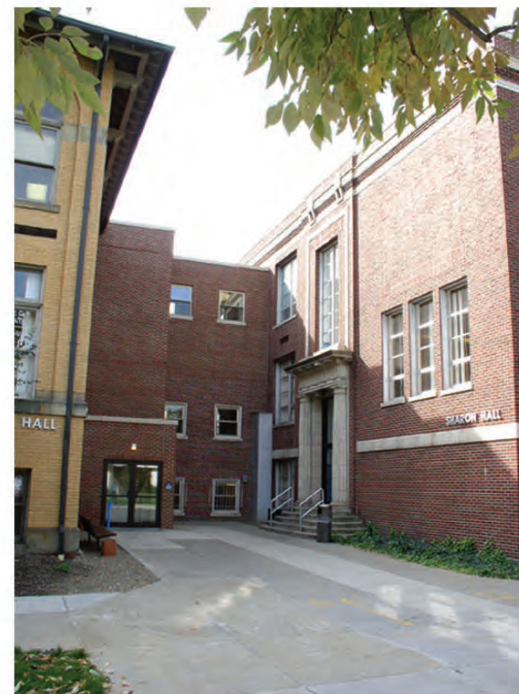
Before

Lecture Hall and Sharon Hall join to form one of the most active open spaces on campus. The space is currently underdeveloped and poorly furnished. The opportunity exists to create an appealing outdoor gathering area while at the same time strengthening the existing east-west pedestrian mall.

Recommend installation of enhanced paving material and seating in addition to a focal element at the intersection of the mall walkways.

Construction cost for a project of this magnitude using quality materials could exceed \$100,000.

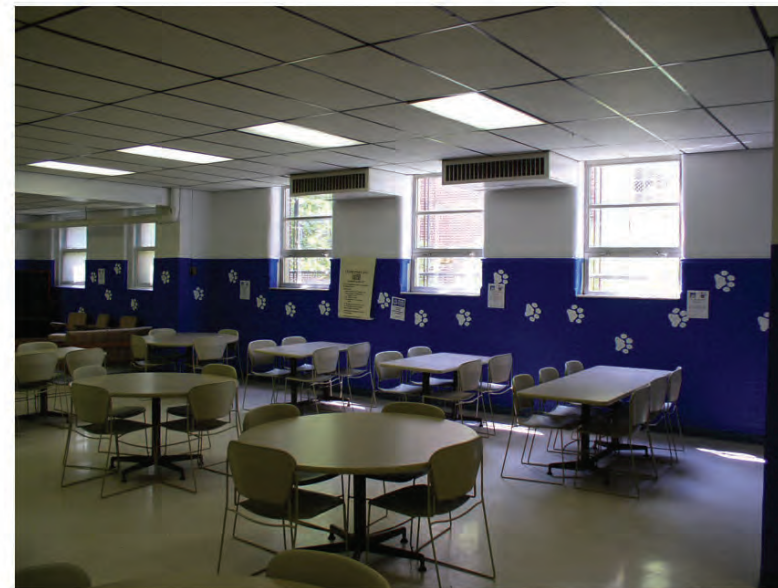
Before

The existing courtyard space between Lecture Hall and the auditorium wing of Sharon Hall is a dead space without purposeful use. The opportunity exists to provide an outdoor access to the student lounge space in the basement of Lecture Hall which can also function as breakout space for the auditorium.

Recommend storefront window and door replacement along south face of Lecture Hall and landscape improvements to courtyard space.

Construction costs for a project of this magnitude including architectural modifications to provide access to Lecture Hall could exceed \$100,000.

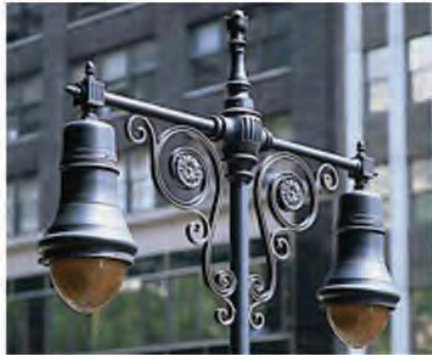
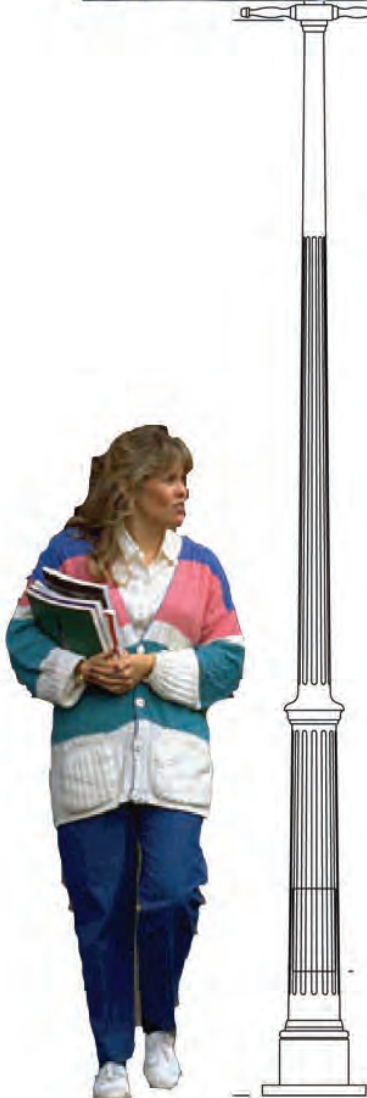
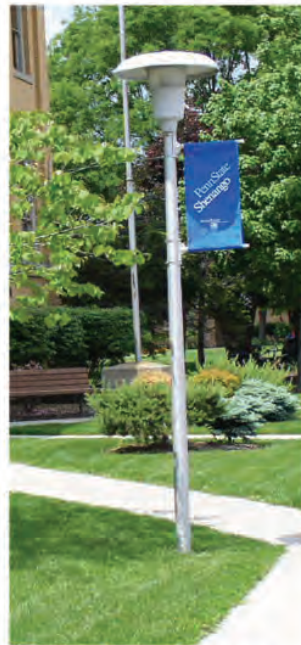
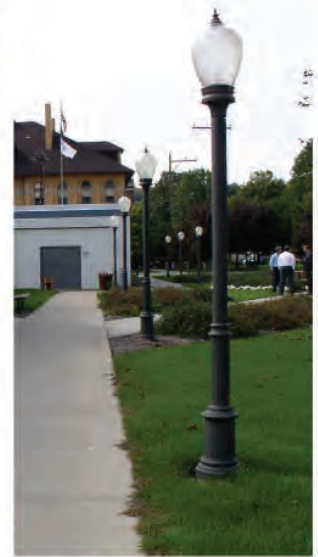
Existing campus light fixtures

Campus lighting is inconsistent stylistically with respect to luminare and lamp type as well as pole design and color. The campus currently does not benefit from the unifying effect of a comprehensive exterior lighting scheme.

Recommend replacement of all existing lights with metal halide, cut-off fixture that is distinct stylistically, yet complimentary to City of Sharon period style street lights.

Cost for complete replacement and supplementation of existing lights is estimated to be in excess of \$100,000. System design and cost estimation by a licensed professional will be necessary.

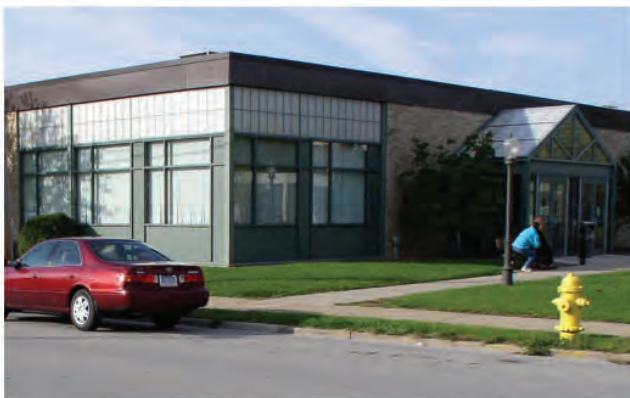
Before

As with Chadderton Lab, the color scheme of the Black and Bashore Building is not complimentary to the colors used on other principal campus structures. In addition, the existing siding on this structure is in disrepair. This structure flanks the entrance to the pedestrian mall opposite the library forming a “bookend” to this campus gateway.

Recommend siding repair and painting the building in a color scheme compatible with that of the library. The estimated construction cost for this improvement is in the range of \$25,000 to \$50,000 depending on the condition of the existing siding.

Consideration should be given to complete removal and/or replacement of this structure at some point in the future.

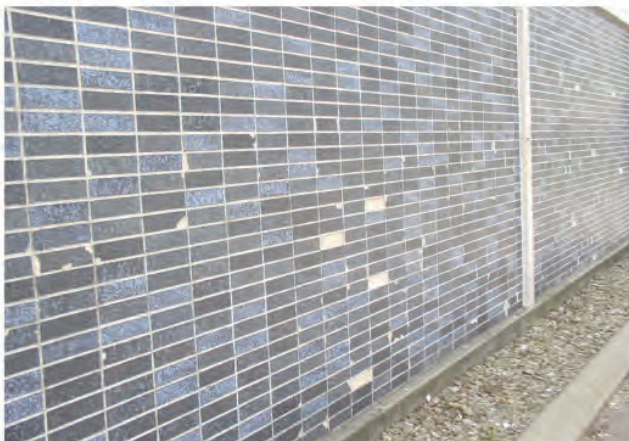
Before

As with Chadderton Lab, the color scheme of the Black and Bashore Building is not complimentary to the colors used on other principle campus structures. In addition, the existing siding on this structure is in disrepair. This structure flanks the entrance to the pedestrian mall opposite the library forming a “bookend” to this campus gateway.

Recommend siding repair and painting the building in a color scheme compatible with that of the library. The estimated construction cost for this improvement is in the range of \$25,000 to \$50,000 depending on the condition of the existing siding.

Consideration should be given to complete removal and/or replacement of this structure at some point in the future.

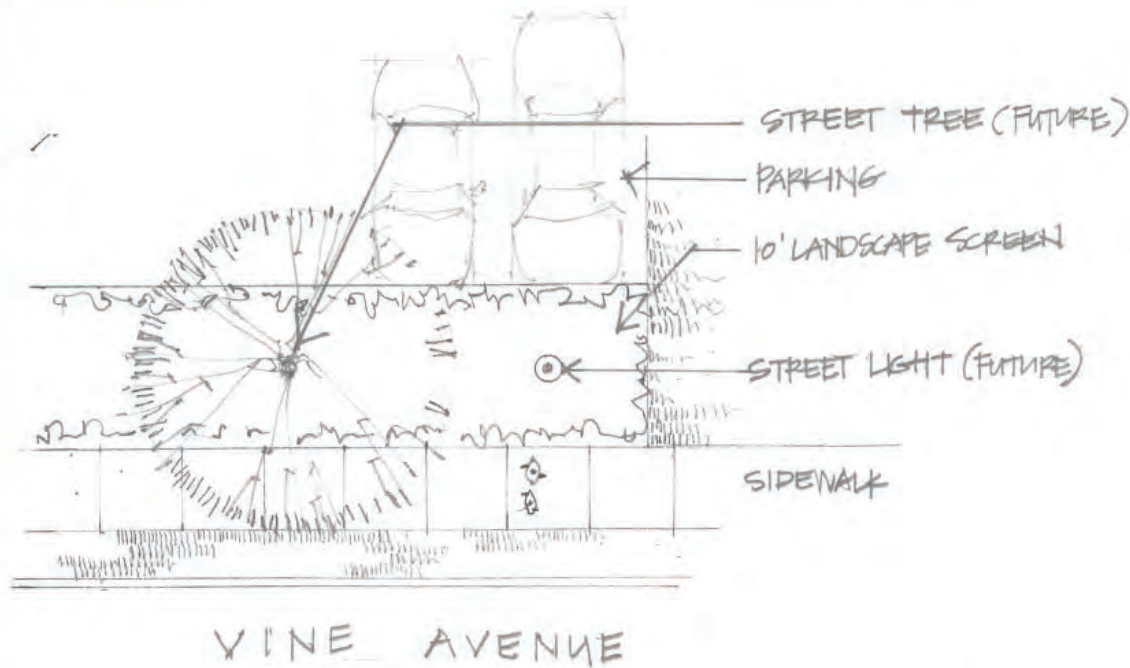
Before

Parking lots east of Shenango Avenue have been developed without the benefit of landscape screening to adjacent streets. The addition of plantings between parked cars and sidewalks will help to define campus edges as well as softening the harsh appearance of pavement and cars.

Establishment of screening will require removal of some pavement and replacement with suitable soil material and planting. Estimated construction cost range for this improvement is \$45,000 to \$50,000.

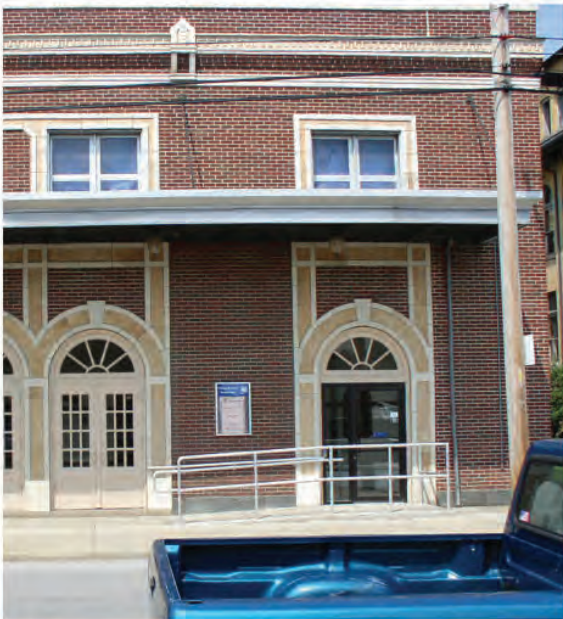
Before

Auditorium ramp with handrail was installed to meet requirements of the ADA for accessibility by those with handicaps. A preferred solution to the installation of pipe railing would be to adjust the slope of the walking surface to eliminate the step thereby eliminating the need for railing. This simple improvement will meet ADA requirements while at the same time eliminating an obstruction in the walking surface that doesn't compliment the architectural style of the building.

Recommend removal of the railing and replacement of the concrete sidewalk to eliminate the step into the building.

The estimated construction cost range to complete this improvement project is \$4,000 to \$4,500.

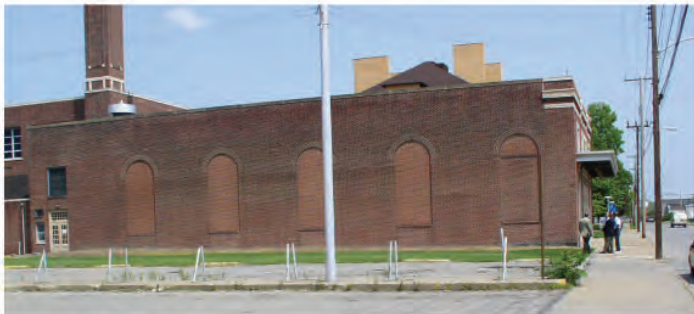
Before

The arched windows on the north and south sides of the auditorium have been sealed inside and out. The opportunity exists to restore the openings with glazed windows to improve the aesthetic quality of the building facade as well as the quality of the interior lighting.

The construction cost to accomplish this project have been estimated to be in excess of \$100,000.

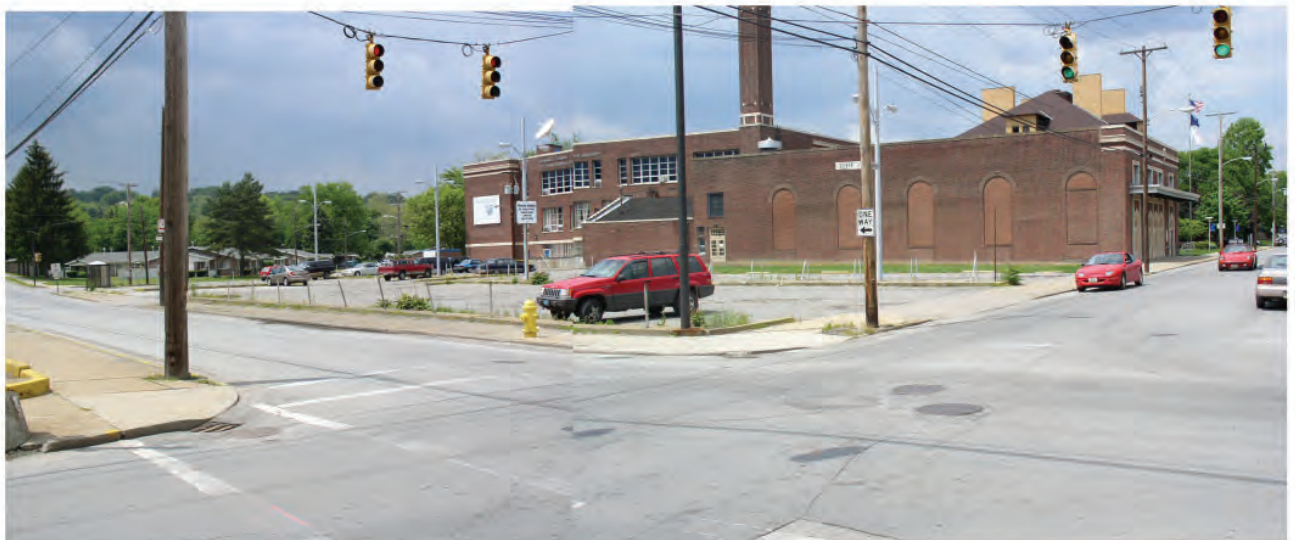
Before

The corner of Shenango Avenue and Silver Street is currently occupied by a parking lot in degraded condition. Such an image is not suitable at the main entry to campus.

Upon reaching agreeable lease terms with the current owner, recommend removal of bituminous paving and concrete islands and replacement with a lawn surface and hedge screening. The estimated construction cost range for this project is \$15,000 to \$20,000.
