Penn State  
All Greater  
Allegheny

Campus Exterior Architectural Plan  
April 2010

# Contents

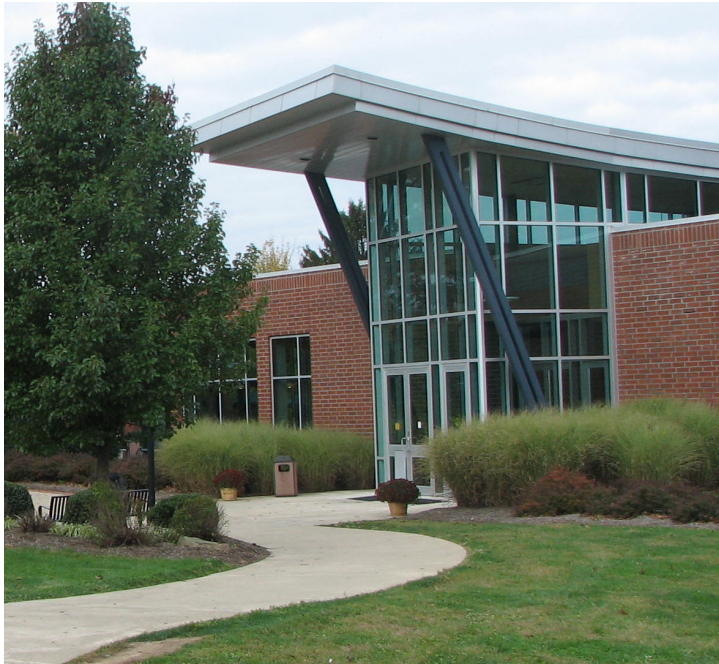
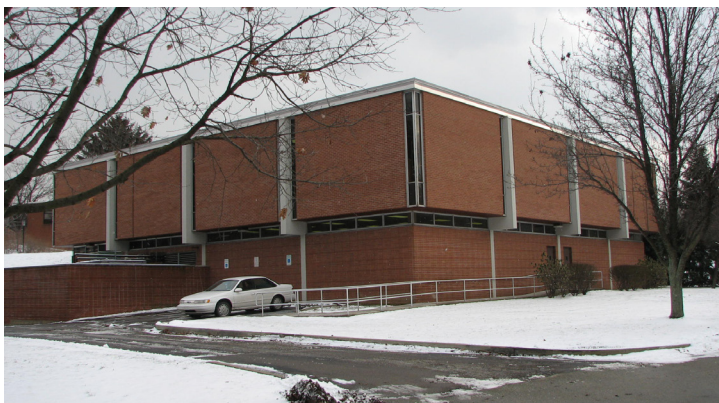
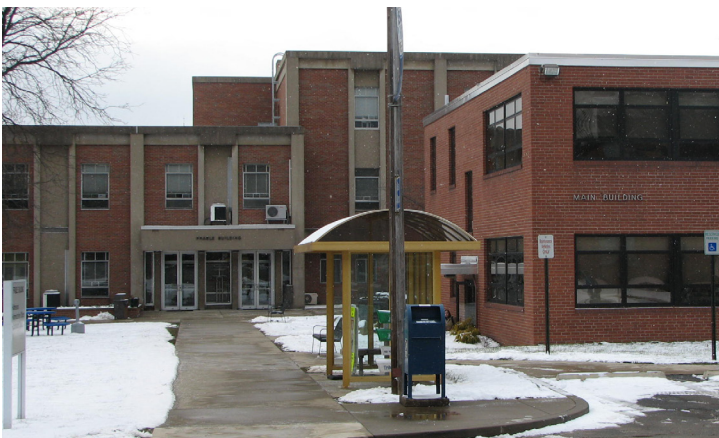
At Greater Allegheny, the architecture of the campus is unified through the use of brick masonry. The structures are appropriately scaled.

The unadorned mid 20th century design style is prevalent in all campus buildings.

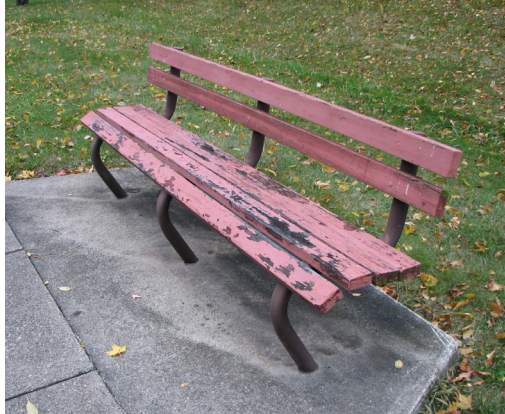
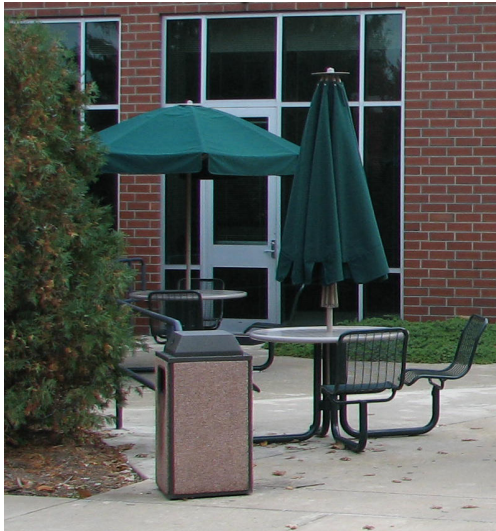
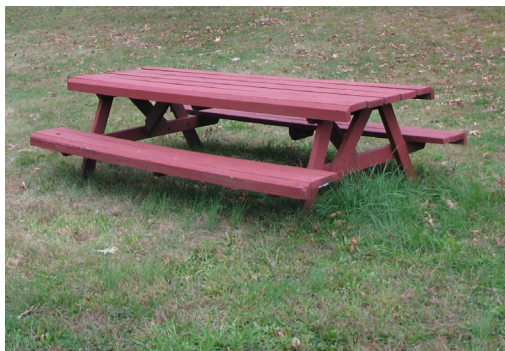
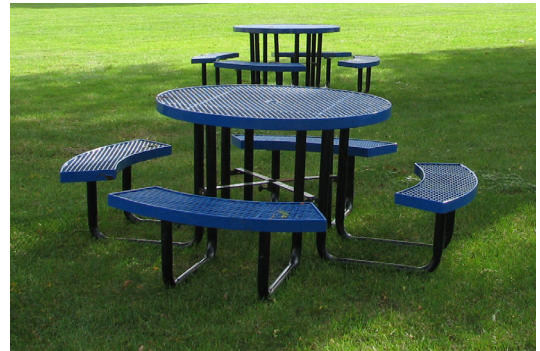
Benches, trash receptacles and tables are varied with respect to design style, material, color and quality.

Site furnishings designed in a style “family” are aesthetically unifying.

Wooden furnishings should be eliminated and/or replaced.

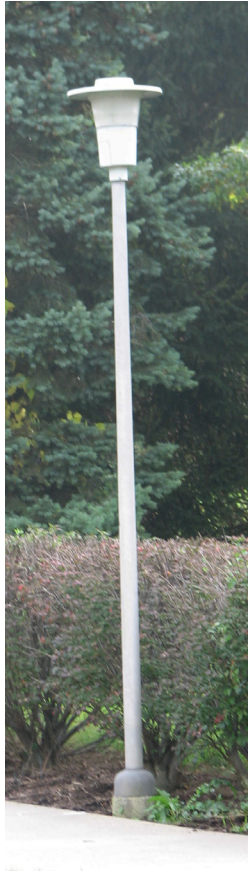
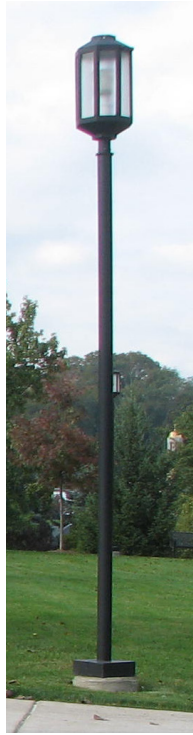
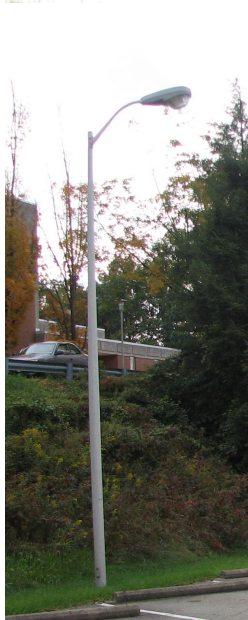
The style of walkway light fixtures varies across campus. As replacements are installed over time the style should be standardized. “Cobra head” parking lot lights should be replaced with the “shoebox” style fixture to minimize light trespass and improve efficiency.

Replacement of any antiquated, inefficient pedestrian walkway and parking lot lighting is recommended. Metal halide lamps in cut-off luminaires mounted to poles are recommended for pedestrian walkways. High pressure sodium type lamps are acceptable for parking lot lights. Newly emerging LED technology may also be considered.

Color/finish for all fixtures should be consistent campus wide. Avoid the use of bollards due to vulnerability to snow removal operations and vandalism. It is also recommended that wall mounted “utility style” fixtures be avoided.

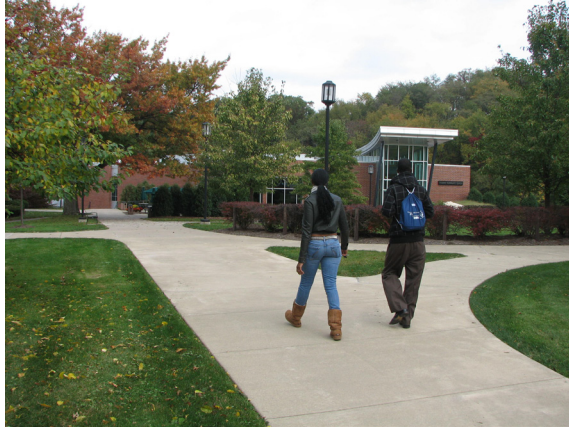
The landscape of Greater Allegheny campus is characterized by mature shade trees, and modestly sized lawn areas. Concrete walkways are appropriately located and sized creating a comfortable pedestrian friendly feel.

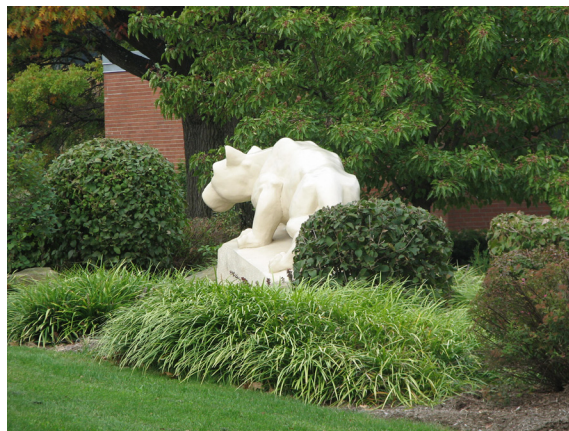
Mature trees dot the academic core. Understory plantings including shrubs and groundcover are appropriate.

Routine maintenance of trees and shrubs should include removal of dead wood and total replacement of poor quality or dead specimens.

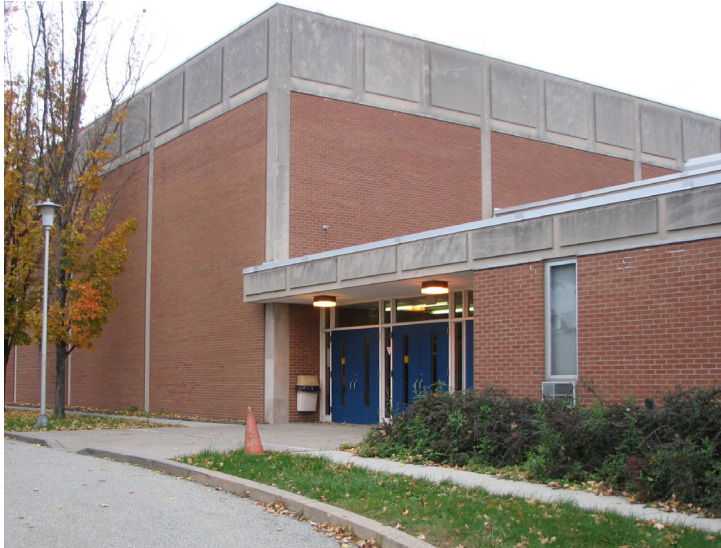
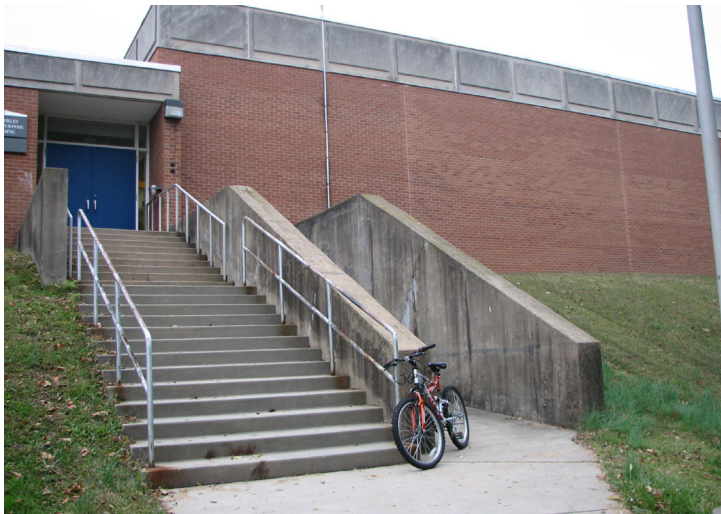
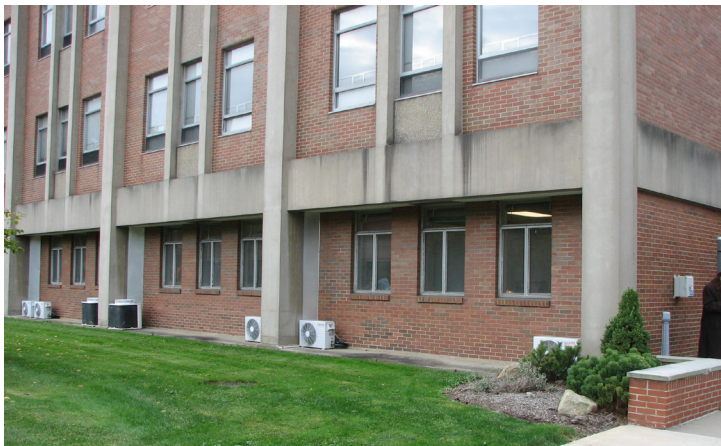
# Power Wash

Over time, masonry becomes dirty and stained. Routine maintenance should include power washing to remove dirt and brighten masonry.

Wunderly Multi-Purpose Building

Frable Building

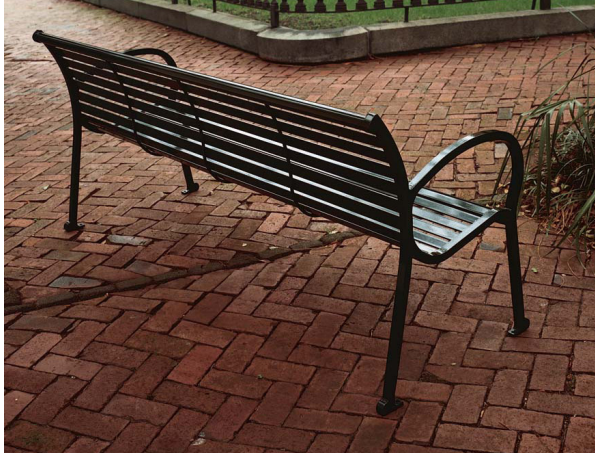
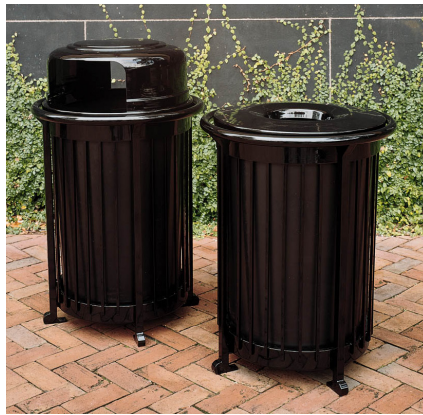
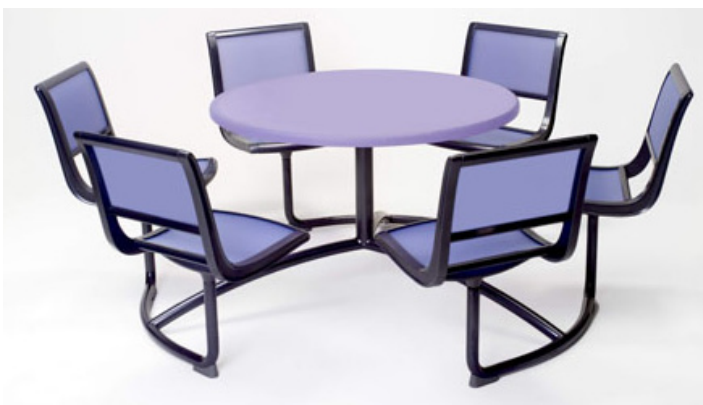
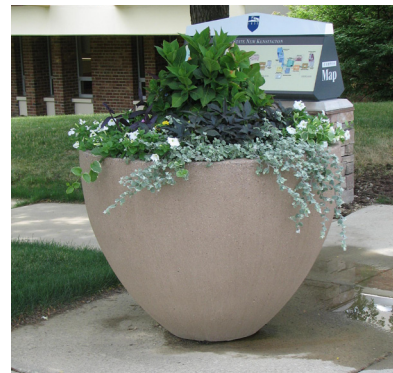
## 2A

Overly stylized and colorful designs should be avoided because their appeal wanes before their useful life.

Freestanding landscape planters should be appropriately designed and sized for the space they occupy and be constructed of durable, quality material.

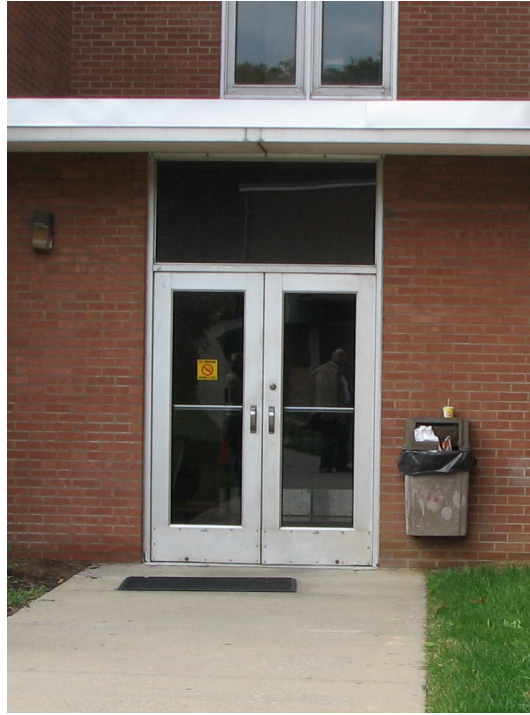
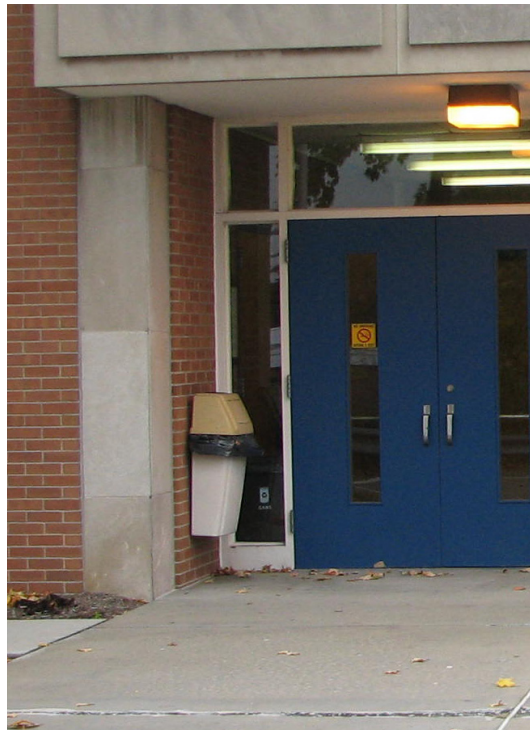
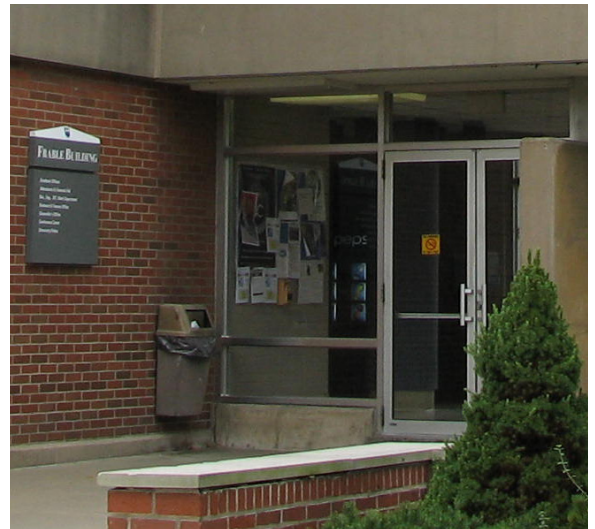
## 2B

Existing

Wall mounted plastic trash receptacles should be replaced with a new campus standard fixture that compliments the style of other site furnishings. See 2A

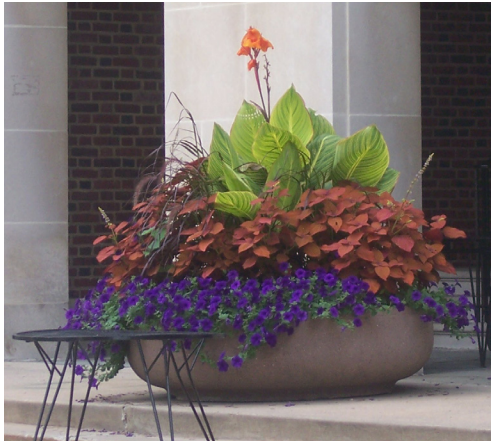
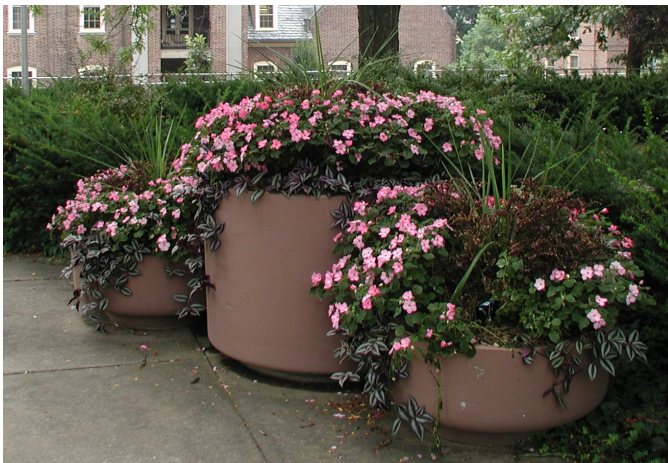
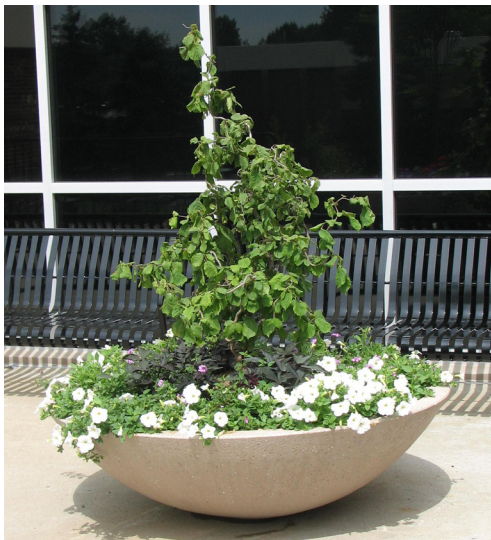
The use of perennial and annual flowering plants should be limited to high impact areas. The aesthetic value of flowering plant displays peaks when the campus is least populated. Perennials and annuals also require the most intensive maintenance effort.

A more dramatic visual effect can be achieved by confining annuals and perennials to appropriately scaled containers placed strategically near building entrances and outdoor gathering spaces.

Examples of container plantings designed to incorporate all types of vegetation with dramatic visual effect

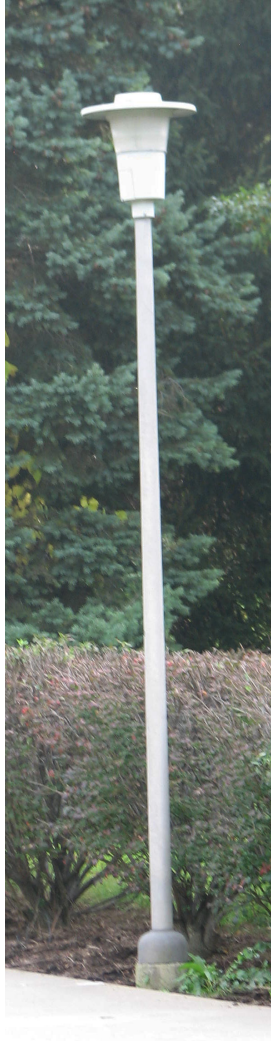
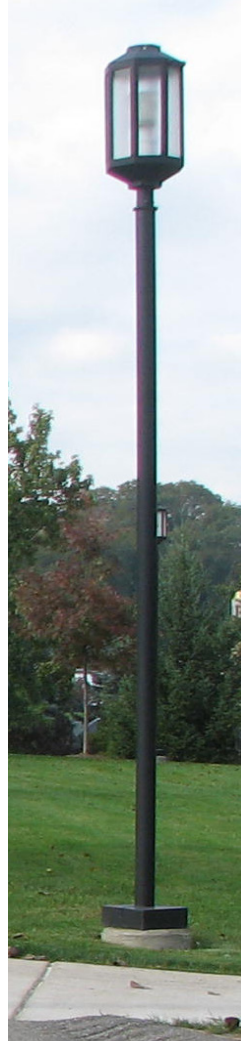
# Lighting

Old

New

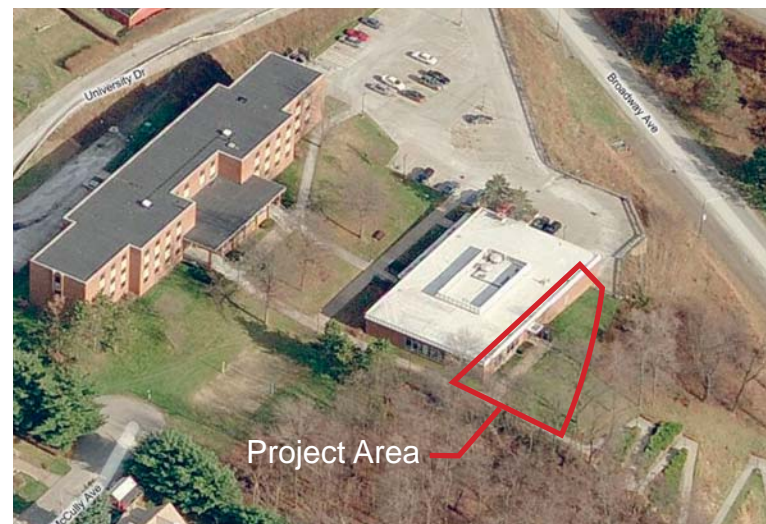
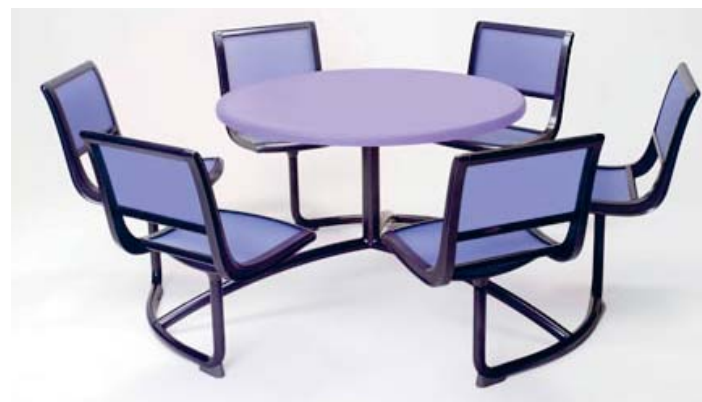
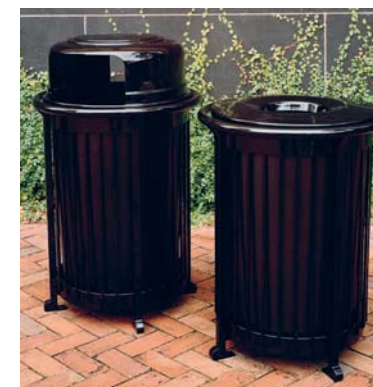
The opportunity exists to establish a small outdoor gathering space overlooking campus on the south side of the newly renovated Fitness and Cultural Center.

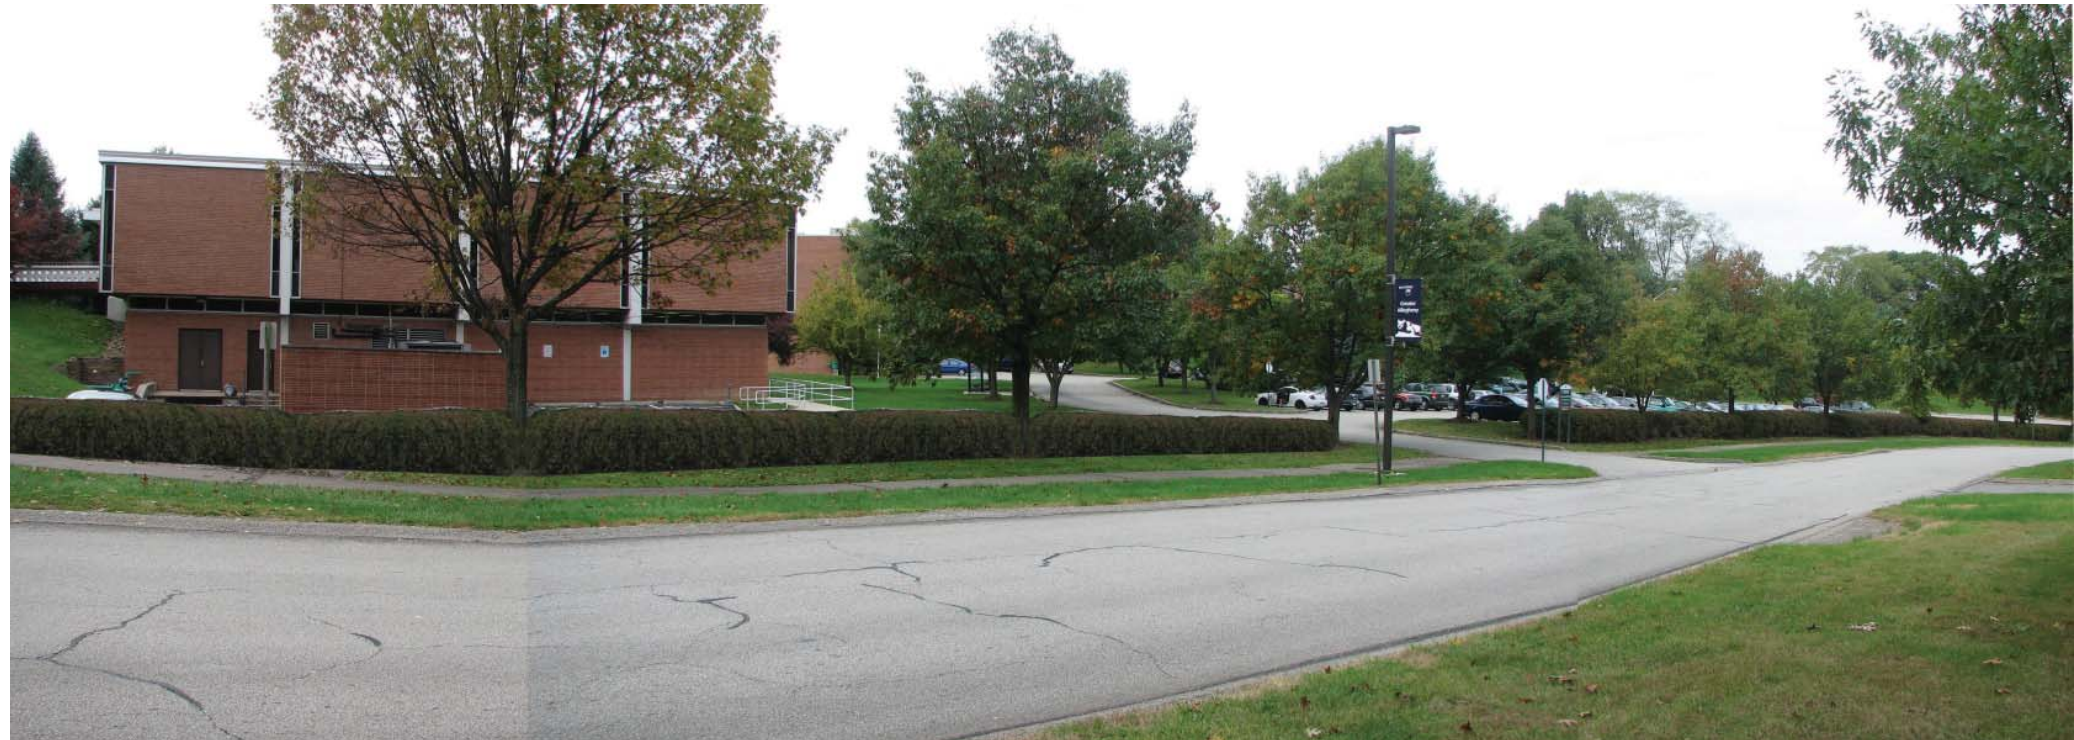
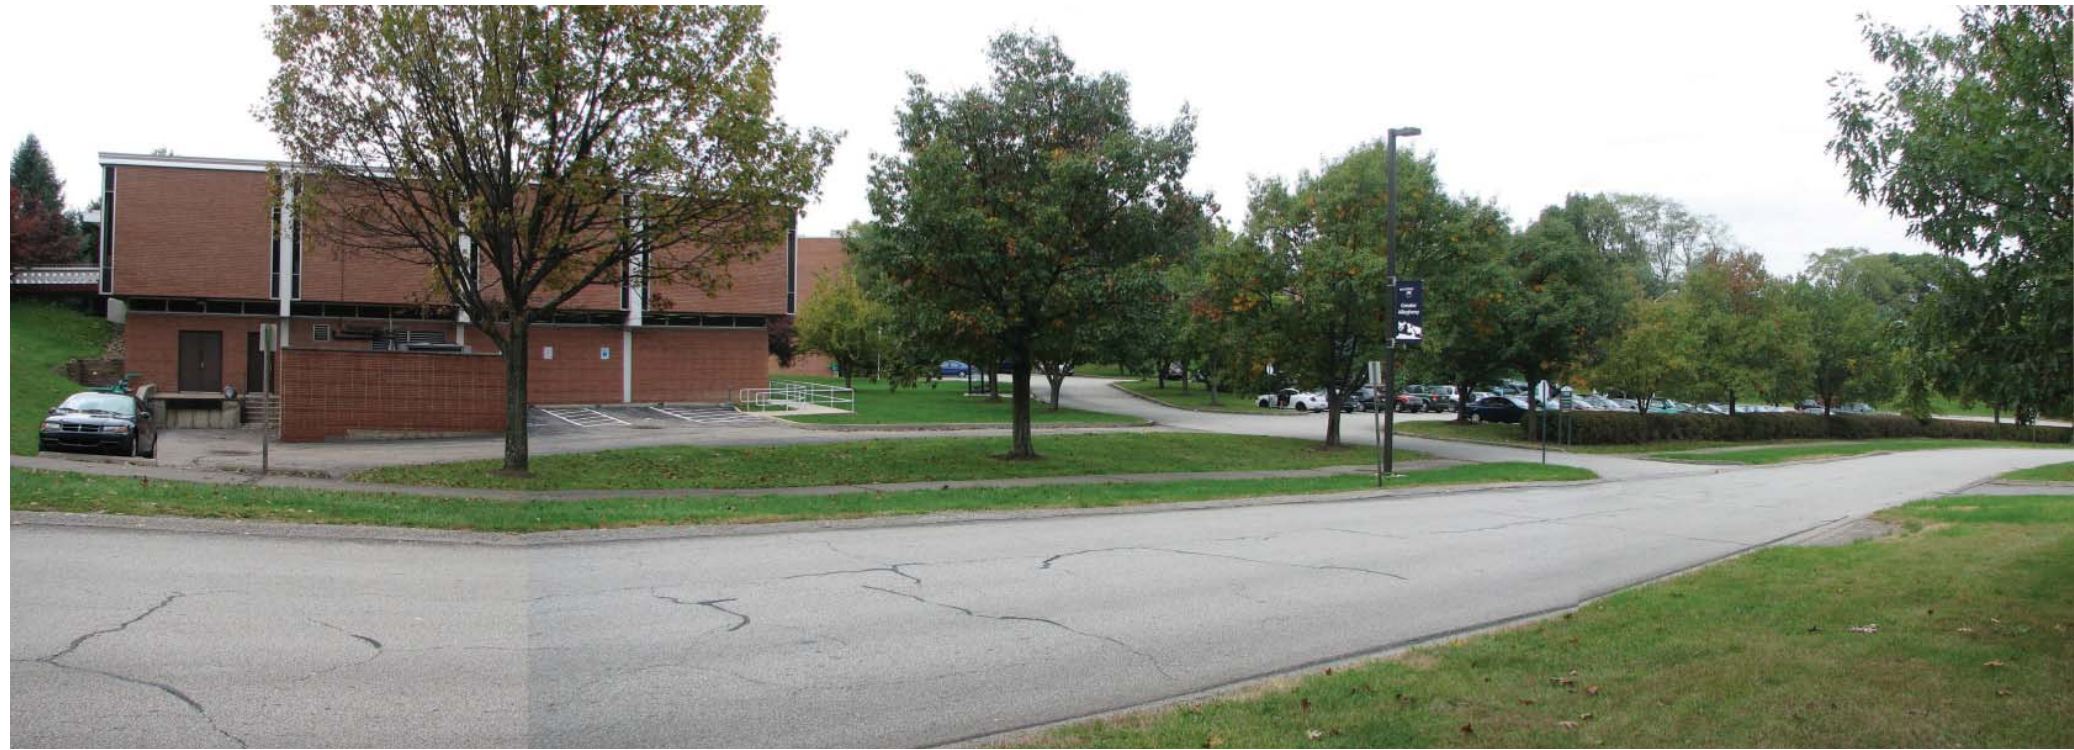
# Parking Lot Landscape

The loading dock and parking lot between Kelly Library and Broadway Avenue is unscreened.

After

Before

This first impression of campus can be improved through the installation of additional landscape plantings as shown conceptually on the simulation at left. It represents a continuation of the existing shrub hedge lining the lots to the north.

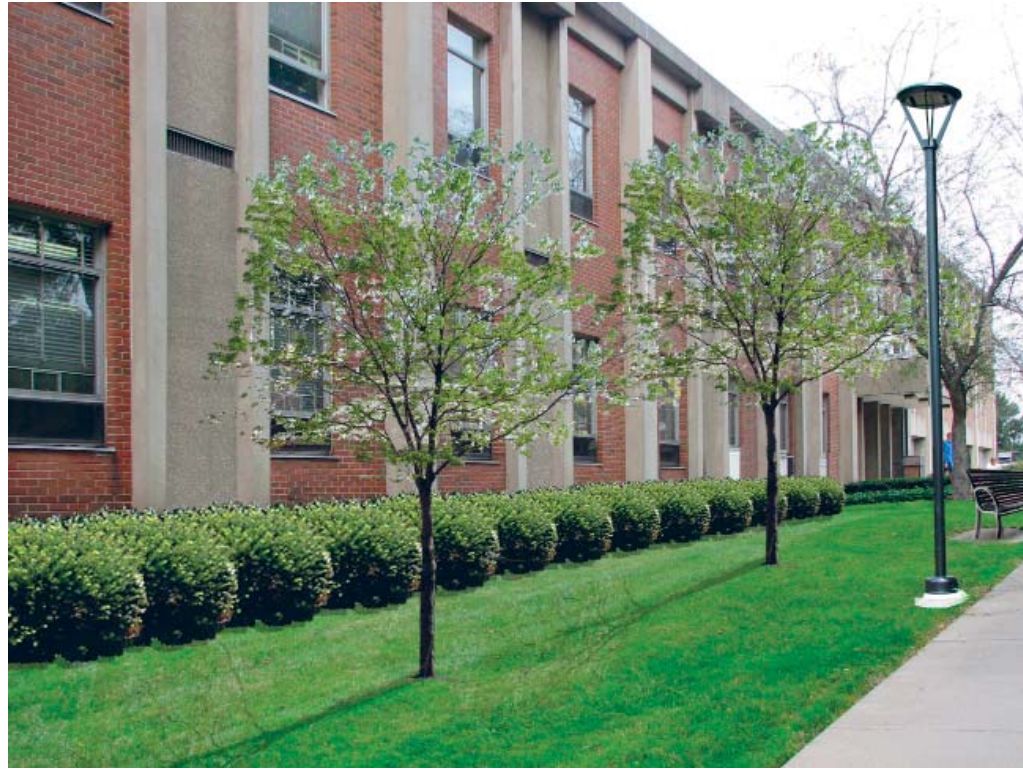
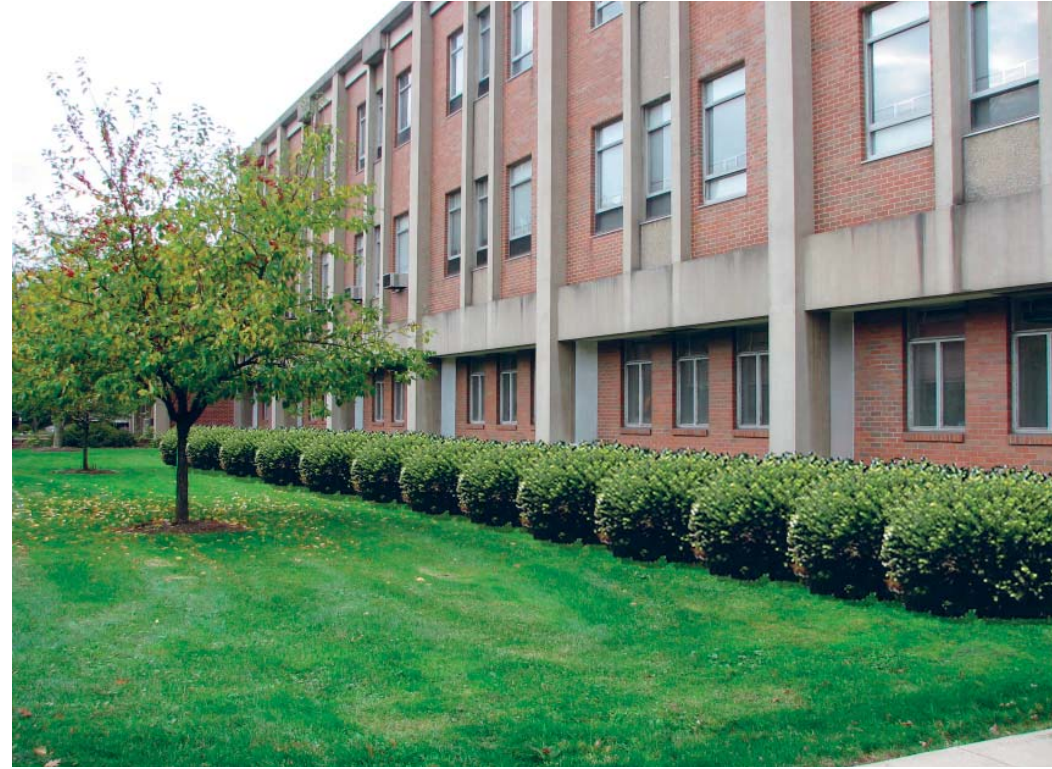
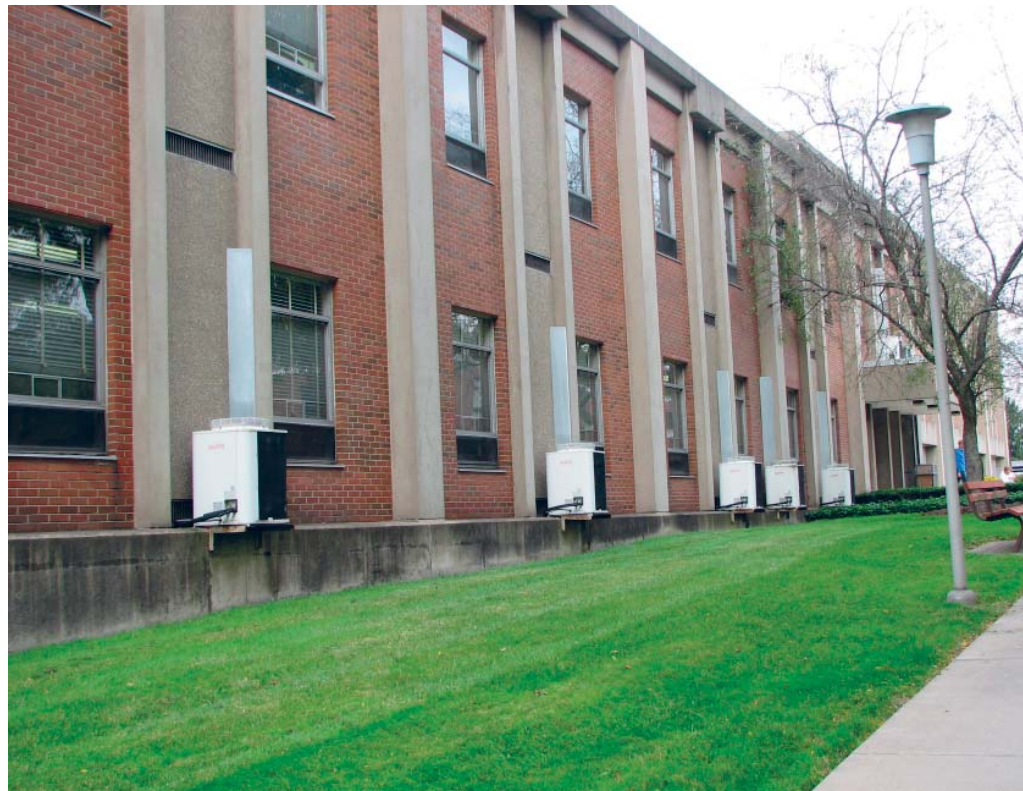
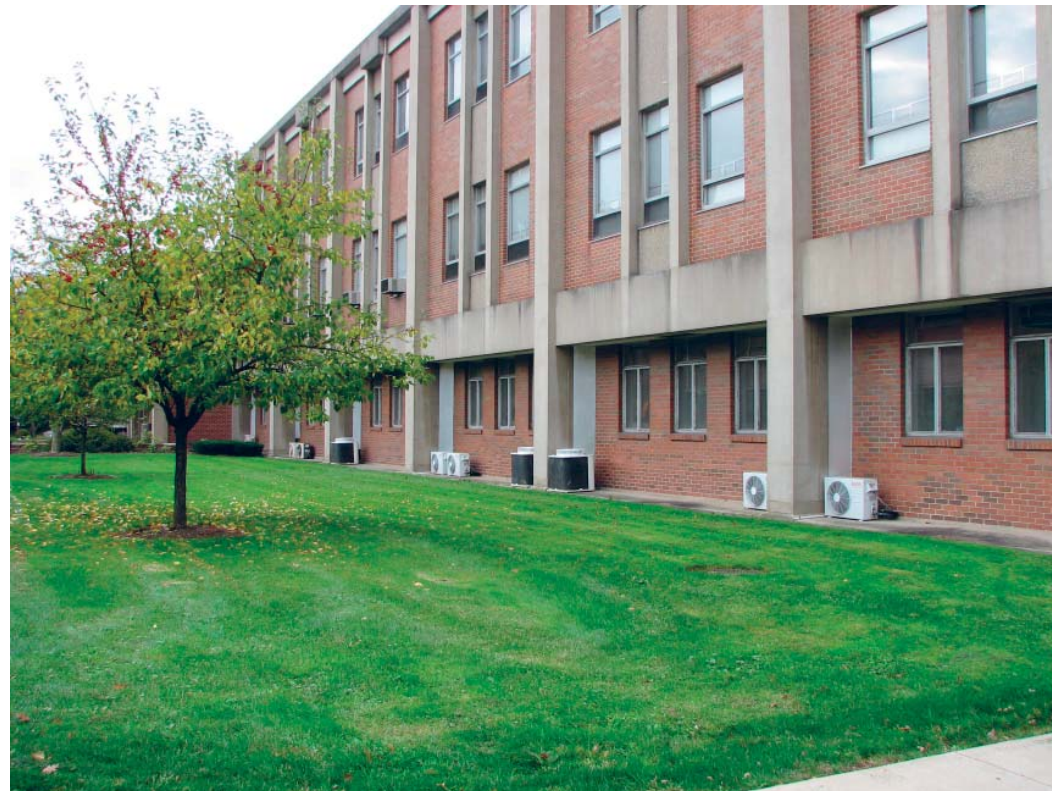
# Frable Bldg. Landscape

Unightly mechanical units mounted to the walls and at grade along the eastern facade of Frable Building should be screened from view.

After

Before

The simulation shown here calls for moving some units to finish grade and planting a dense evergreen hedge between the building and the walkway.

This primary pedestrian corridor through campus should be lighted and furnished with the campus standard.

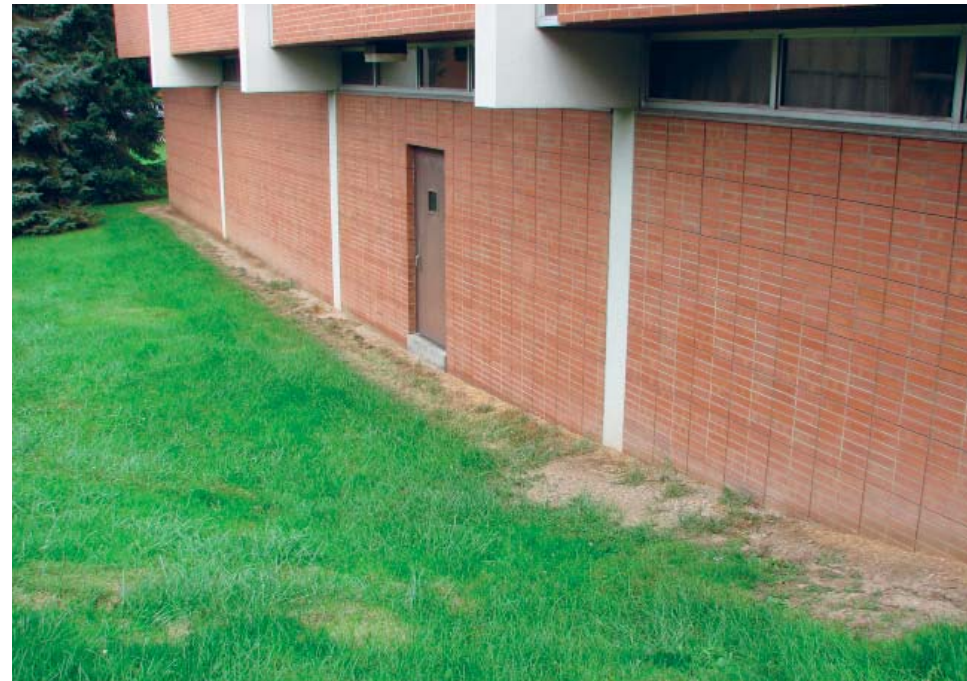
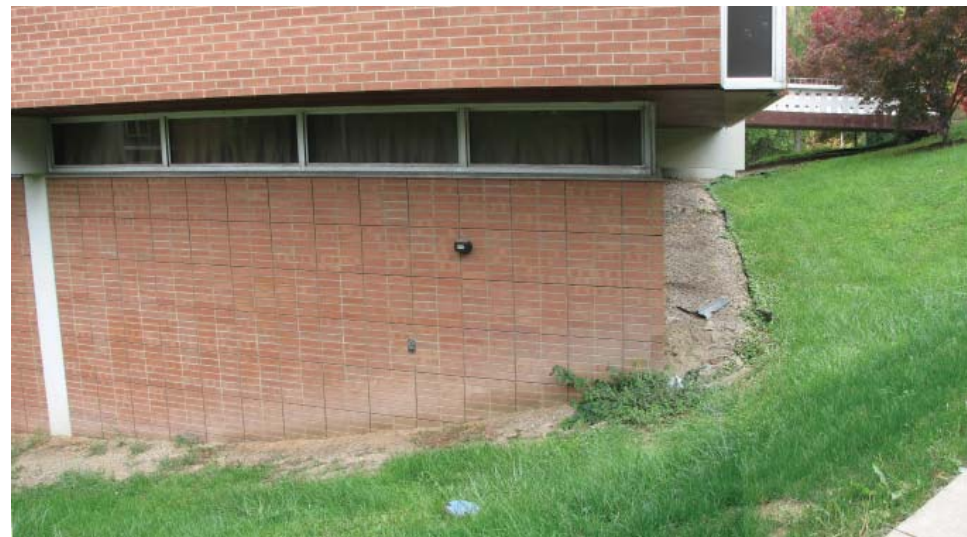
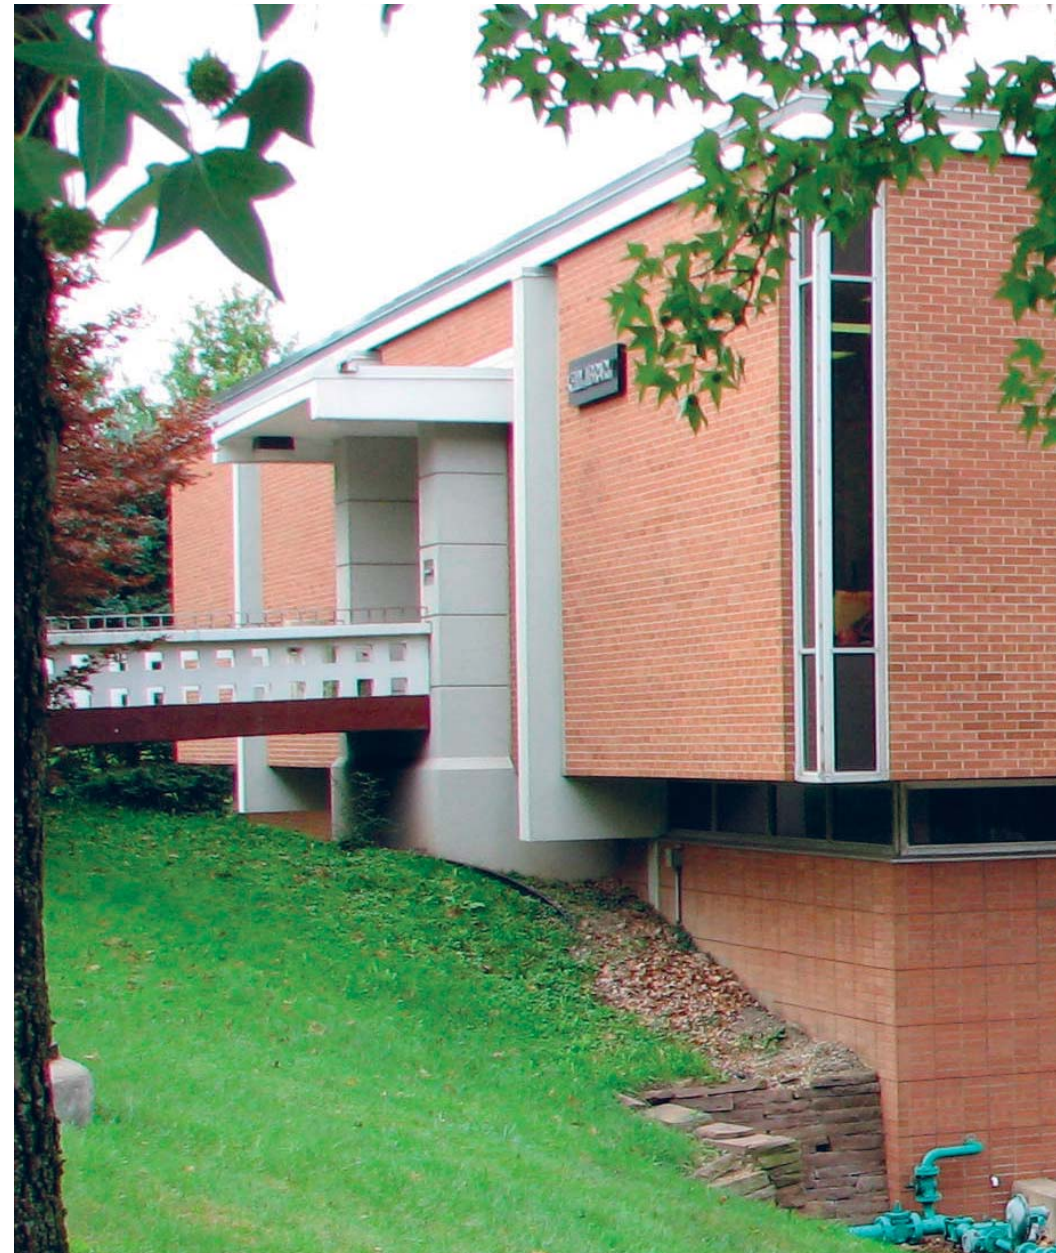
# Drip Edge 4D

Existing

In locations where vegetation can't be established along buildings and beneath overhangs, it is recommended that a permanent stone drip edge be installed to improve the transition to lawn or other landscape elements. Soil staining along the building base will also be mitigated by this technique.

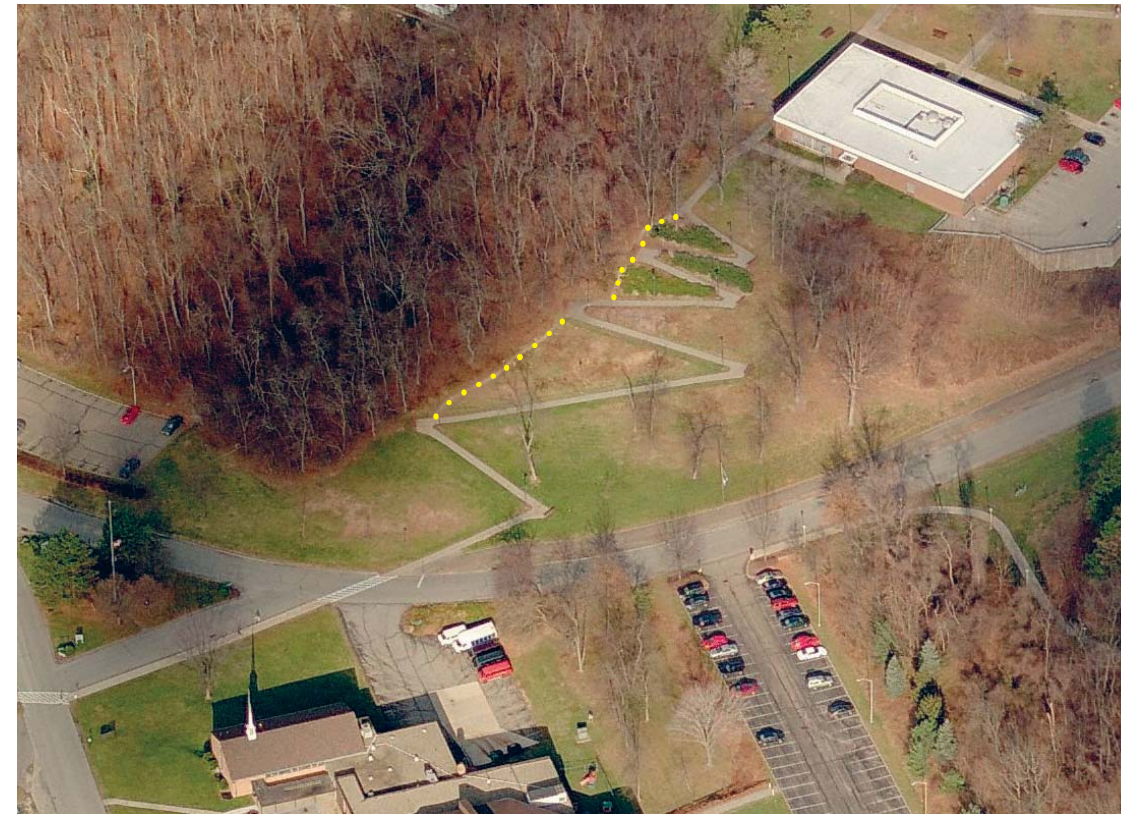
# Ramp/Stair 4E

The existing walk and ramp system connecting the residence hall and fitness center with core campus is not functioning for many users as evidenced by the short-cut trails.

Existing

The addition of strategically placed stair units along the existing path system is a way to mitigate this problem and provide safe pedestrian access to campus.

This solution can also establish a logical framework for supplemental landscape planting to reduce lawn maintenance.

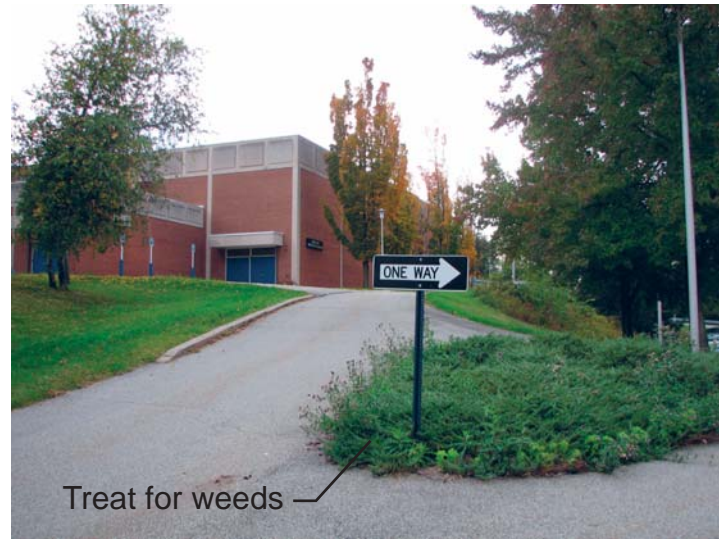
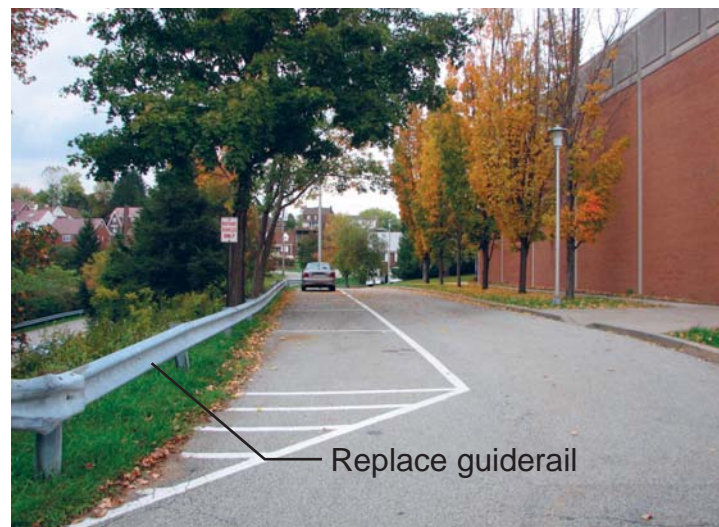
## 4F

The approach to the Wunderley Multi-Purpose Building can be improved using several techniques.

1. Provide pedestrian access to the building from the parking lot.
2. Renovate slope planting to eliminate invasive vegetation and weeds.
3. Prune deadwood from existing trees and shrubs.
4. Replace "highway style" guide rails.
5. Update site lighting.

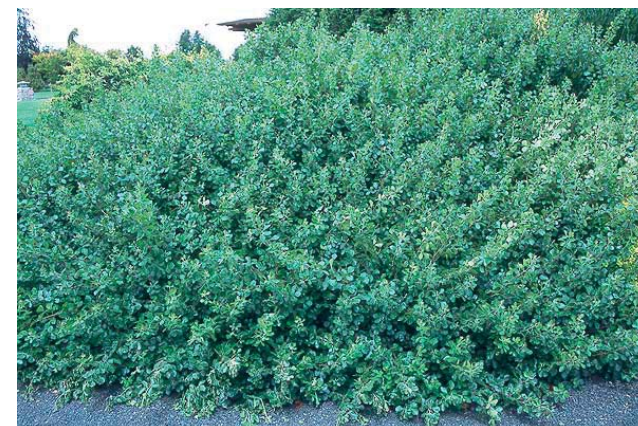
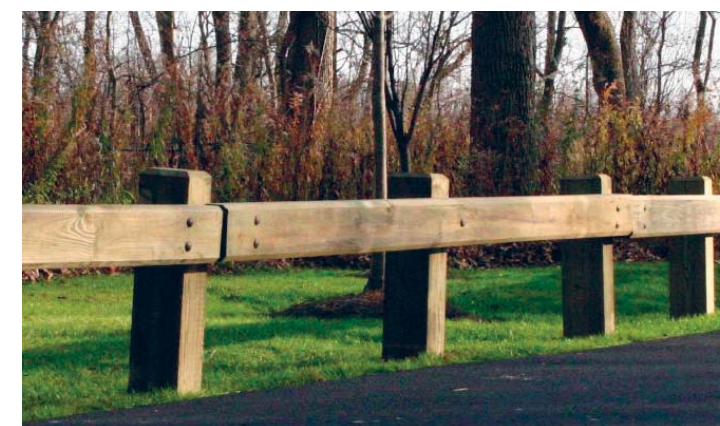
Gro-Lo Sumac groundcover

Timber guiderail

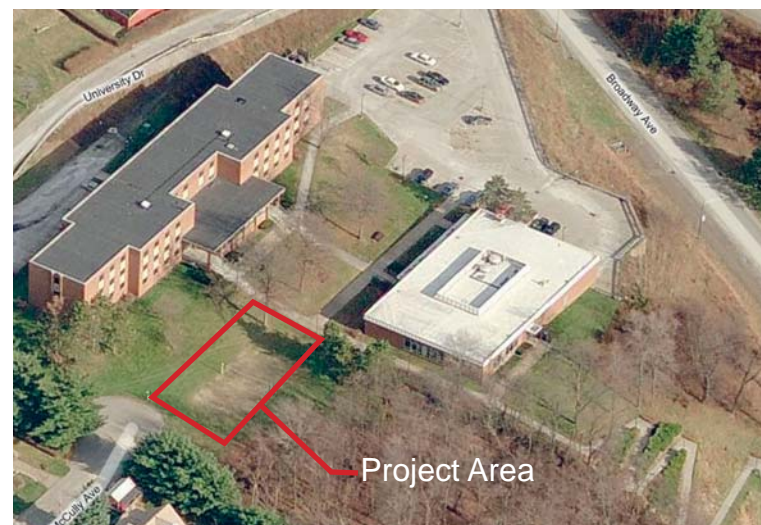
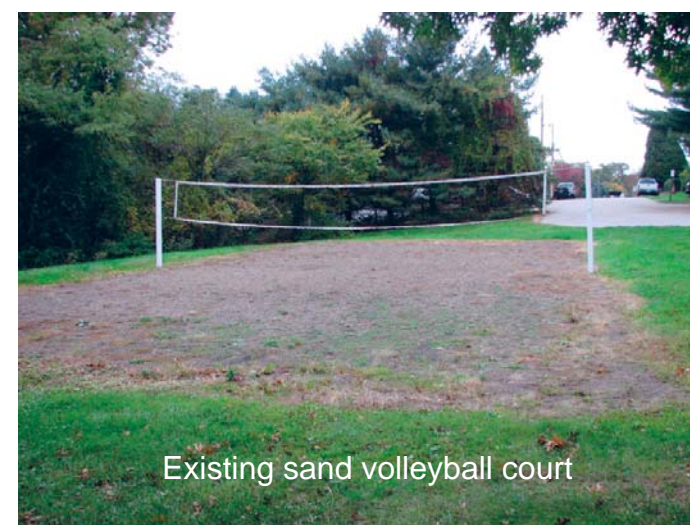
A surfaced sports court capable of supporting a variety of recreational activities is recommended in lieu of the existing sand volleyball court. Installation of a full court for basketball with perimeter fence will appeal to a broader range of student users.

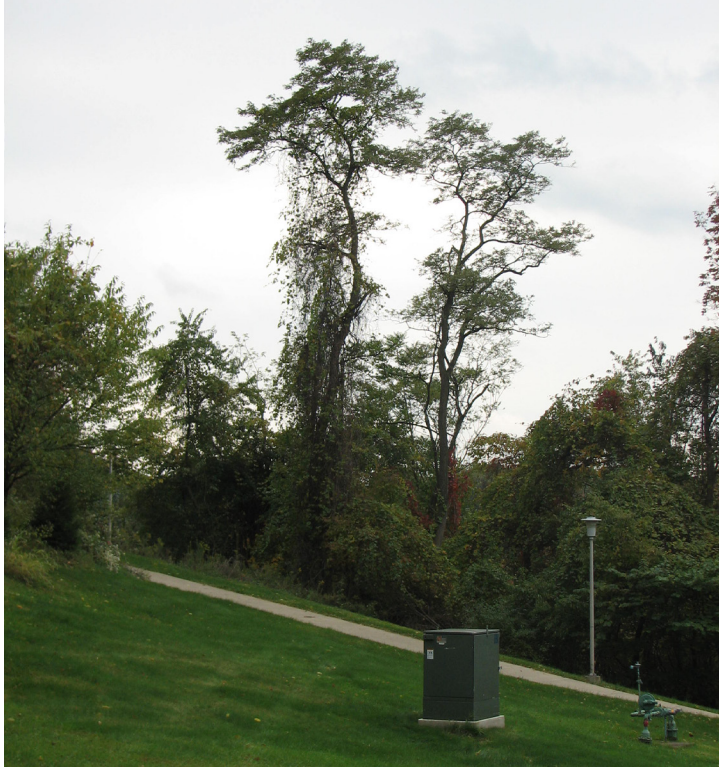
## 5B

The presence of invasive plant species has been noted on the northeast portion of campus in particular. To preserve existing trees and enhance the ecological and aesthetic quality of the campus landscape, it is recommended that a program be undertaken to eradicate invasive species.

Existing

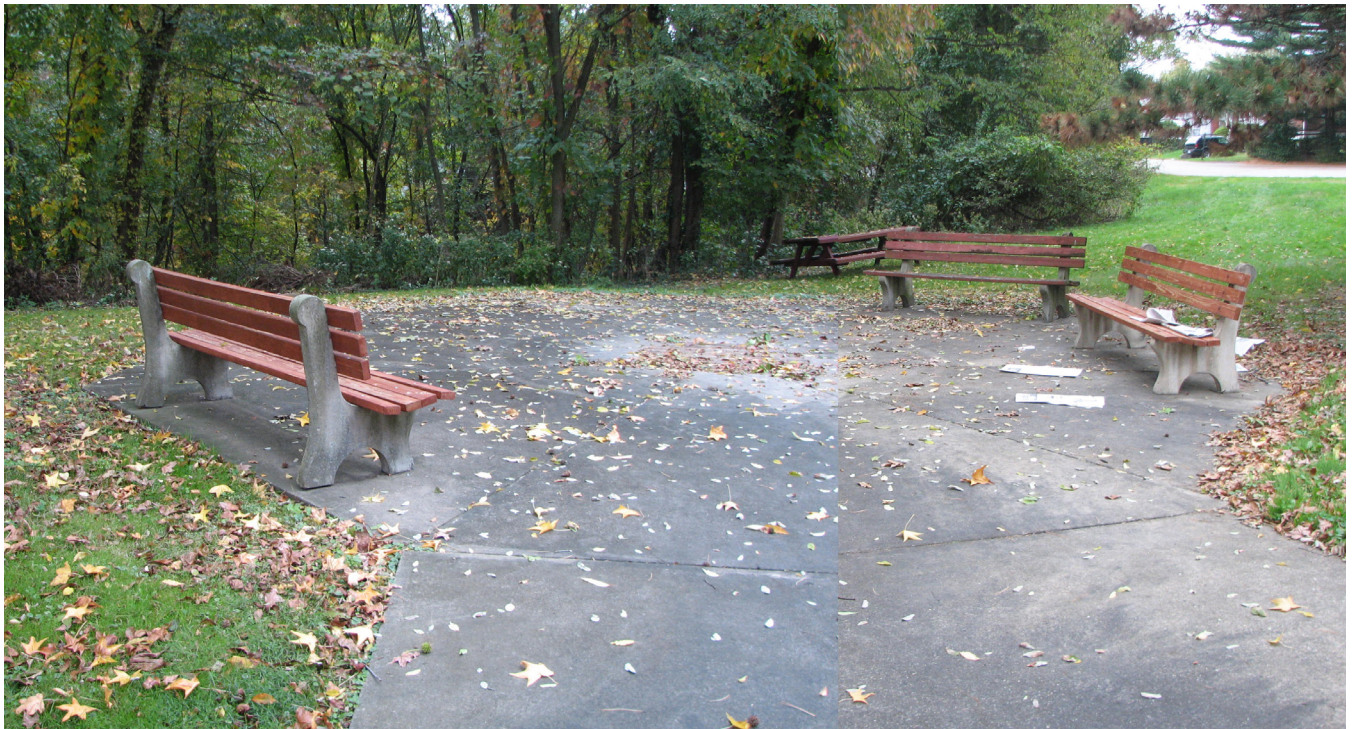
# Fire Pit 5c

Open fires are prohibited by White Oak Borough Ordinances. The existing pit area should be removed and replaced with turf lawn. The exterior gathering space proposed for the east side of the building will accommodate the displaced seating.

Existing
