Penn State  
All Greater  
Allegheny

Campus Exterior Architectural Plan  
April 2010

# Contents

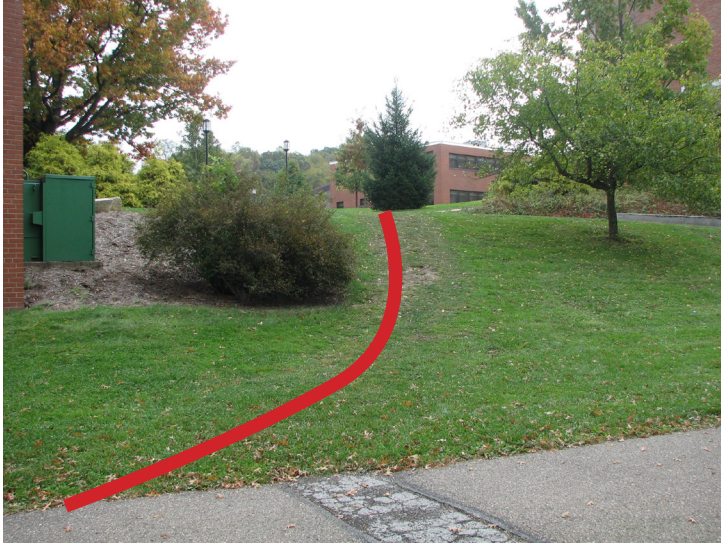
# Pedestrian Walkway 5D

Due to the absence of a suitable walking surface, pedestrians have created a “desire line” across the turf between Crawford and Frable Buildings.

Existing

Because of the sloping condition, a stair will be necessary to establish a permanent and maintainable pedestrian route.

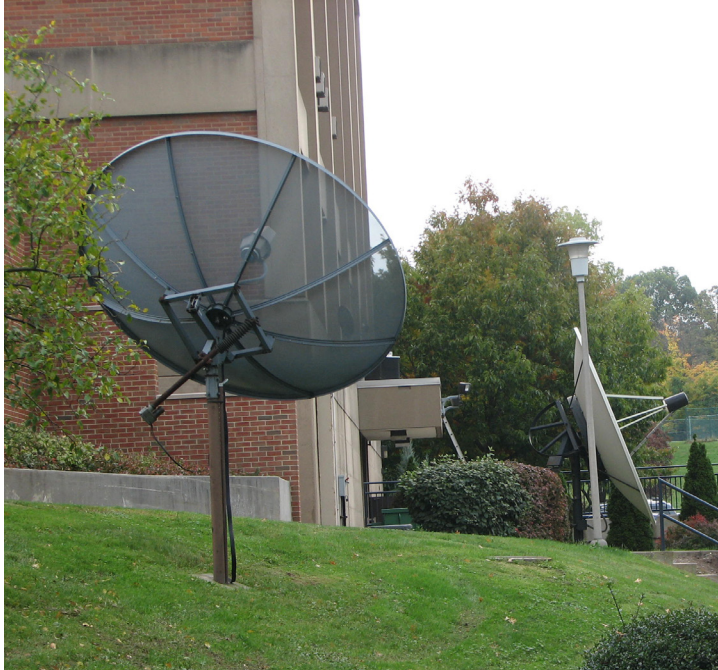
# 5E

Existing satellite dishes that are no longer in service should be removed.

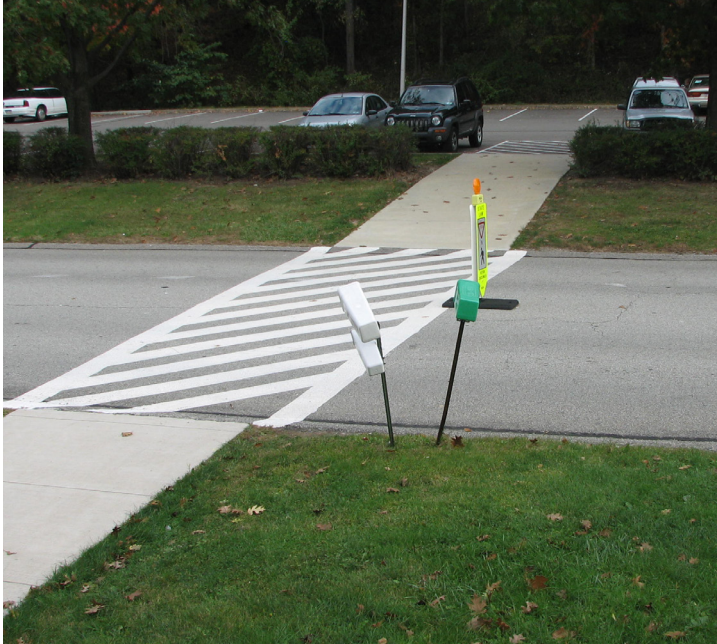
# Newspaper Delivery Box <sup>5F</sup>

Existing

If newspaper delivery must take place curbside then a new permanent receptacle should be purchased or fabricated. The new unit should compliment the design of other site furnishings. See 2A

A preferred alternative would be for the campus to take delivery of the paper(s) inside one of the campus buildings allowing for complete removal of this fixture.

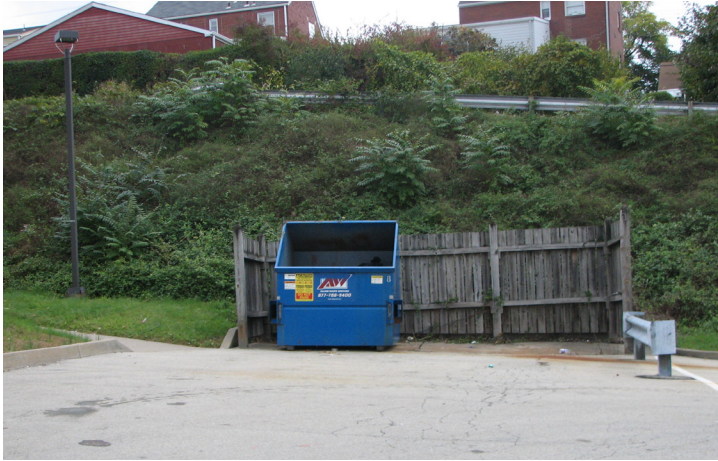
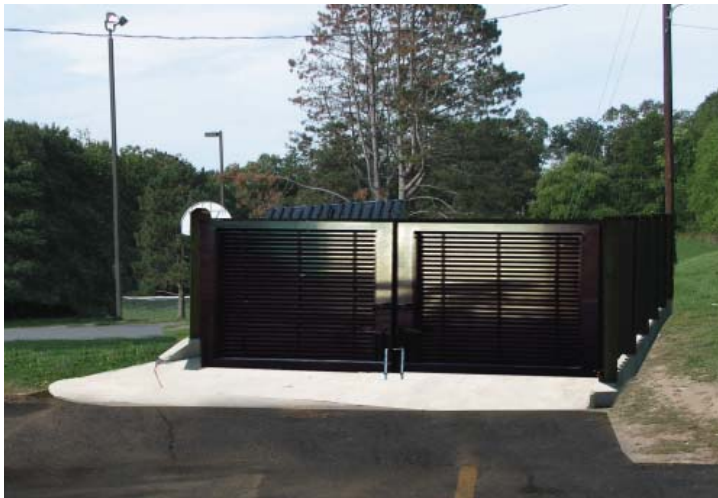
# Dumpster Enclosure 5G

The existing enclosure around the dumpster at the residence hall should be replaced.

Existing

Recommendation

Recommend that the new screen be fabricated or durable material such as metal. It is also recommended that the enclosure have swinging gates to conceal the use.

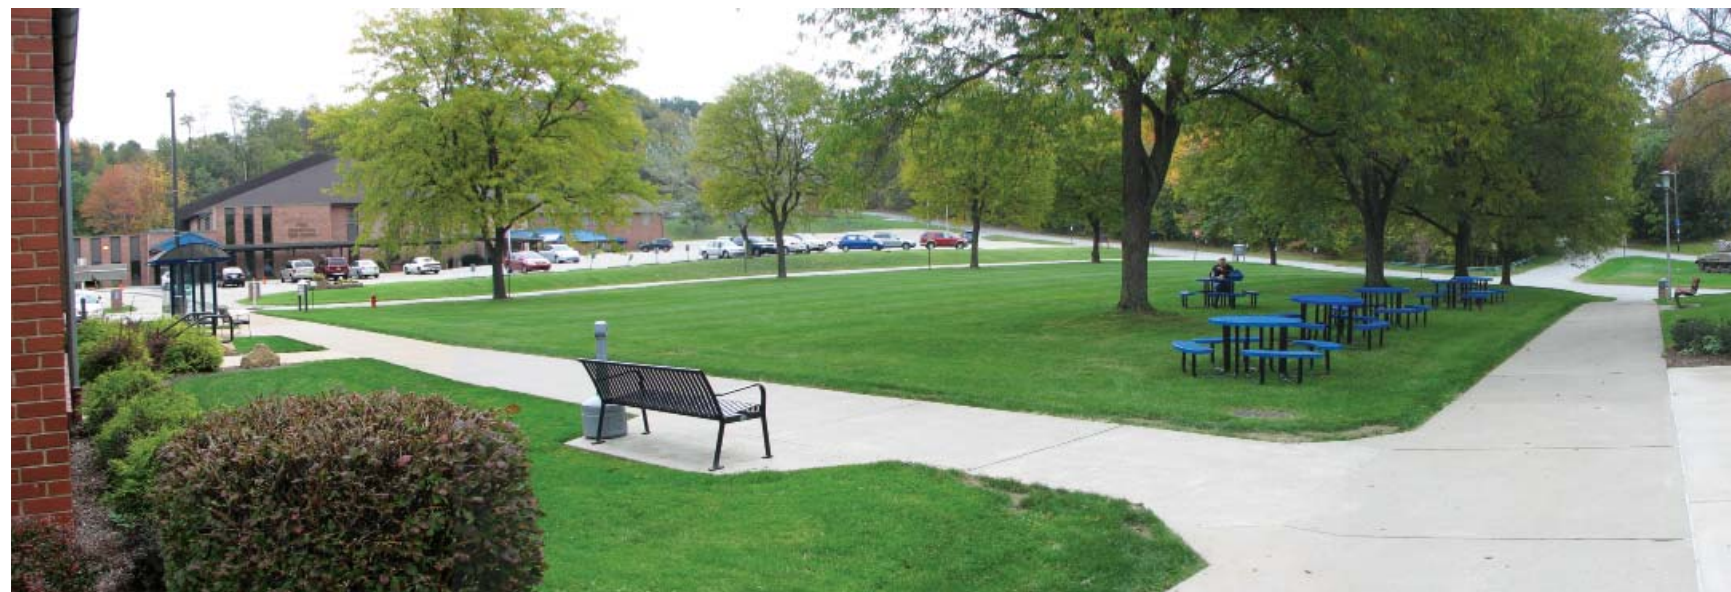
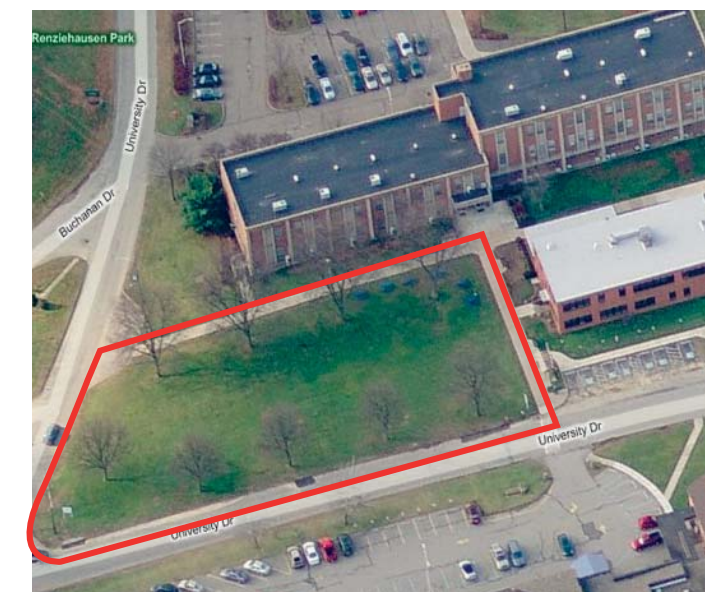
## Campus Green

The open space at the corner of University Drive and Walnut Street should be improved to provide varied seating opportunities. By establishing a walking path that's reinforced by planting and bench seating, the unused area can be integrated into the open space as a campus green.

Existing

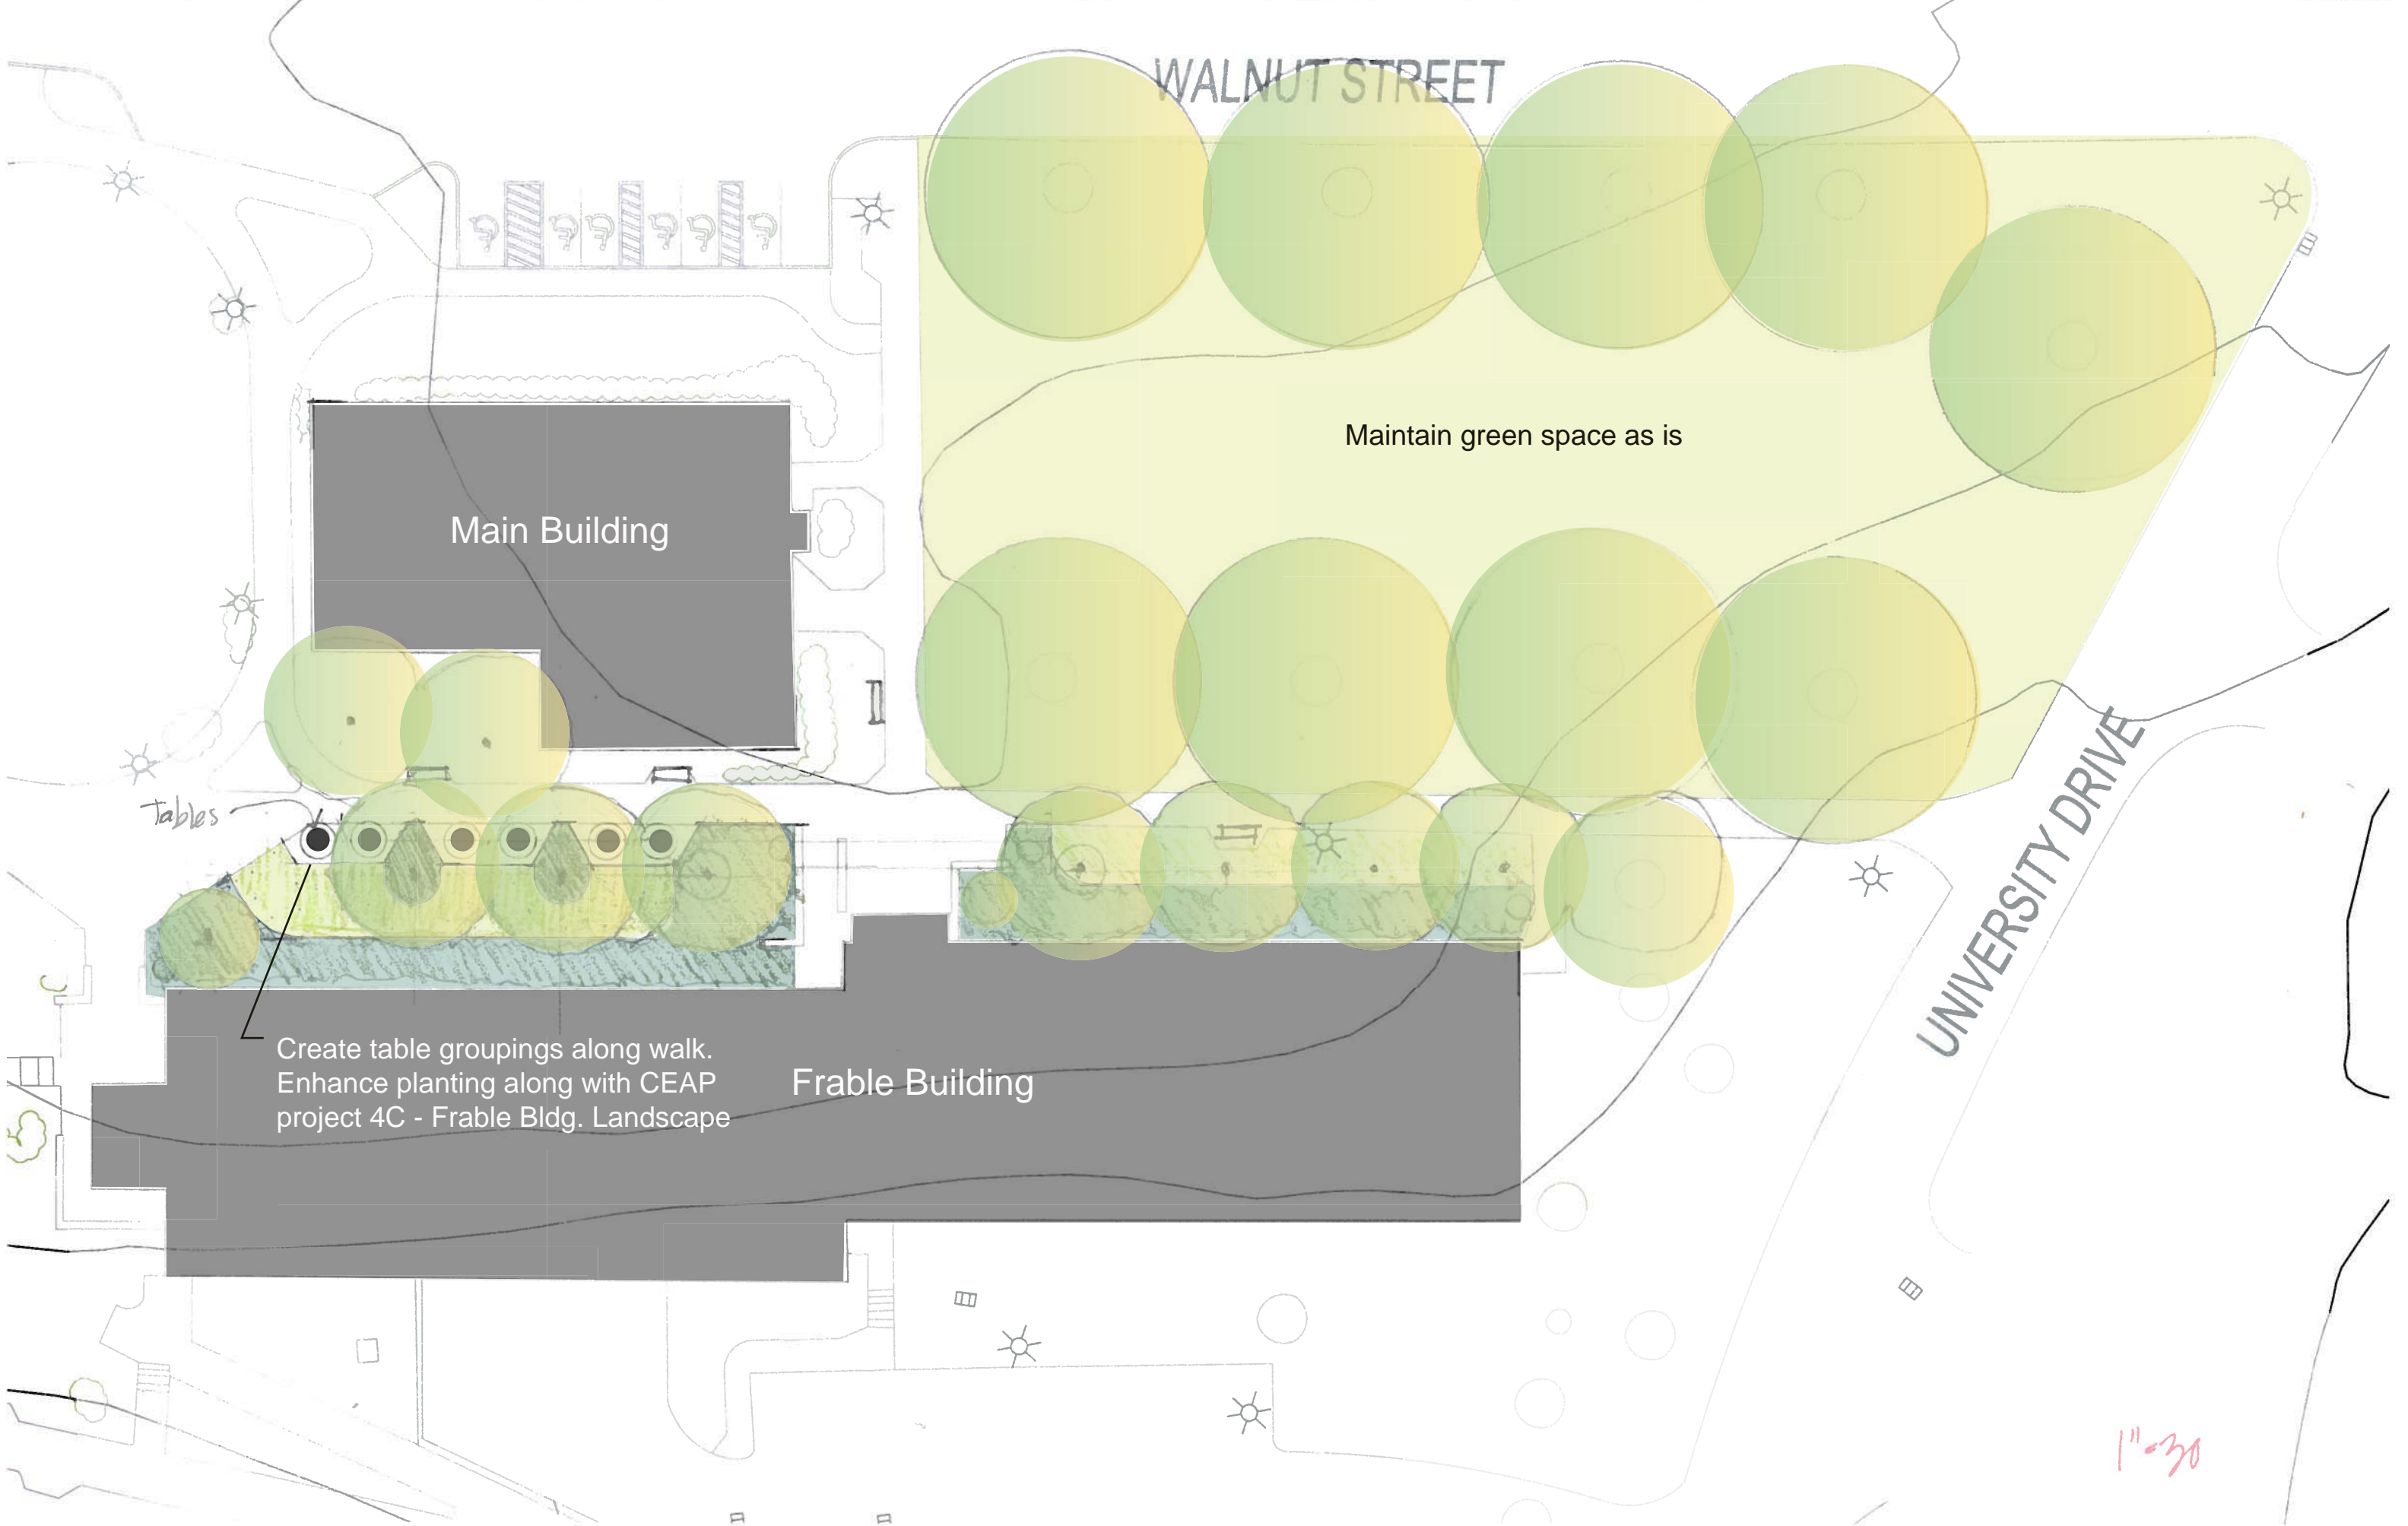
Maintain green space as is

Create table groupings along walk.  
Enhance planting along with CEAP  
project 4C - Frable Bldg. Landscape
