Penn State Altoona

Campus Exterior Architectural Plan
September 2008

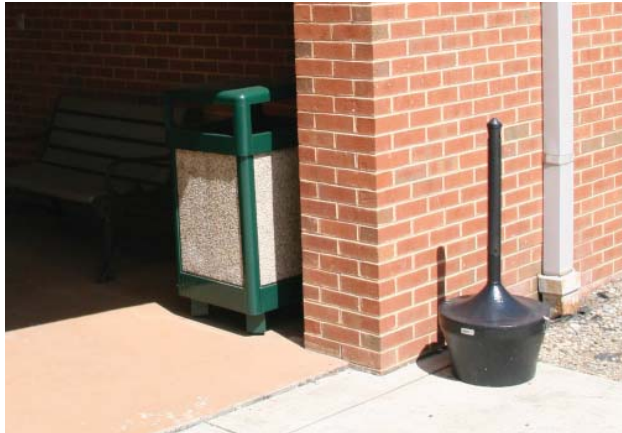
Benches, trash receptacles tables and bike racks across the campus are varied in design, color and material.

It is recommended that a standard design for furnishings be selected that will aid in unifying the campus aesthetic.

In addition to aesthetic appropriateness, the longevity and maintenance of site furnishings should be considered when specifying.

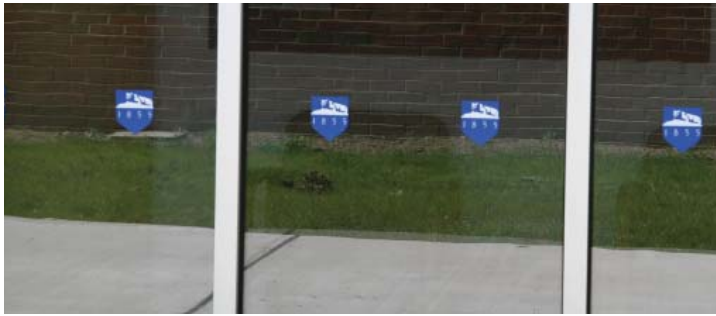
1B Window Stickers

The ubiquitous presence of the mark diminishes its relevance as an identifier of Penn State. In addition, some of the appliques are peeling from the glass surface.

Decals should be removed from the windows.

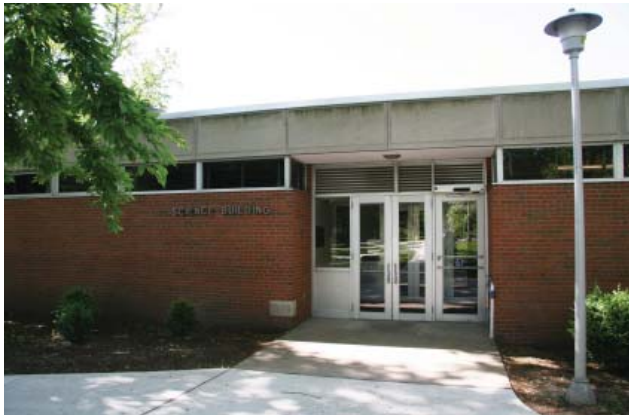
Before

The entrances to many campus buildings should be enhanced to convey a more welcoming feeling. This is the point where students, faculty, staff, and visitors are in closest contact with the campus architecture.

Possible treatments include new doors, powerwashing of facades as needed, planters, standardized signage, new lighting, and complimentary landscaping.

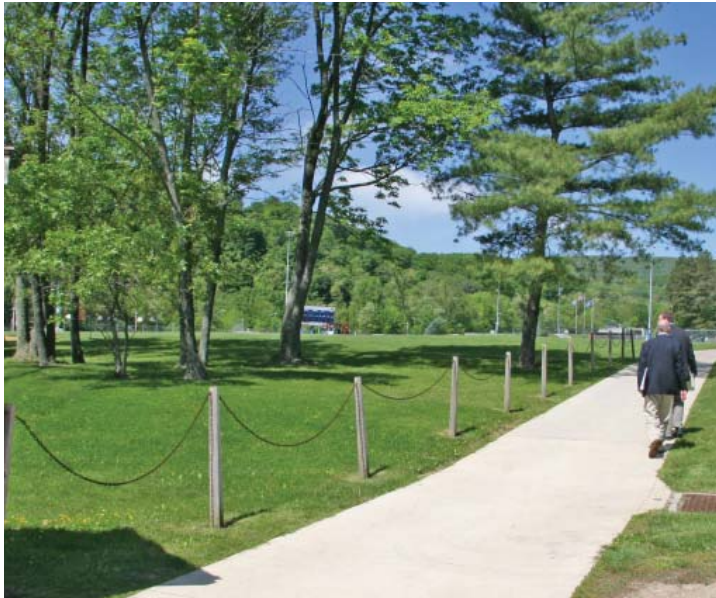
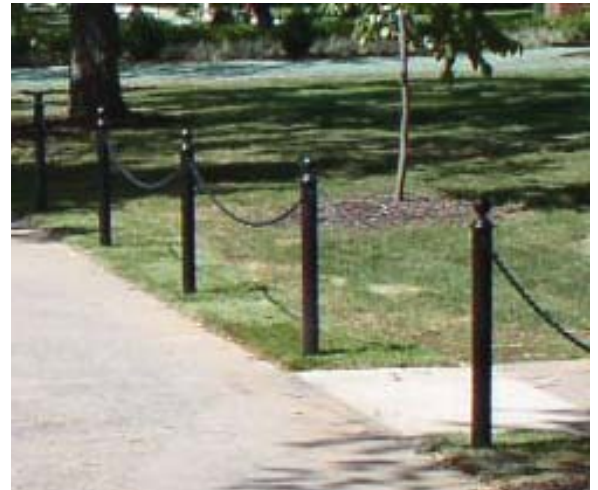
Post and chain should be used sparingly to discourage pedestrian movement through planting areas. There are some areas on campus where existing post and chain do not appear to be serving a purpose and may, therefore, be removed.

Where post and chain is absolutely necessary, the University standard should be phased in.

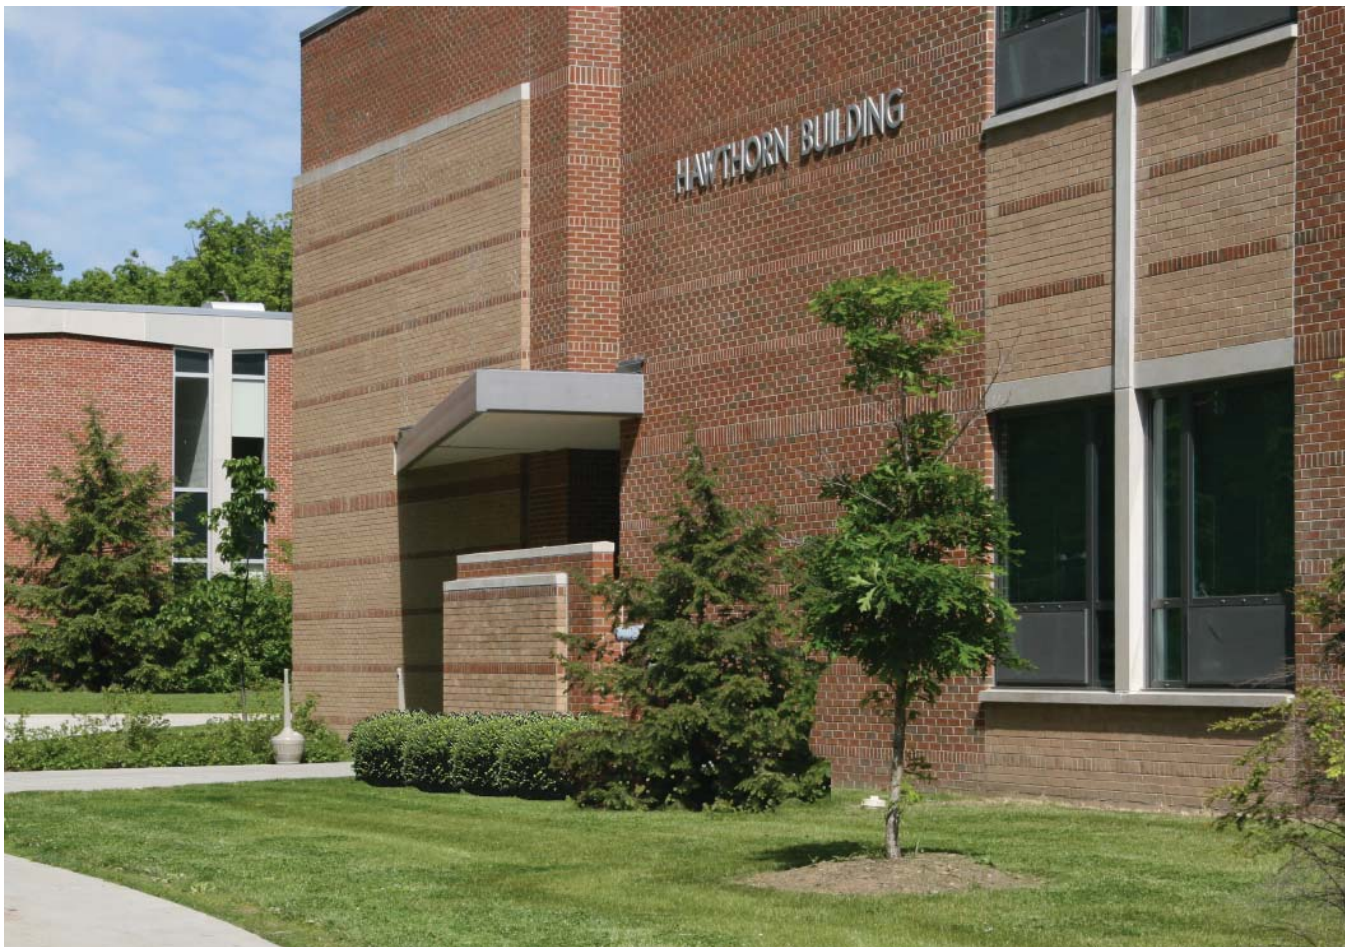
The attempt to screen the existing utility meter at the entrance to Hawthorne Building using the masonry walls is unsuccessful from the parking lot approach.

Recommend the installation of evergreen landscape plant materials to complete the needed screen.

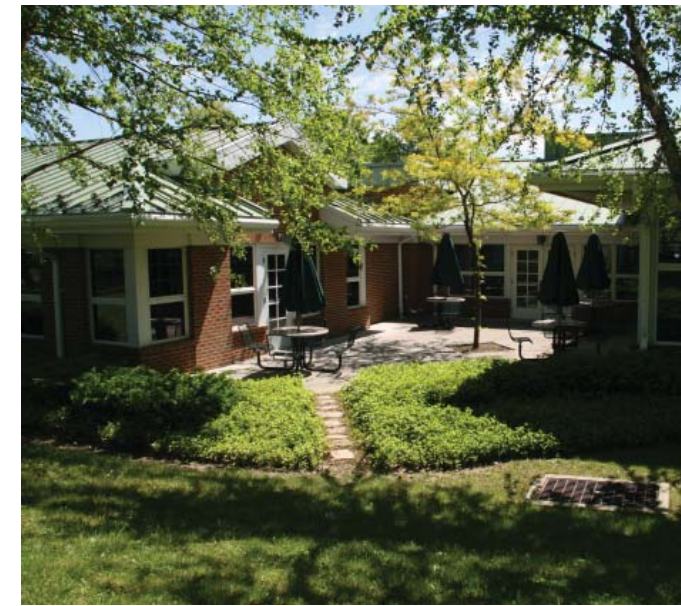
Existing undersized cafe' patio

The existing outdoor patio at the Port Sky Cafe is too small to serve a campus community of this size. An expansion is recommended as is a sidewalk connection to the existing barbeque pavilion. A new adjoining patio is proposed for the north entrance. Surrounding landscaping would provide shade and enclosure and help to direct pedestrian traffic to sidewalks. The existing post and chain can be removed.

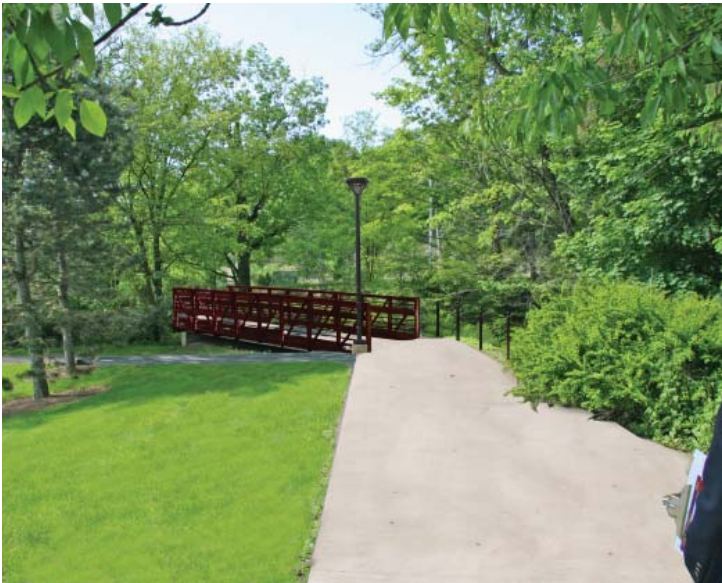
The opportunity exists to reduce pavement. Primary campus walkways should not exceed 10 feet in width. Minor walkways should be 8 feet in width to facilitate snow removal. It is also recommended that stamped and painted asphalt be removed and replaced with concrete.

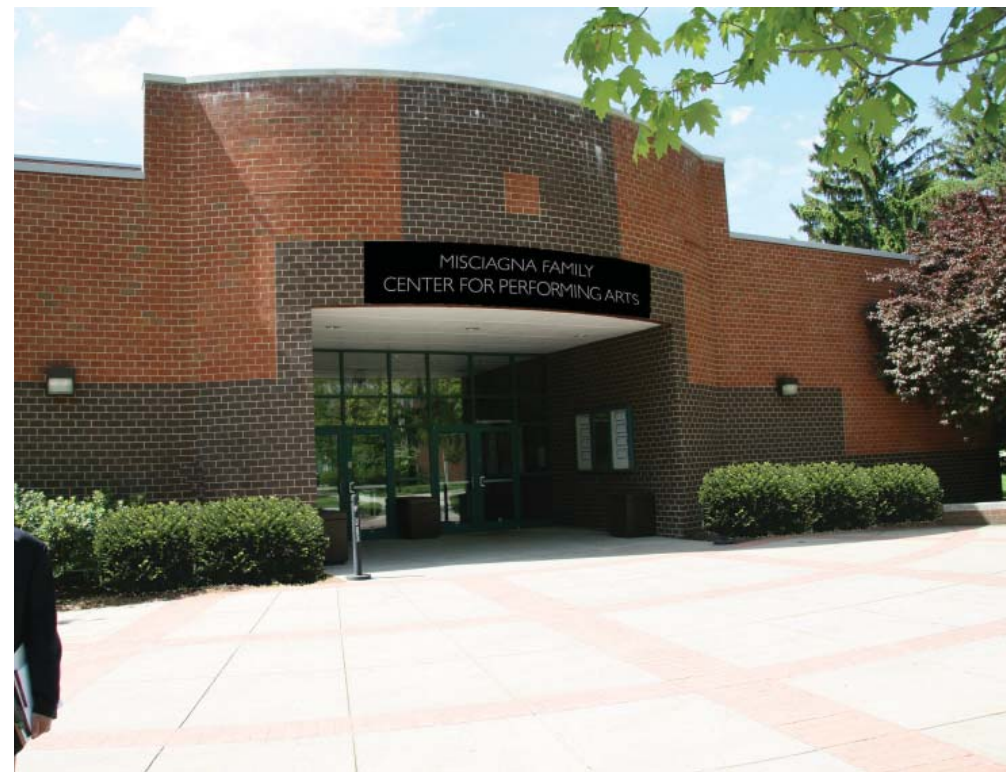
Existing Plaza and Building Sign

The plaza space at the main entrance to the performing arts center is in need of repair and enhancement. This highly visible public space is important to conveying a sense of quality and care to all University users.

The wall capstones and incised masonry sign are deteriorating due to age and possibly vandalism. The shrub plantings surrounding the plaza area would benefit from a renovation. Trash receptacles and ash urns should be replaced with new fixtures consistent with a campus standard.

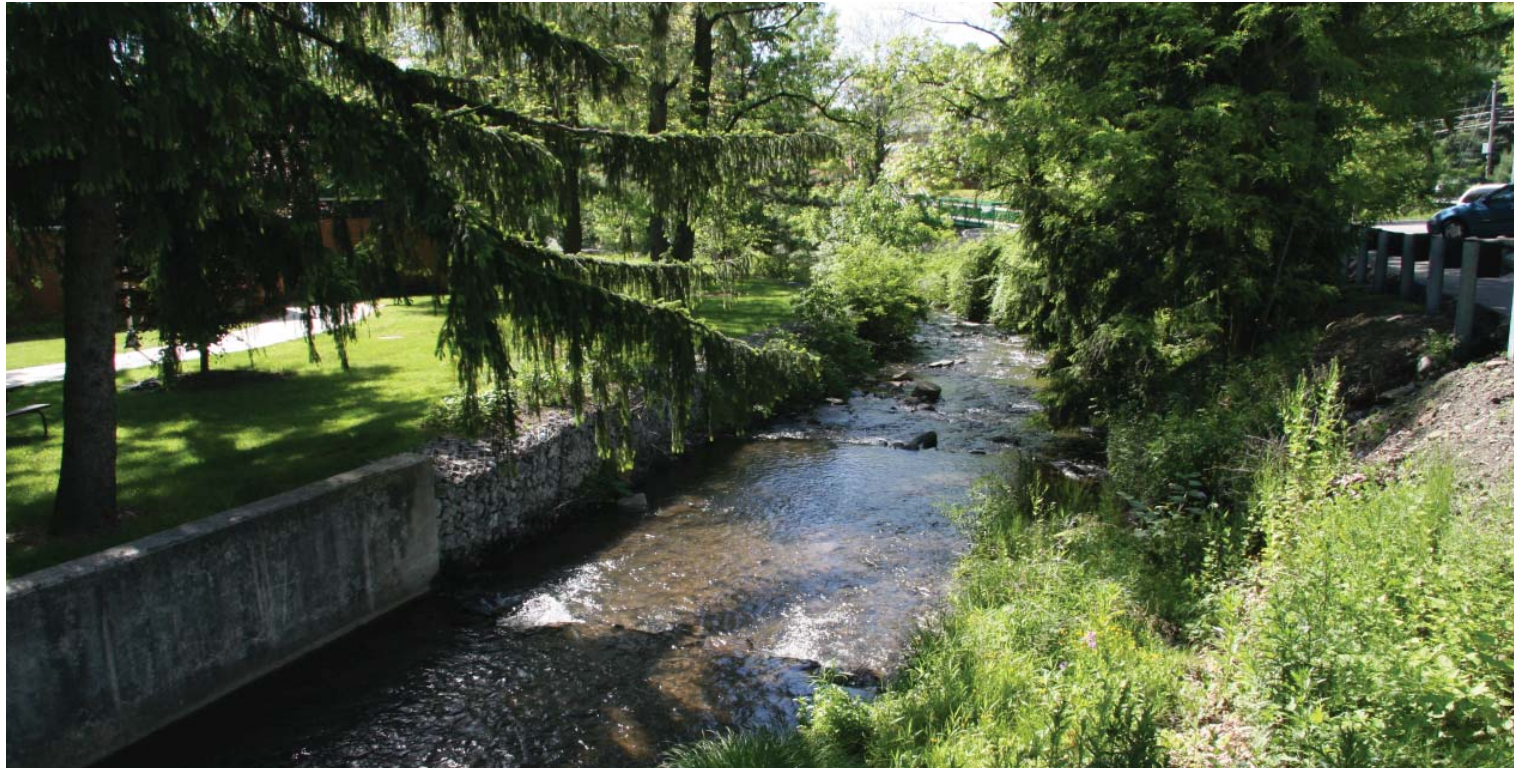
Existing engineered stream edge

Another way to strengthen the water theme at Penn State Altoona is to create an access point to Spring Run, which runs the entire length of the campus. This project could include an element of streambank restoration. An engineering study would clarify where the most feasible spot is for this type of project, but an inside turn of the waterway is the most likely location.

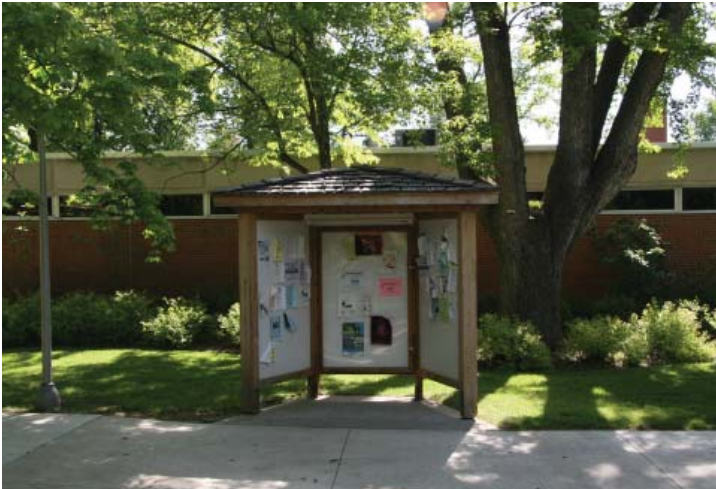
7^A Post Boards

The rustic character of lumber and shingle style exterior post boards is not compatible with the image of quality and permanence of a Penn State campus. Management of content is often irregular or inconsistent.

Space for managed posting of relevant notices should be limited to interior locations in common areas of buildings.

It is recommended that the existing exterior wooden post boards be removed from campus.

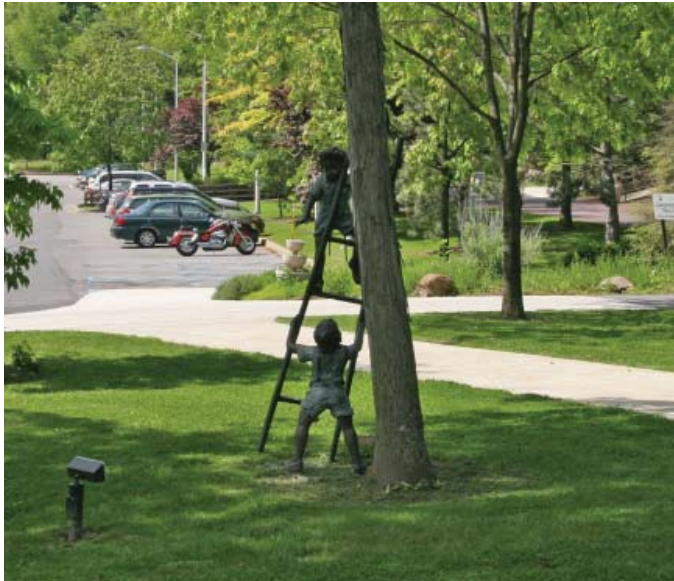
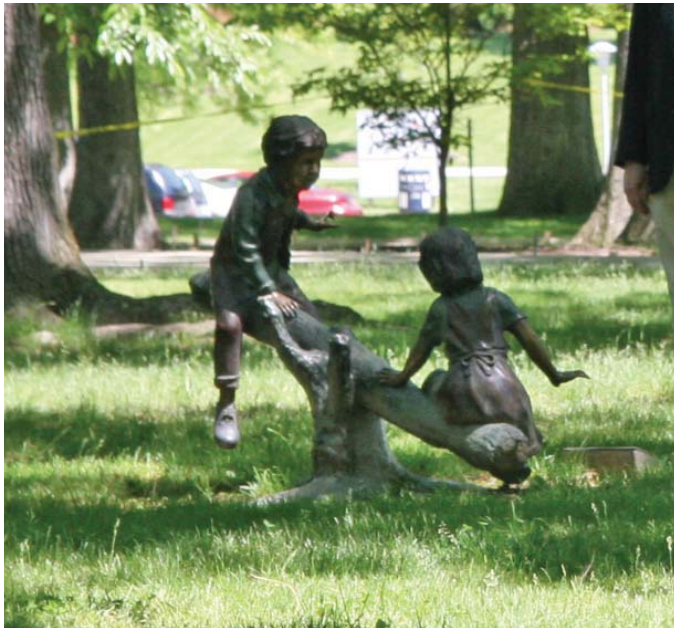
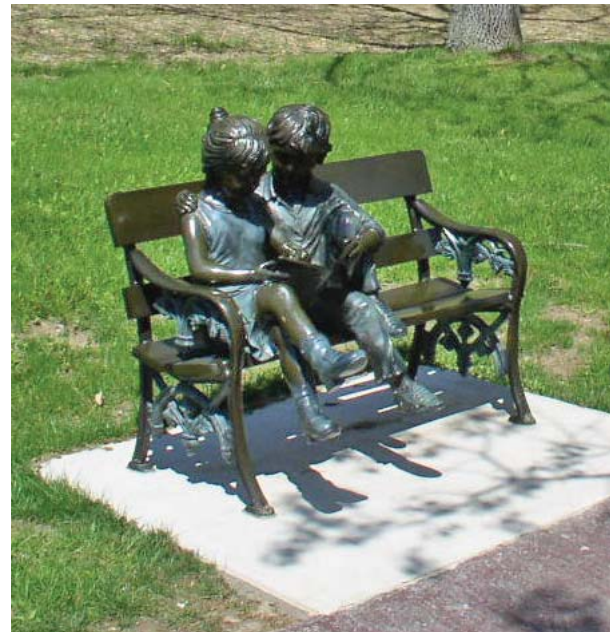
7B Lawn Ornamentation

Elements of whimsy in the landscape can be charming if used in moderation. With repetition of such a feature a theme may begin to develop. The campus should consider whether these ornamental sculptures are establishing a theme and if so, is this appropriate for an institution of higher learning. The recommendation of this CEAP is that the sculptures be congregated to one area of campus or removed altogether.

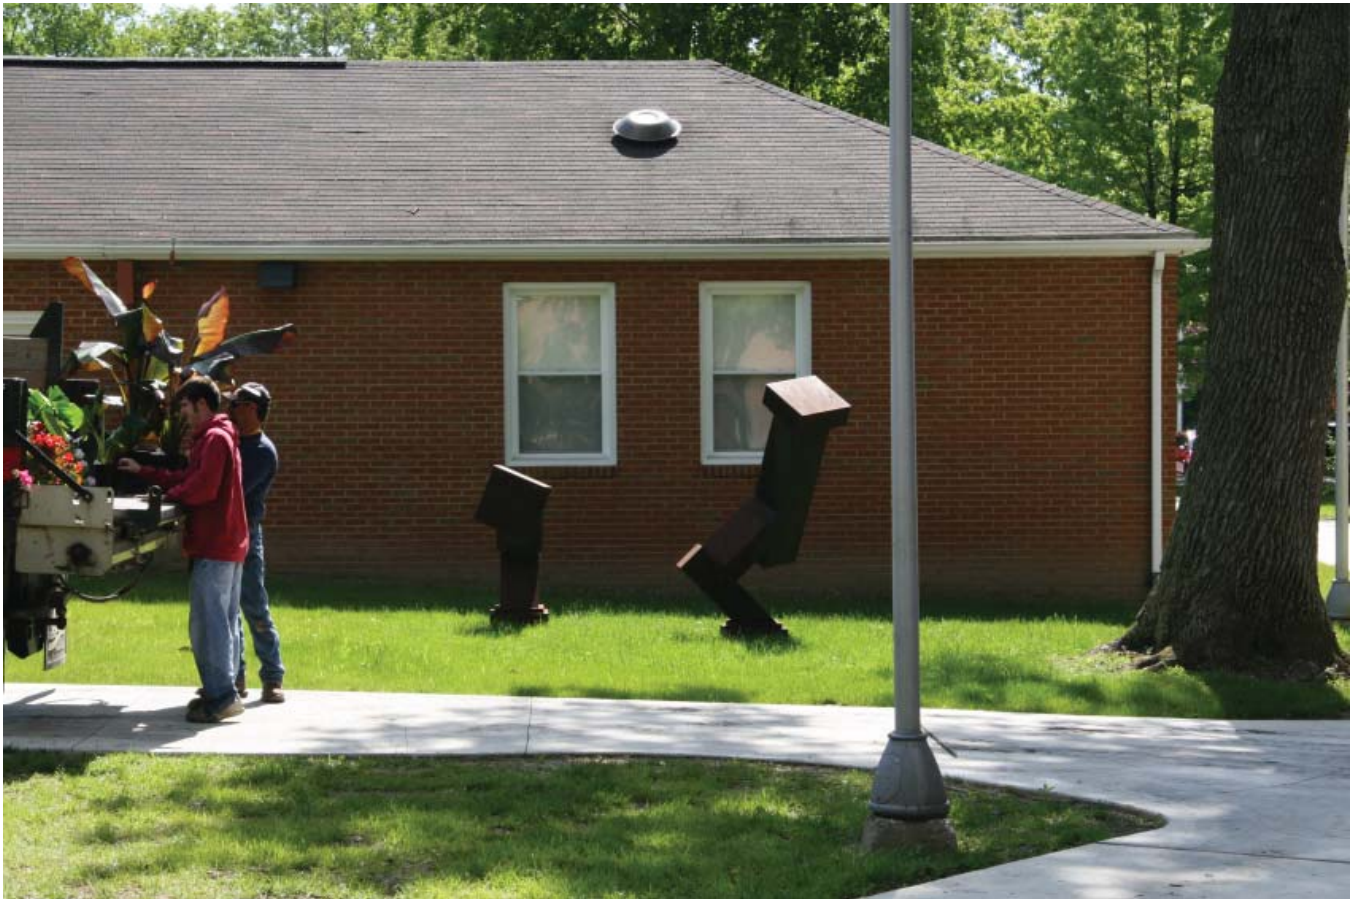
7C Relocate Elm Building Sculpture

The metal sculpture between Elm and Pine Buildings should be showcased in a more appropriate location such as the proposed Ivyside Parklet.

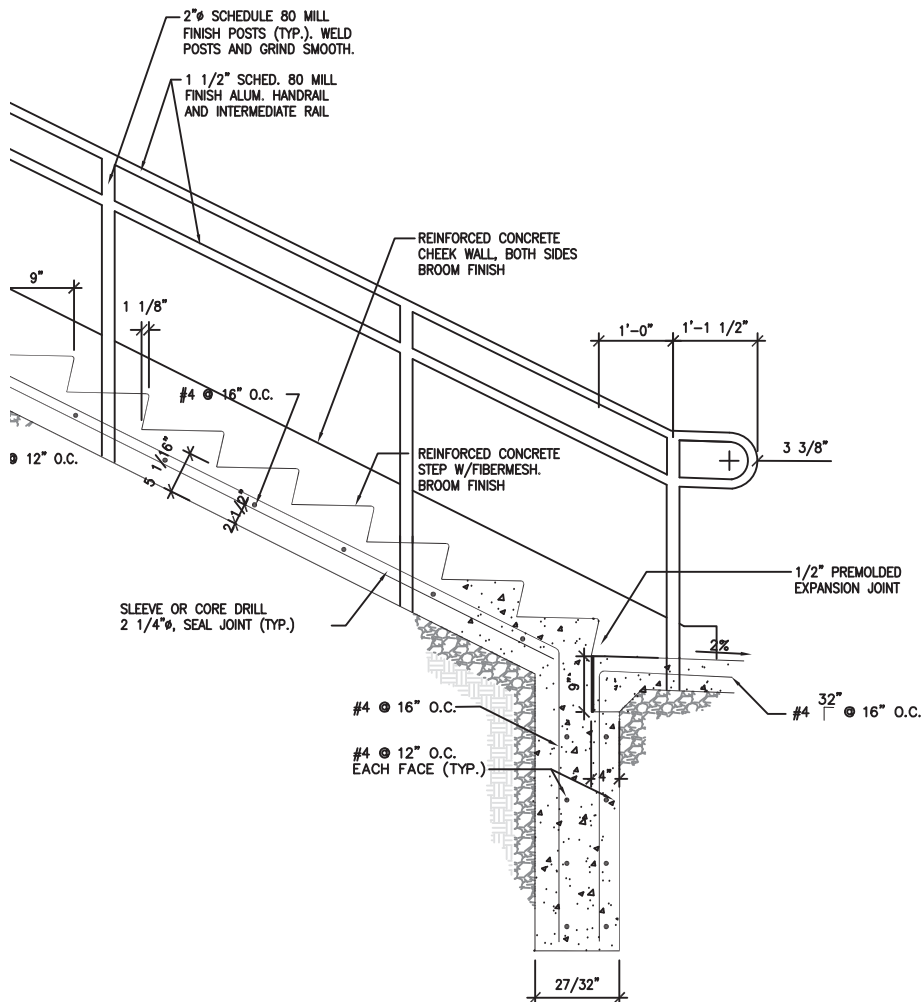
7D Handrail

The existing site steps in the south parking lot next to the main entrance do not have code required handrails in place. It is recommended that this deficiency be corrected.

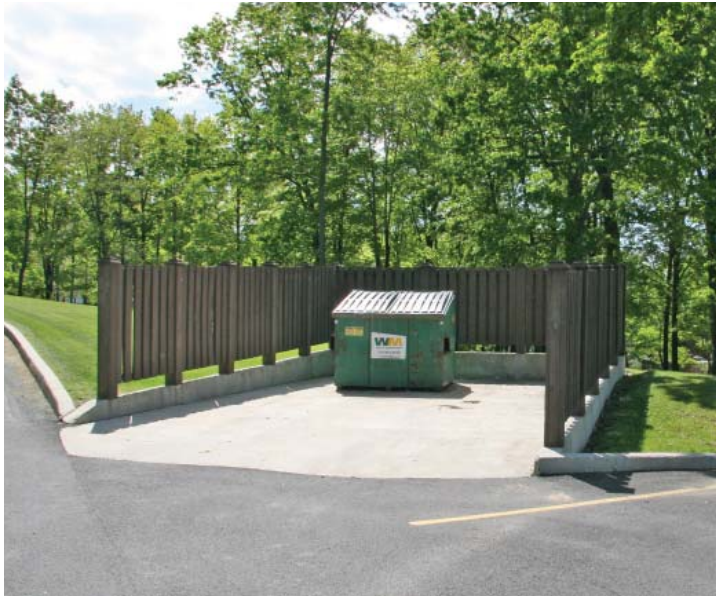
Before

Waste and recycling receptacles are necessary for the management of disposable materials. The campus has done a good job of strategically locating a minimal number of unsightly receptacles and has screened them from view.

There is opportunity to further mitigate the negative aesthetic impact of waste collection by placing gates at access points to enclosures.

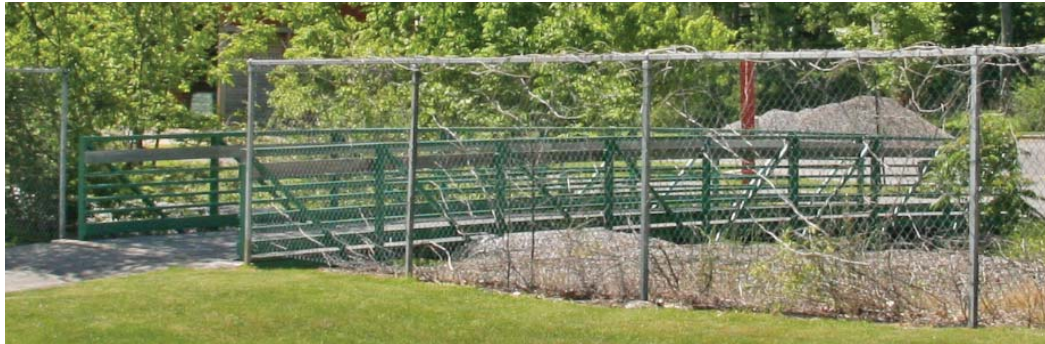
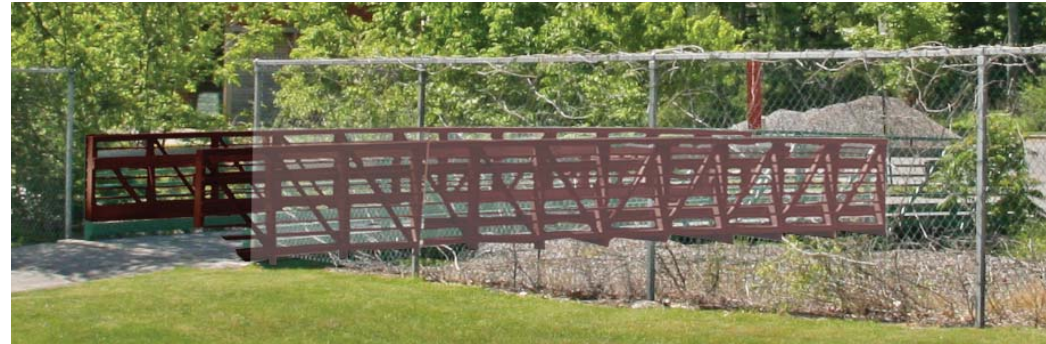
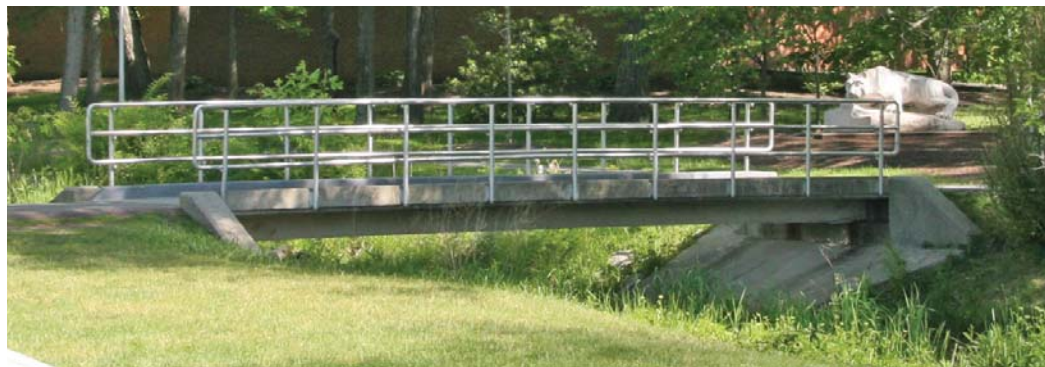
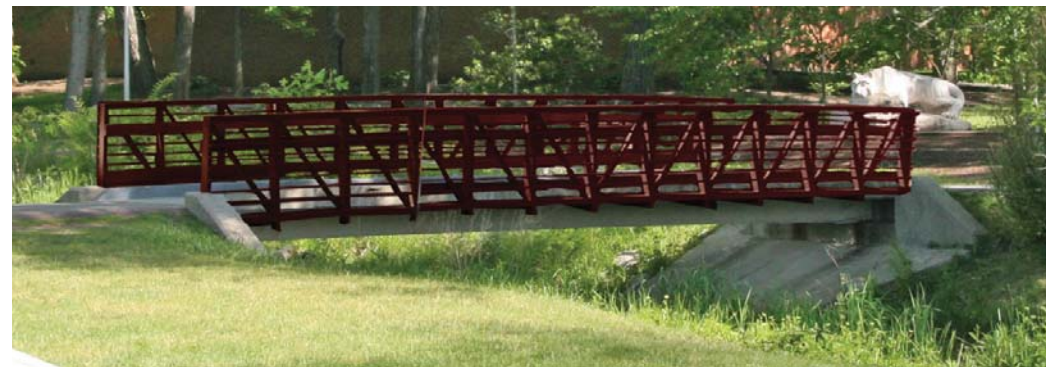
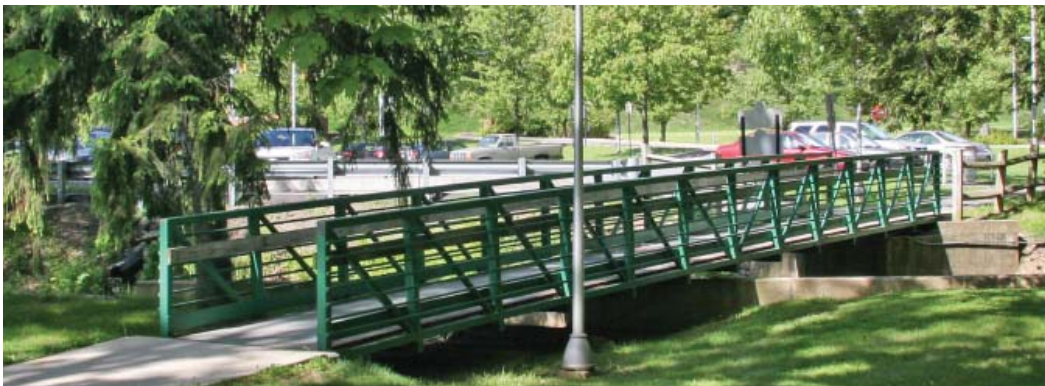
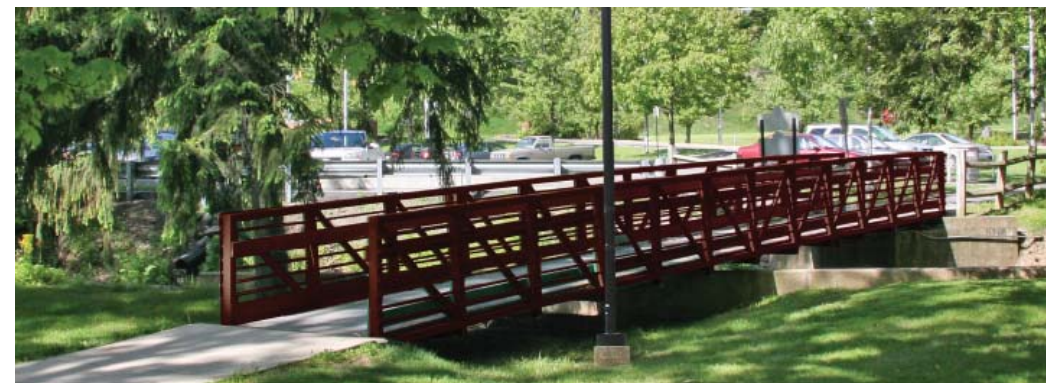
Existing Pedestrian Bridges

Water elements abound throughout the Altoona campus. One way to strengthen this theme is to create a consistent look to the four pedestrian bridges that span Spring Run.

Railing design should be consistent on all four bridges and color should be complementary to the surrounding vegetation. A subtle choice would be a natural dark brown. A bolder color choice would be a complementary red.
