Penn State
Erie
The Behrend College

Campus Exterior Architectural Plan
January 2008

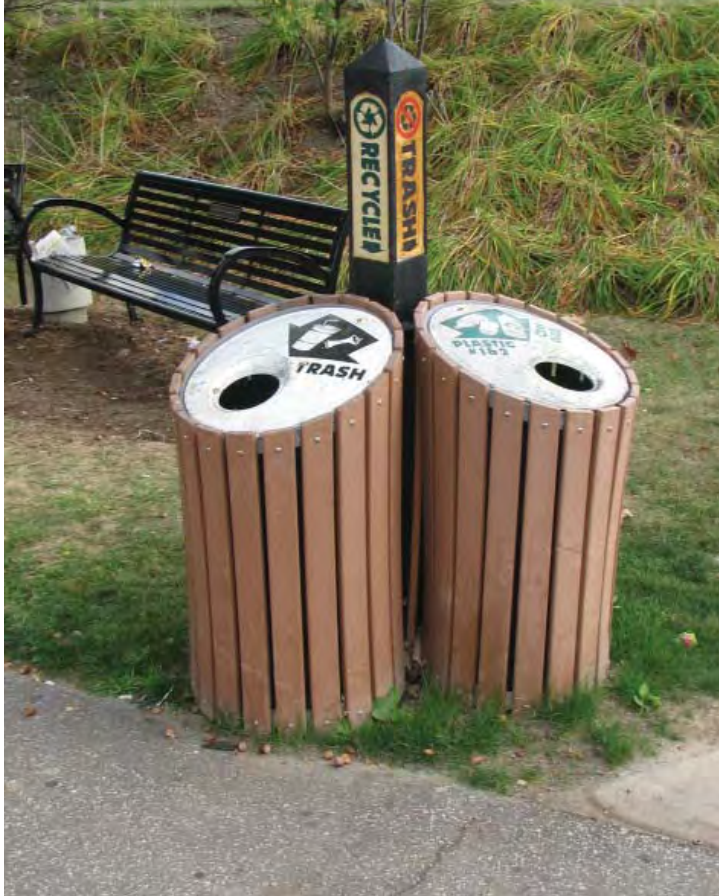
The campus is sparsely furnished with benches and trash receptacles. With the exception of a few benches like the one in the photo at left, existing site furnishings are not comparable to the high quality of buildings on campus. Aesthetic continuity and unity can be enhanced through the use of a stylistically appropriate “family” of furnishings.

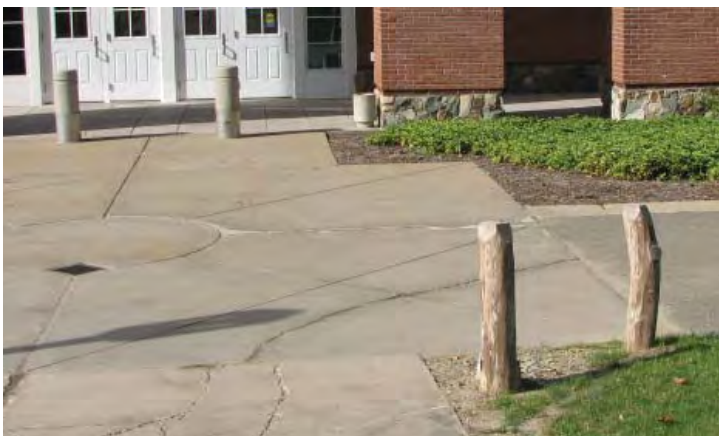
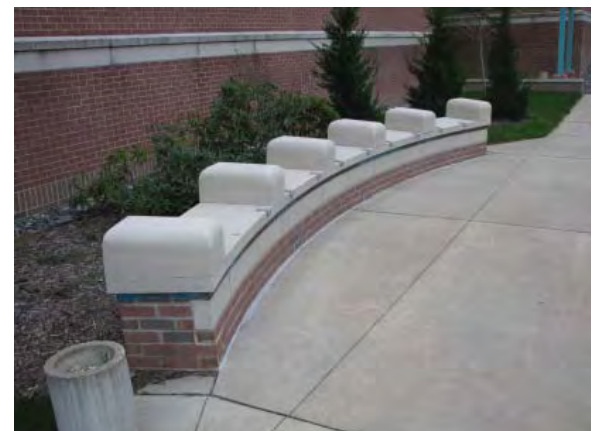
The use of wooden post & chain to direct pedestrian and vehicular flow should be minimized. Where its use is deemed necessary, the post and chain should compliment the style and quality of other site furnishings.

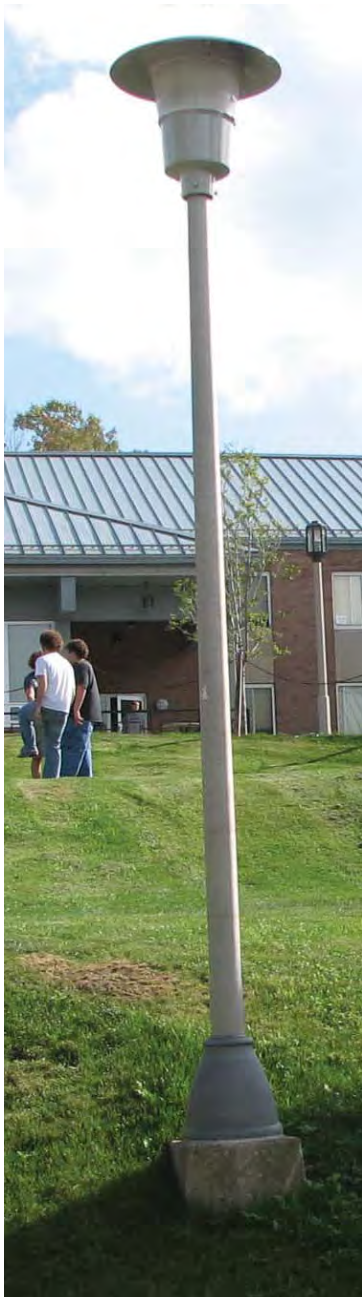
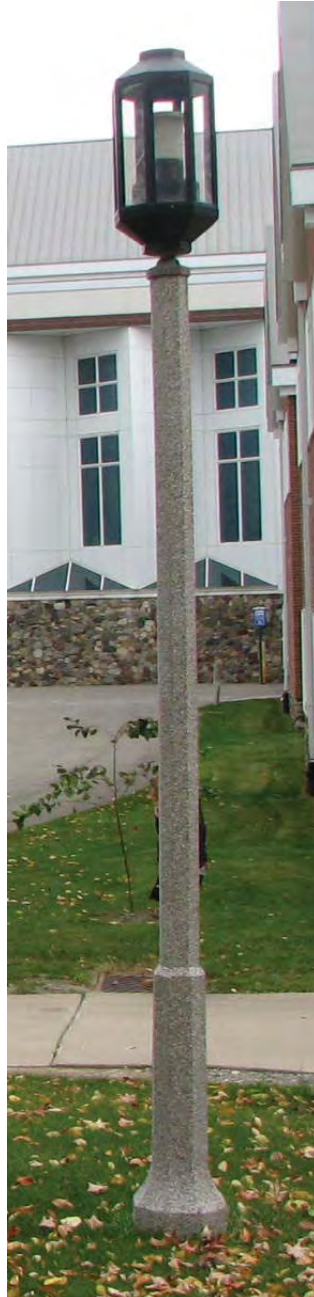
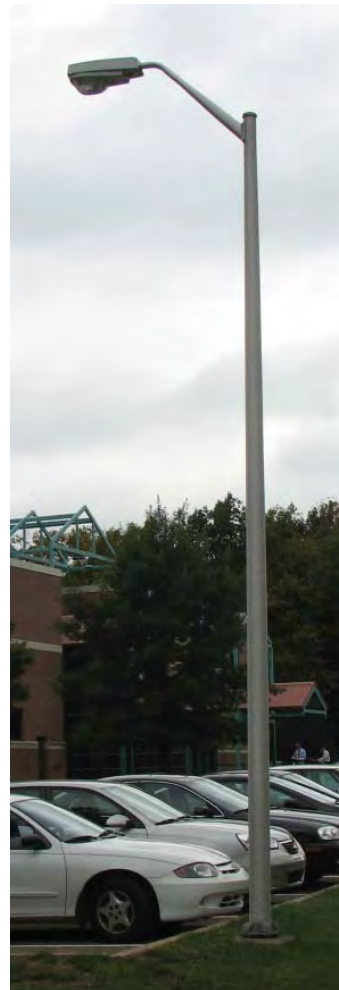
Exterior light styles are uniform across the campus for the most part. Outdated pedestrian walkway and parking lot light fixtures should continue to be replaced with the existing campus standard. Note that the use of cut-off optics are recommended to diminish the effect of light trespass and glare.

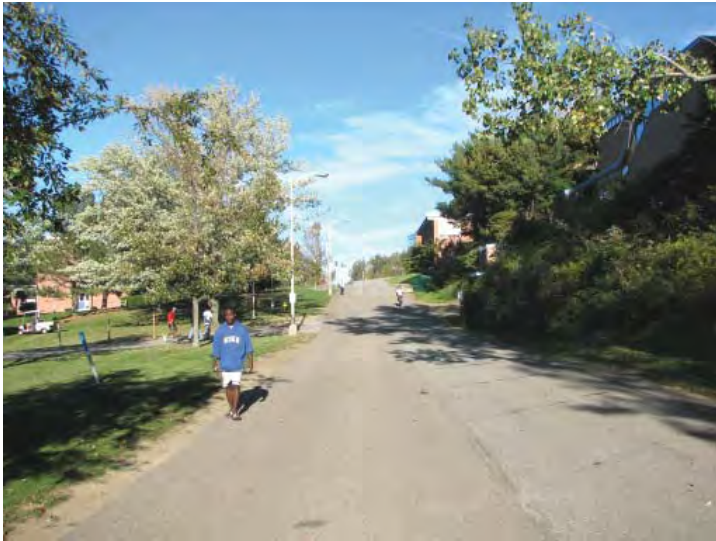
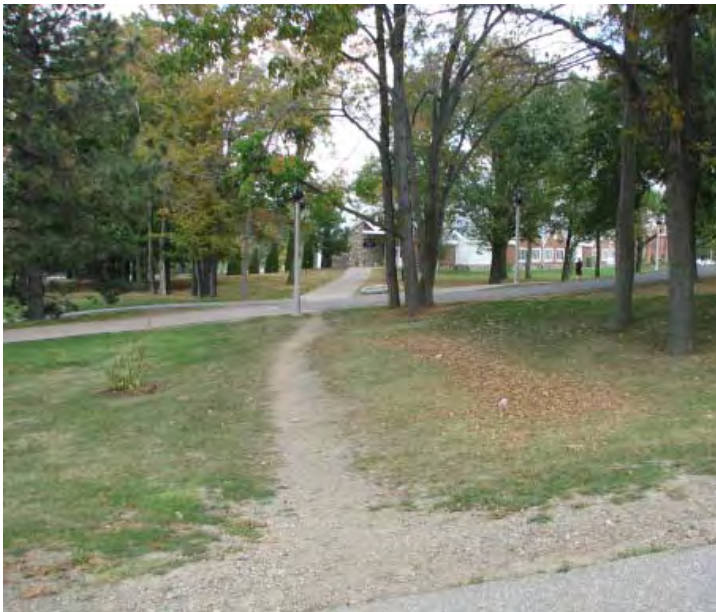
Pedestrian circulation routes across campus follow logical and efficient lines between destinations. Topographic extremes have required the use of exterior stairs and enclosed vertical circulation towers. As a result of weather extremes and the need for the use of de-icing materials, it has been difficult to maintain conventional concrete surfacing.

A campus design standard of asphaltic material for the construction of new and replacement of existing walkways is recommended. To avoid the expense of construction, maintenance and adverse aesthetic impact it is recommended that walkway width standards be developed and implemented at the campus.

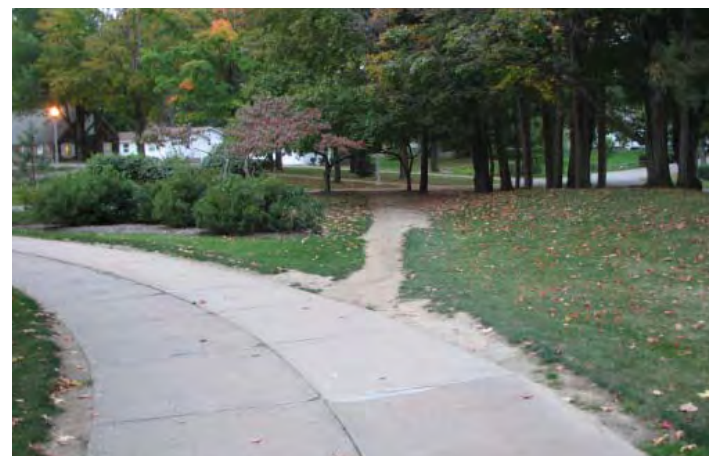
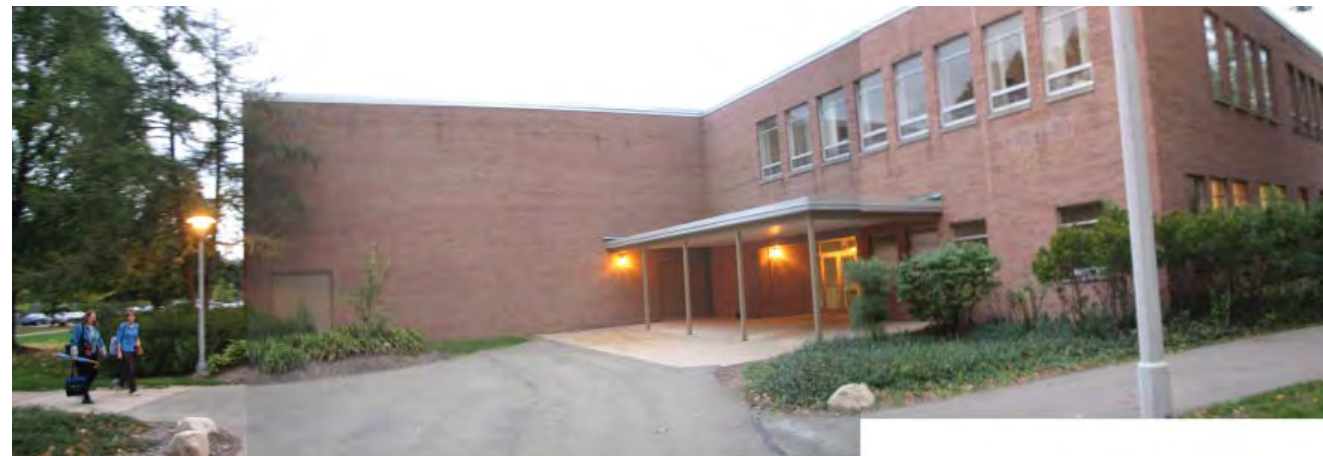
Reed NW Entrance ^{2b}

The presence of a long-standing unimproved pedestrian route across the lawn should be remediated by installing a paved surface. The need for additional site lighting along this new segment of walkway should be assessed.

As indicated in concept recommendation 1a, the walkways and paved areas at the northwest entrance to Reed Building should be reduced to allow for enhanced landscape plantings and give the entrance a more significant aesthetic appeal.

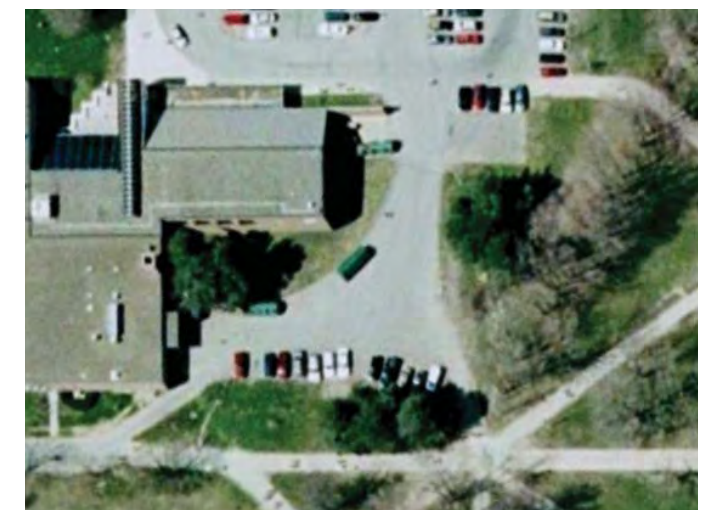
Reed Service Area 2c

Note that the proposed reduction in paved areas will result in the loss of 12 existing parking spaces.

This concept diagram illustrates several recommended improvements to the east end of Reed Building.

- Projects include:
- Reduce excess paving and create pedestrian circulation separated from vehicular circulation areas
 - Consolidate and screen loading dock/service area (see 4f for additional recommendation)
 - Reconfigure lift dock at Bookstore (see 4g for additional recommendation)
 - Create new walk to Library.
 - Supplement landscape planting.
 - Replace existing east/west walkway and resolve drainage issues

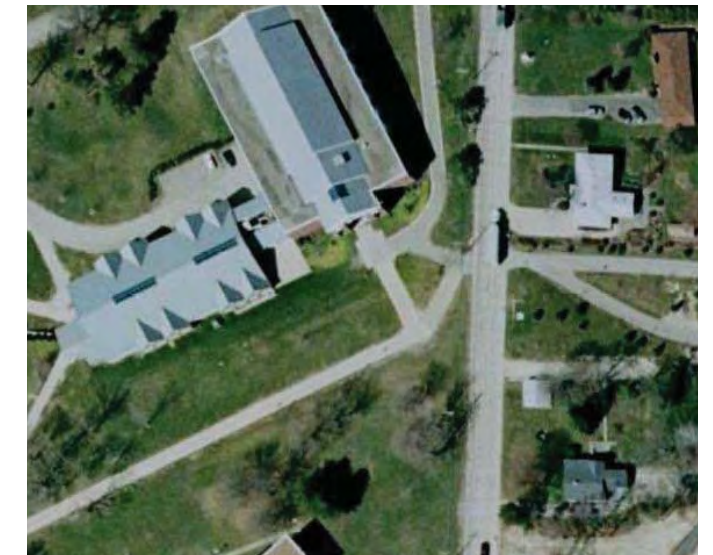
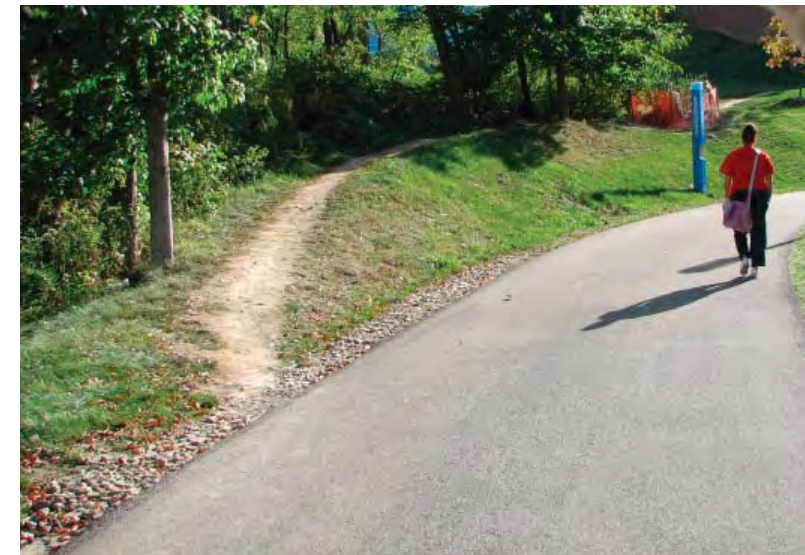
REDC Walk Access 2e

Pedestrian access to and from the REDC in a north south direction is circuitous resulting in the formation of an unimproved path.

Recommend the installation of a walkway and stair system with required site lighting to accommodate the inevitable traffic this route will receive.

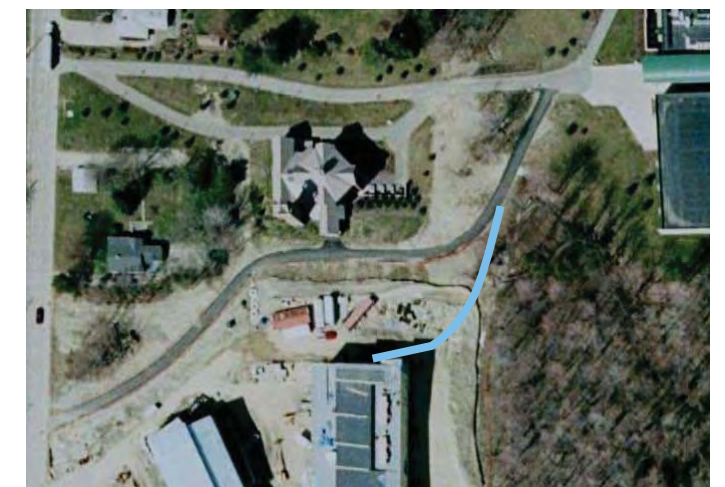
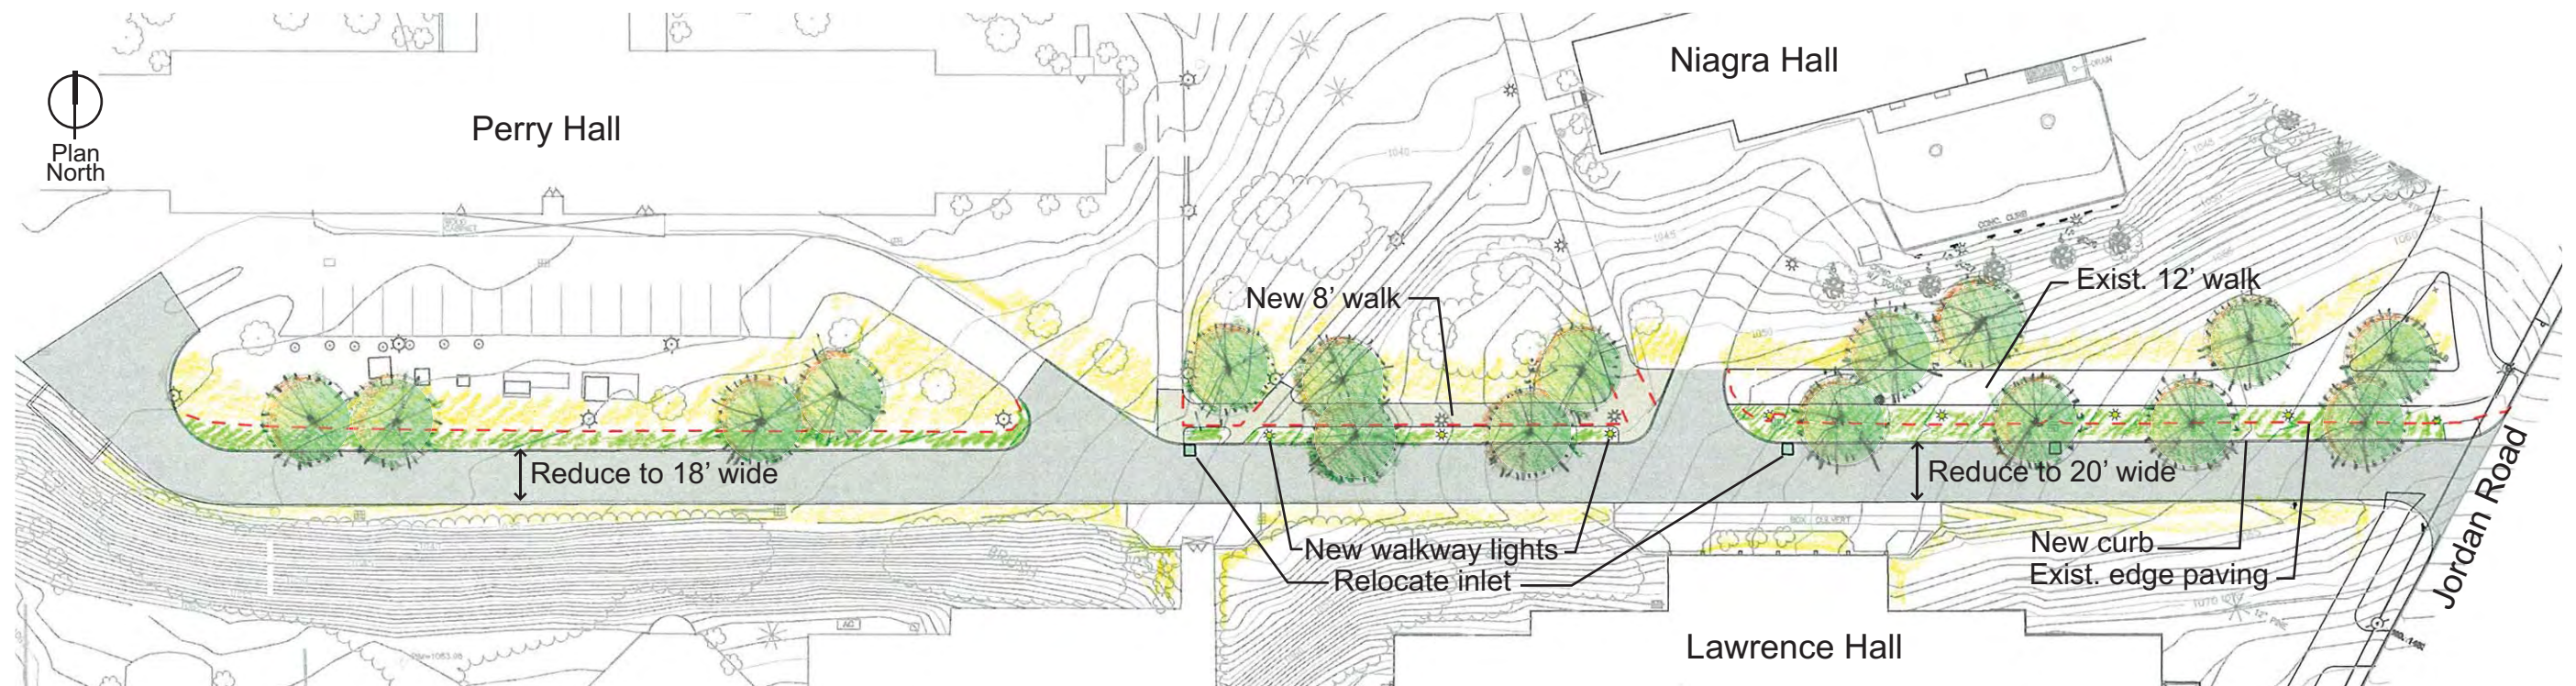
Aquarius Drive Pavement Reduction ^{2f}

Aquarius Drive cartway width is excessive. With the recent installation of parallel walk at Niagra Hall the redundancy is more evident.

Recommend that existing paved area be reduced per the sketch below. New curb and storm inlet relocations will be necessary to manage water run-off. To accommodate pedestrian users, a new section of 8' walk should be placed west of the Niagra Hall parking lot entrance. Lighting along the corridor should be evaluated and supplemented as necessary. Turf ground cover should replace pavement reduction areas. Tree planting along the drive is also recommended.

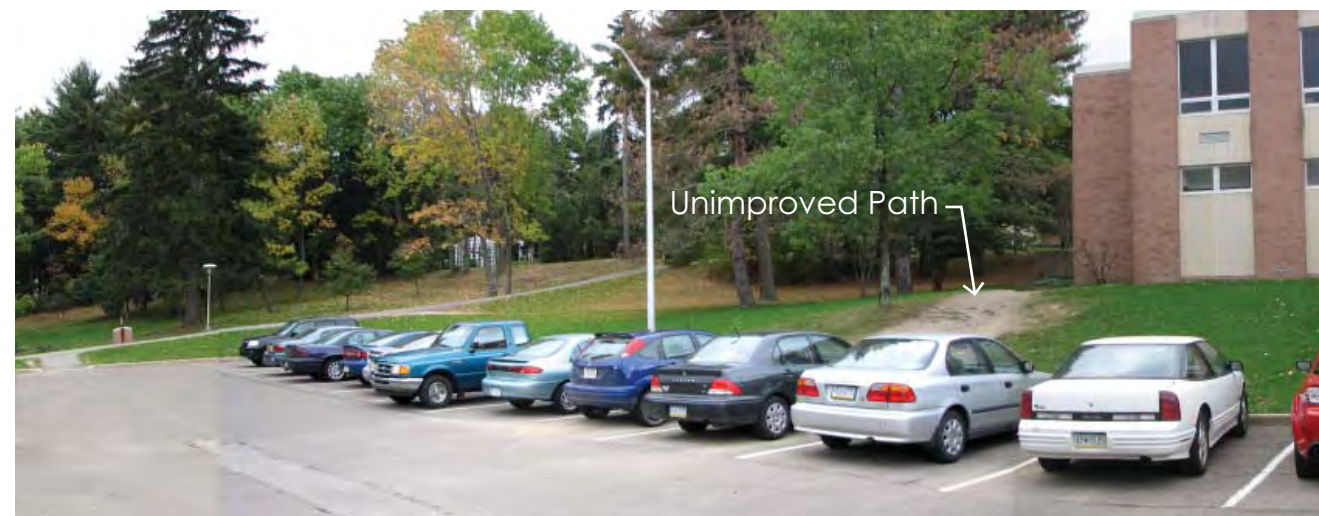
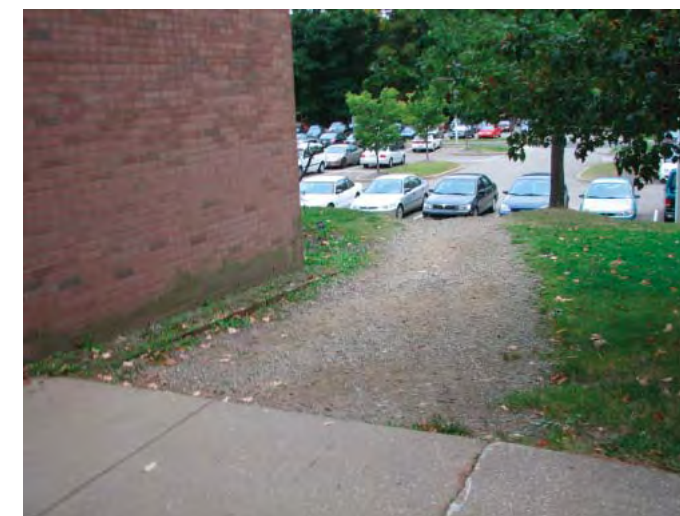
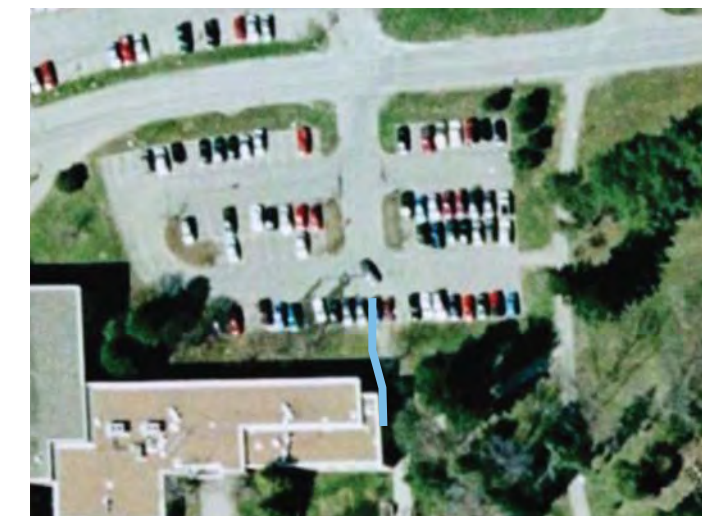
Nick Walk/Stair

The unimproved pedestrian path connecting the east end of the Nick Building with existing commuter parking to the north is a logical and inevitable route. Recommend that a permanent, maintainable surface be installed. A landing area in the parking lot should also be incorporated into the design to signal the walk location from the parking lot side. Additional analysis is needed to determine if gradient of proposed walk is excessive. If it's deemed to be too steep there will be a need for stairs to transition grade.

Additional landscaping and site lighting should be incorporated into the improvement.

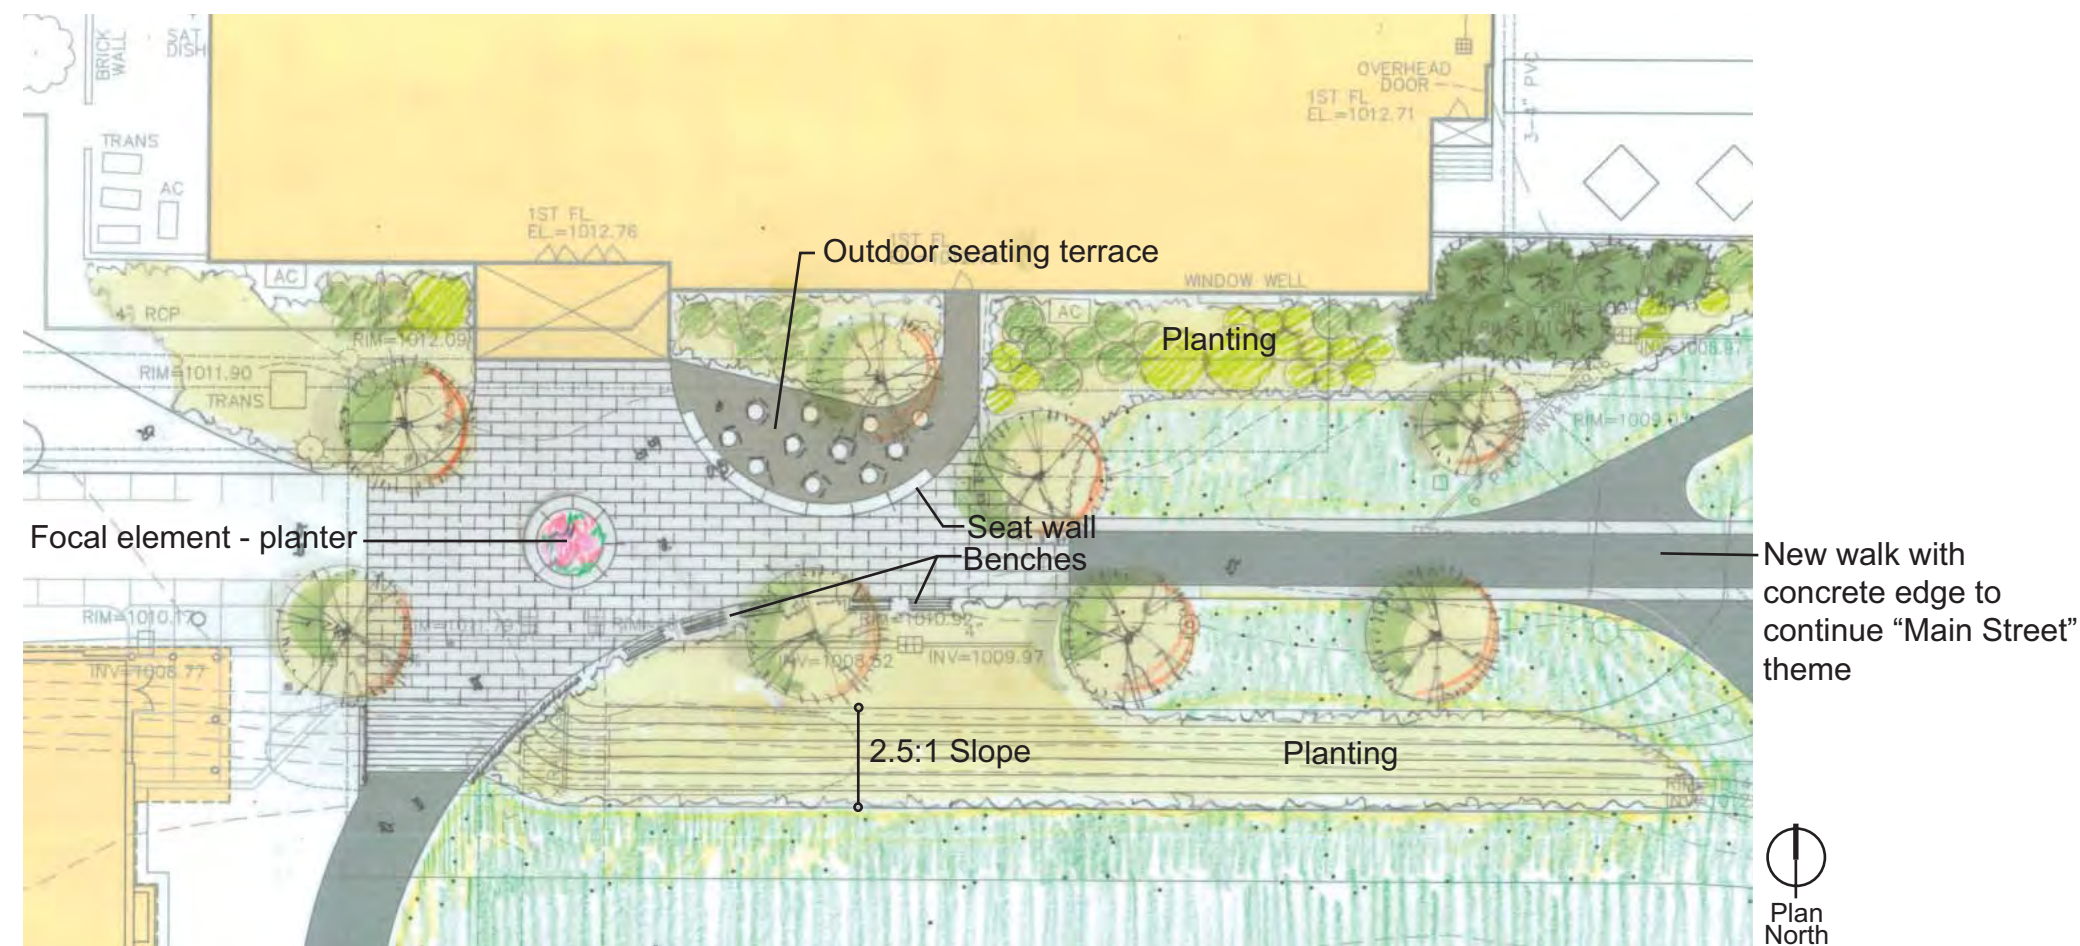
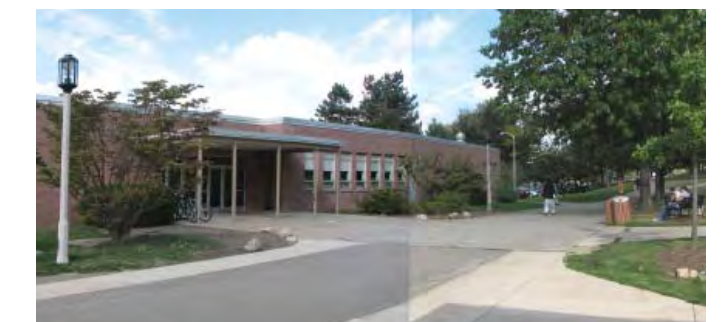
Existing

The area on the south side of Reed Building is a major pedestrian cross roads in the core of campus as well as a hub of social activity due to its adjacency to Bruno's Cafe. Seating and gathering space is lacking in this key outdoor area.

Recommend the creation of a plaza area to include table seating for outdoor dining, bench seating, trash and recycling receptacles, supplemental landscape planting and an enhanced paving surface to signal the special significance of the space. Site lighting as well as management of surface water must also be integrated into the design.

In addition to the gathering area, this concept reflects alteration to the green space and stair connection to the south (see 3c) as well as architectural entrance improvements to Reed Building (see 1b). To be successful, it's important that these improvements be integrated into one unified design solution even if implementation phasing is necessary.

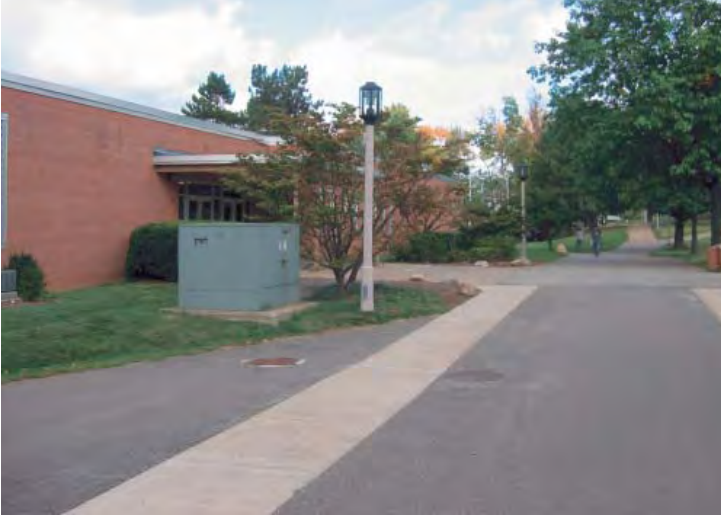
Existing transformer to be screened

Recommend the installation of supplemental landscape plantings along the south face of the Lilley Library. Objectives include screening of utilities, increased visual interest and integration with proposed pedestrian circulation modification (see 2d).

The existing miniature White Pine garden at the patio area would benefit from supplemental vegetation to enhance its visual impact.

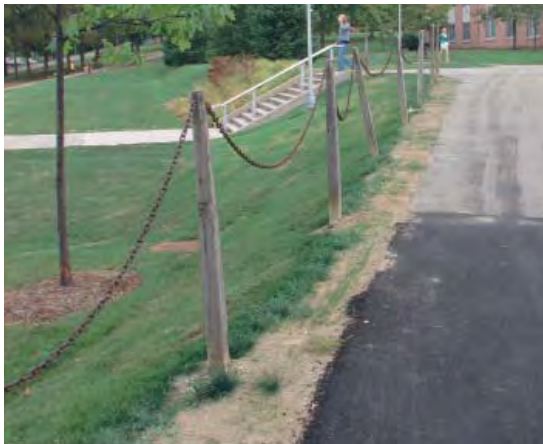
Existing post & chain

Propose the replacement of wooded post & chain with barriers that compliment other furnishings. The barrier(s) should be fabricated from quality, enduring materials.

As a result of changes made to campus circulation over the years, it is recommended that the need for such barriers be carefully evaluated prior to replacement or addition of barriers.

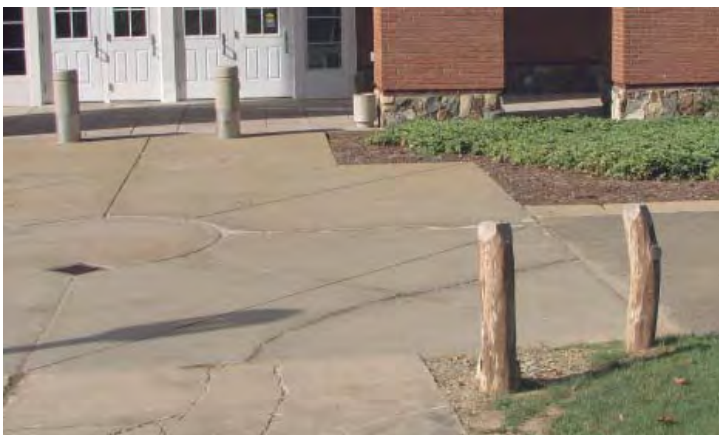
Existing site bollards
