# Fayette

The Eberly Campus

Campus Exterior Architectural Plan

Penn State Office of Physical Plant | August 2017

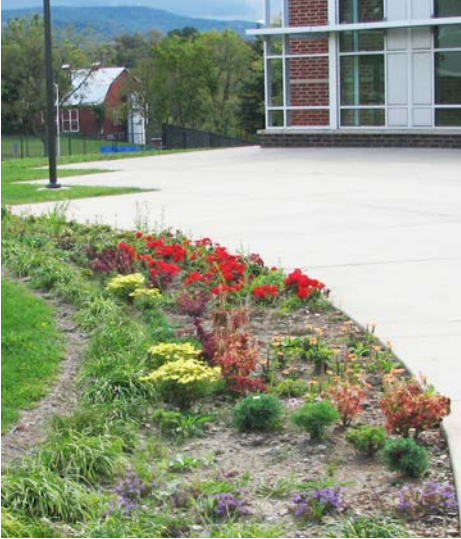
Previous

Shrubs and ground-covers have multi-seasonal appeal compared to annual/perennial flower, which quickly lose their visual appeal after their peak. Shrubs and ground-covers also require much less intensive maintenance.

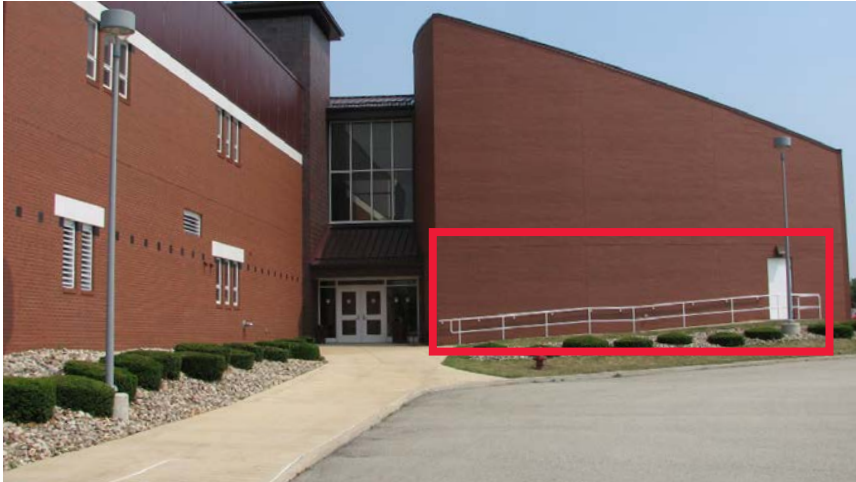
Previous

Previously, service entrances were painted white, which directed attention to them. Since the general public on campus does not use these entrances, they should not draw attention away from the main entrance.

Camouflaging service entrances should be consistent throughout campus

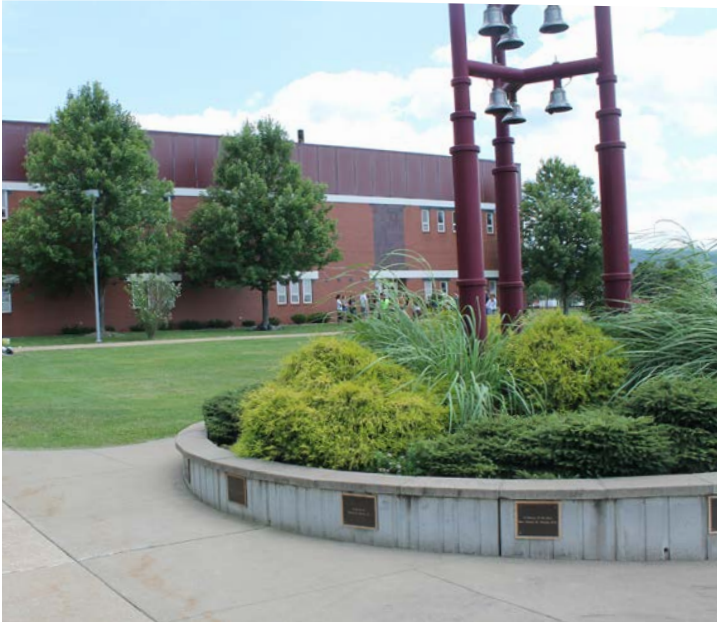
Previous

Previously, the plantings around the base of the bell tower looked scrubby and distracting. The plantings were simplified to create a clean, uniform setting for the focal feature.

The last CEAP recommended a bed of Liriope which blooms throughout the summer and daffodil bulbs which may be planted seasonally for added visual intrigue.

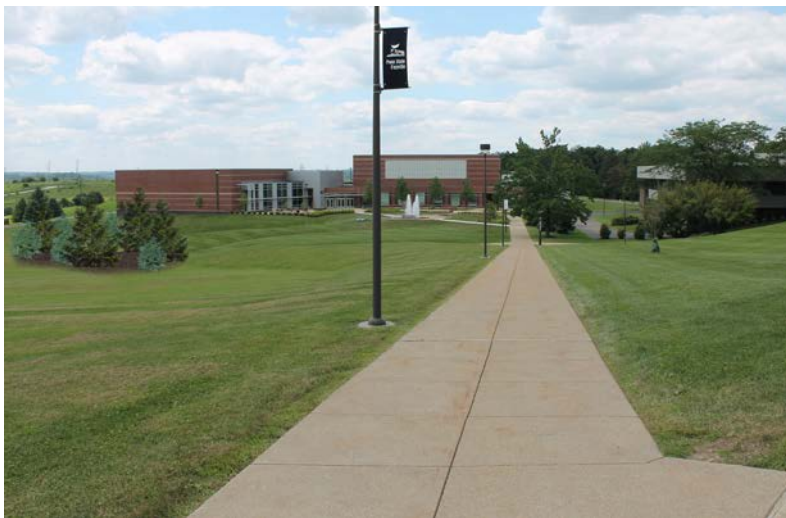
Option 1

The tennis courts are in poor condition and must be either renovated or removed. The surrounding landscape is also in need of improvement from the vast open turf.

Option 1: Renovate the existing courts in-kind. Reduce weekly mowing of the field to once or twice annually. Maintain mowed edges and pathways as cues to care.

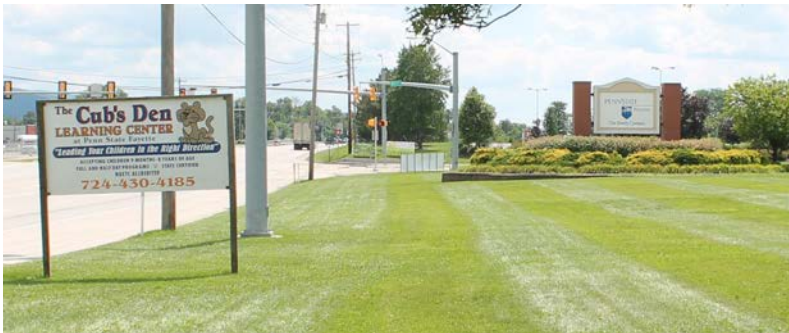
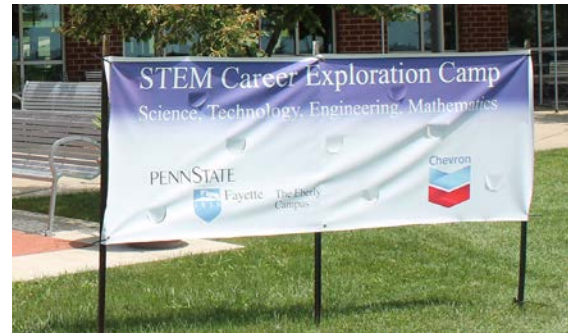
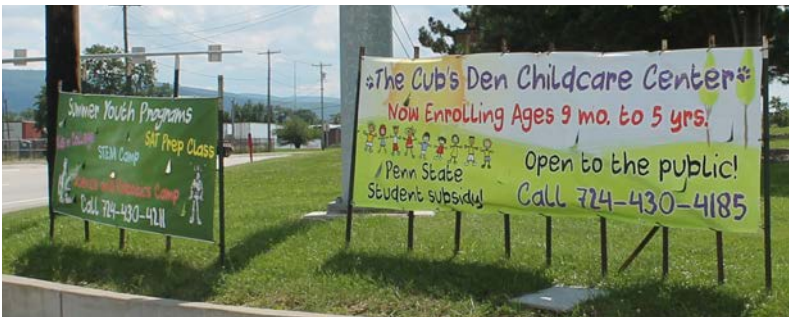
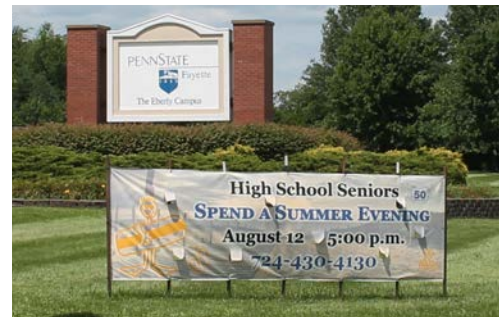
The Eberly Campus has many examples of non-standard signage. Non-standard signage looks out-of-place and as though it does not belong to the campus. Some signs or banners look informal and unsightly.

Recommend removing and replacing non-standard signage with Penn State standard signage.

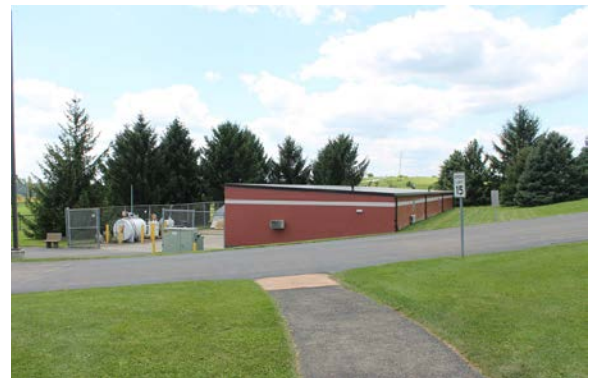
Previous

The Maintenance Building remains open to the campus, even though the majority of the campus does not use this building. Since the last CEAP recommendations, it seems that the building has actually become more noticeable. There are fewer upright evergreens screening the building and the new paint is brighter and higher contrast than before. The chain-link fence physically separates the service yard, but does not visually separate the unpleasant view.

Recommend replacing chain-link fence with an opaque paneled fence. Plant more upright evergreens around the northeast corner to screen the maintenance building.

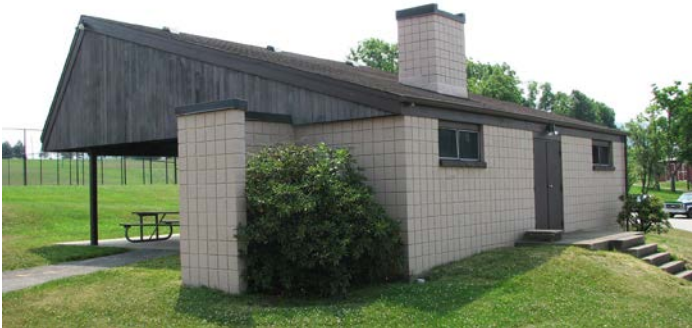
Previous

The Pavilion has been repainted since the last CEAP, however, the color contrasts its surroundings and stands out too much. What little landscaping that used to exist is no longer there.

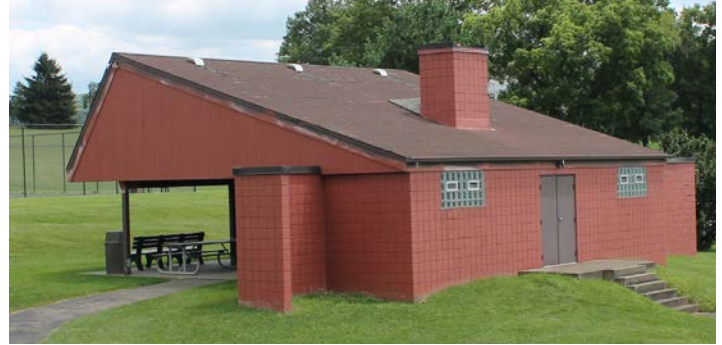
Existing

The Pavilion is outdated, not frequently used, and appears out of place on the campus landscape. There are three options for making better use of this building/space:

If facilities are needed in this location and the more intensive changes are able to be made, architectural modifications or replacement of the pavilion is possible. Recommend replacing the current pavilion with one that is more modern and more true to the aesthetic of the campus.

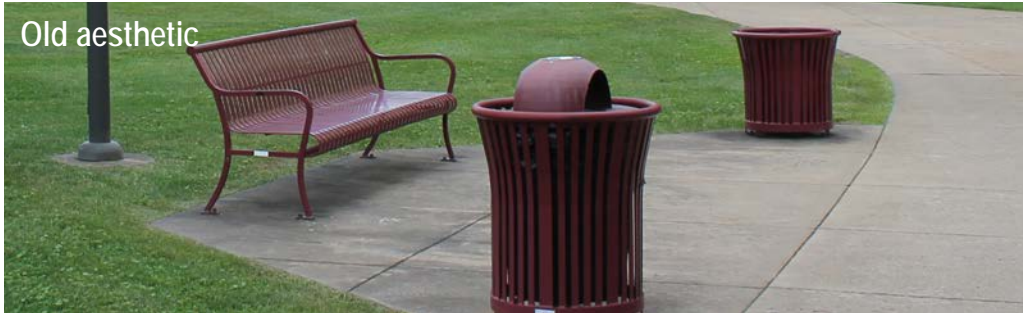
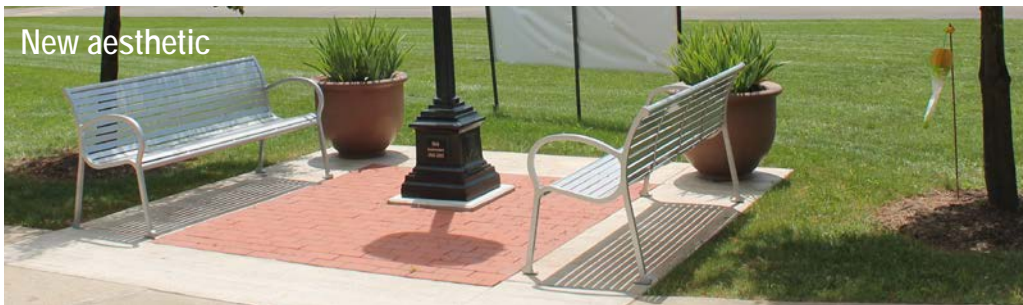
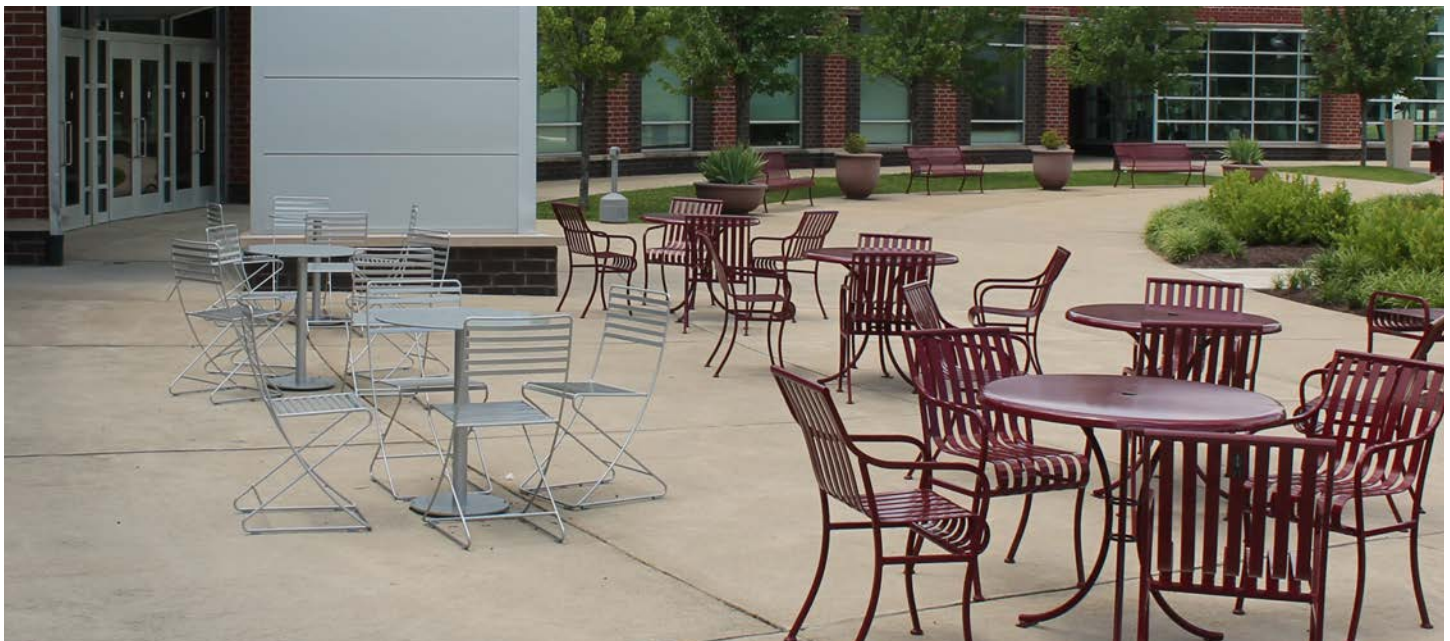
Updating site furnishings to a common standard will provide a cohesive campus identity. Some older furnishings have been replaced as per recommendation from the previous CEAP. The concern is not newer versus older furnishings but rather having all furnishings across the campus matching.

Having both the old and new furnishings scattered throughout campus detract from a unified campus identity. Replacing old, red furnishing aesthetic with new, silver tables and chairs is recommended. It is absolutely necessary to match the style of the furnishings, not just the color.

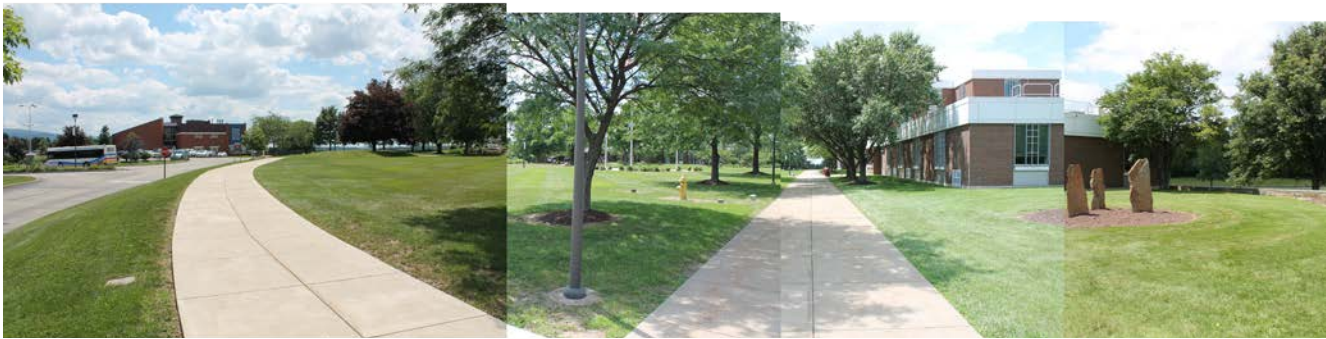
Existing

Many spaces throughout the campus are defined by open turf lawns with few trees dotting corners here and there. Recommend strategically planting trees in order to loosely define spaces.

Establishing usable and comfortable spaces between buildings will tie the campus together. Currently, Penn State Fayette feels more like a series of buildings rather than one unified campus. Incorporating key sight lines and circulation corridors into the planting of trees further helps to define the campus, particularly its most valuable features.

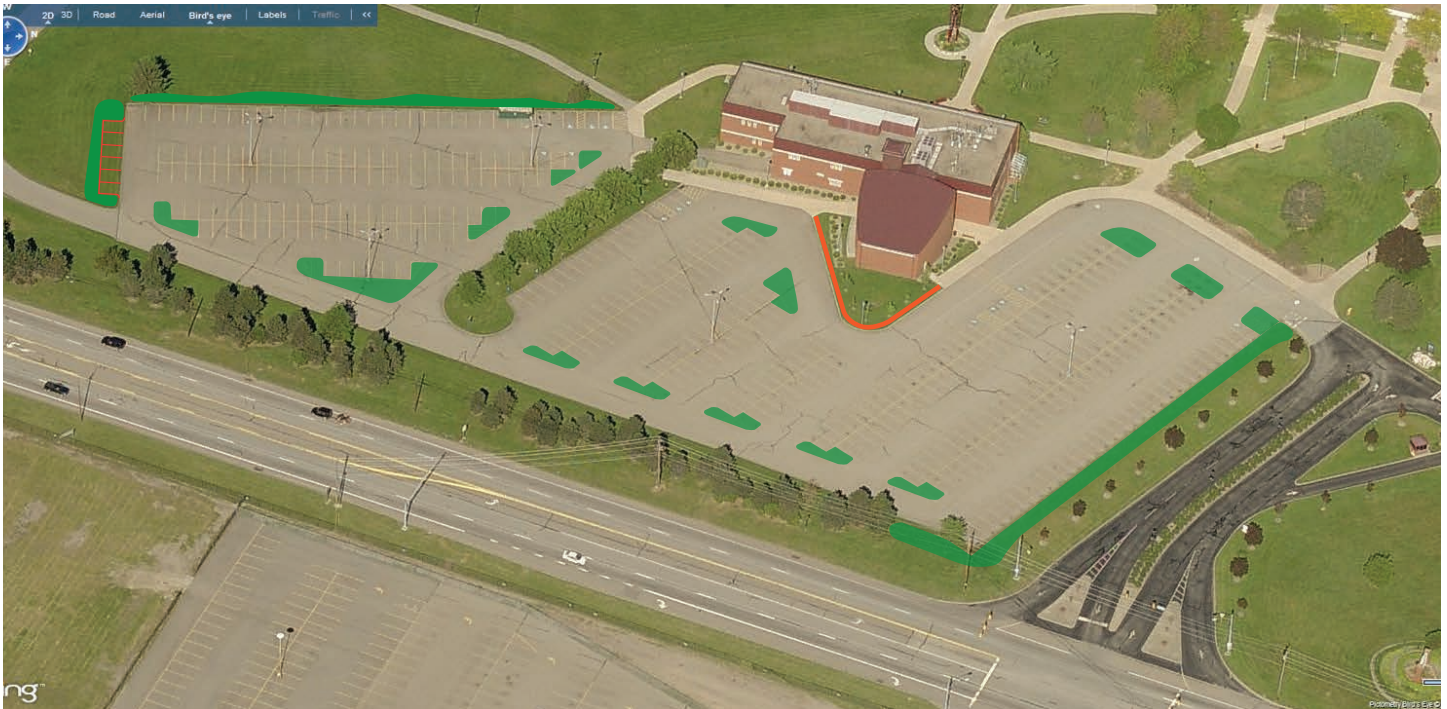
The parking lot between the Biomedical Technology Center and Route 119 is a vast uninterrupted expanse of paving. The view of campus by northbound traffic is adequately screened. The southbound view however lacks a vegetated screen. This first impression of campus can be improved through the installation of additional landscape plantings as shown conceptually in the green shaded areas of the image below.

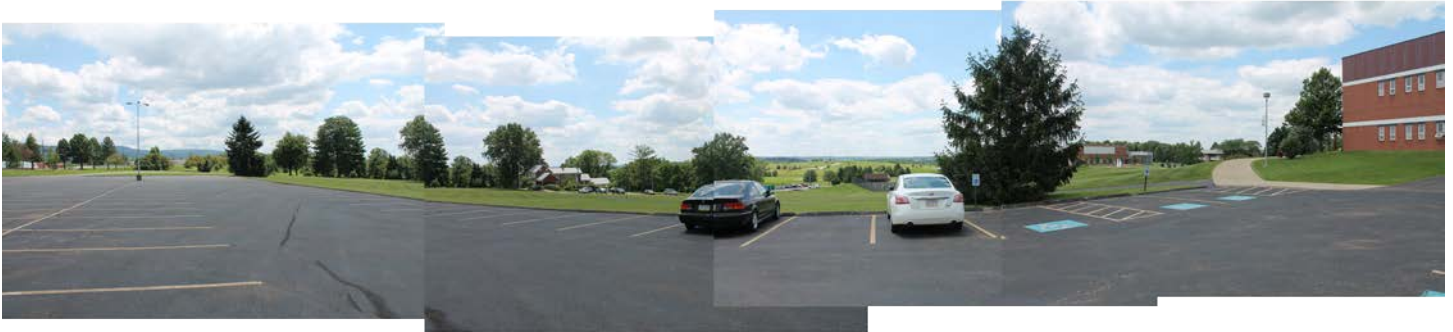
Existing

Parking is necessary for the campus, however, parking lots that are open and exposed to the elements become overly hot in the summer or windswept in the winter, as well as unattractive. Consider adding evergreen trees to screen parking lots and provide wind buffers as well as large canopy trees to provide shade.

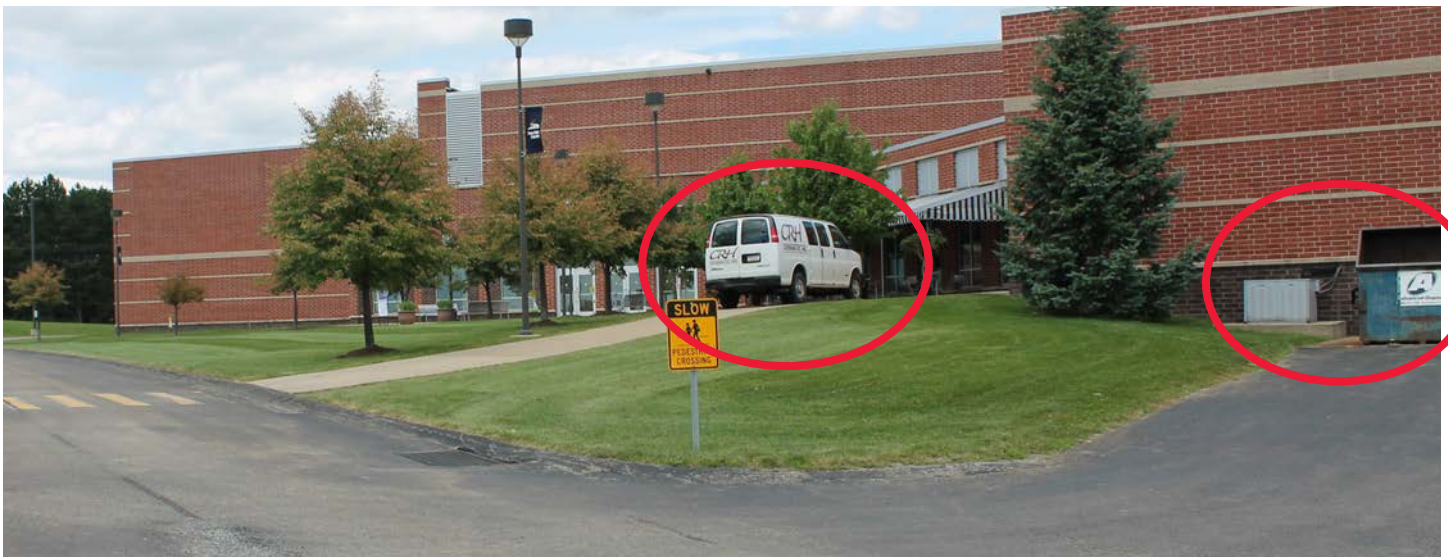
Existing

Service areas are only used by a small population on campus and are generally unattractive. Utility boxes are also unsightly in the landscape. Both of these elements are necessary for the proper function of University buildings, however, simple vegetative screening can hide them from view of the general public. Stronger separation of service areas from public areas will prevent delivery vans or service vehicles from creating conflict with pedestrians.

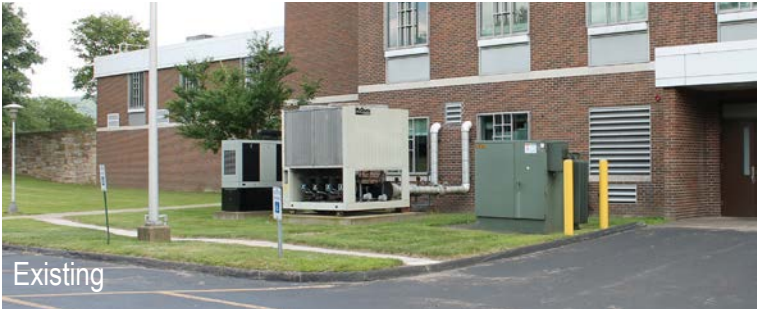
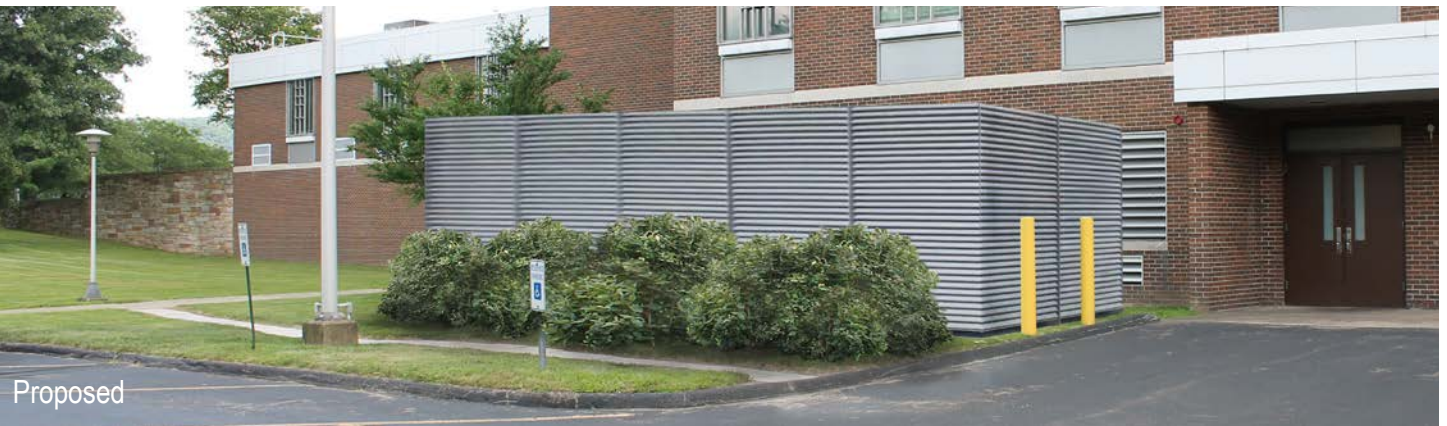
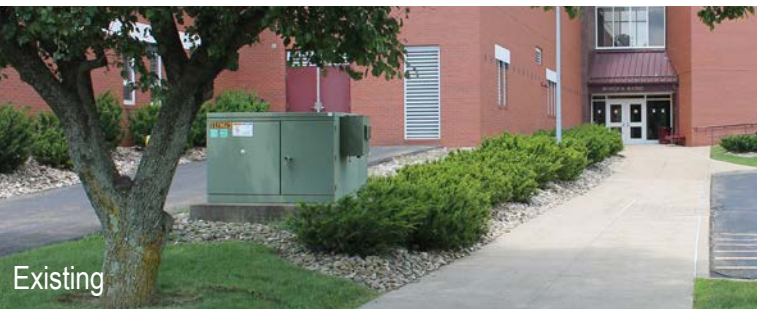
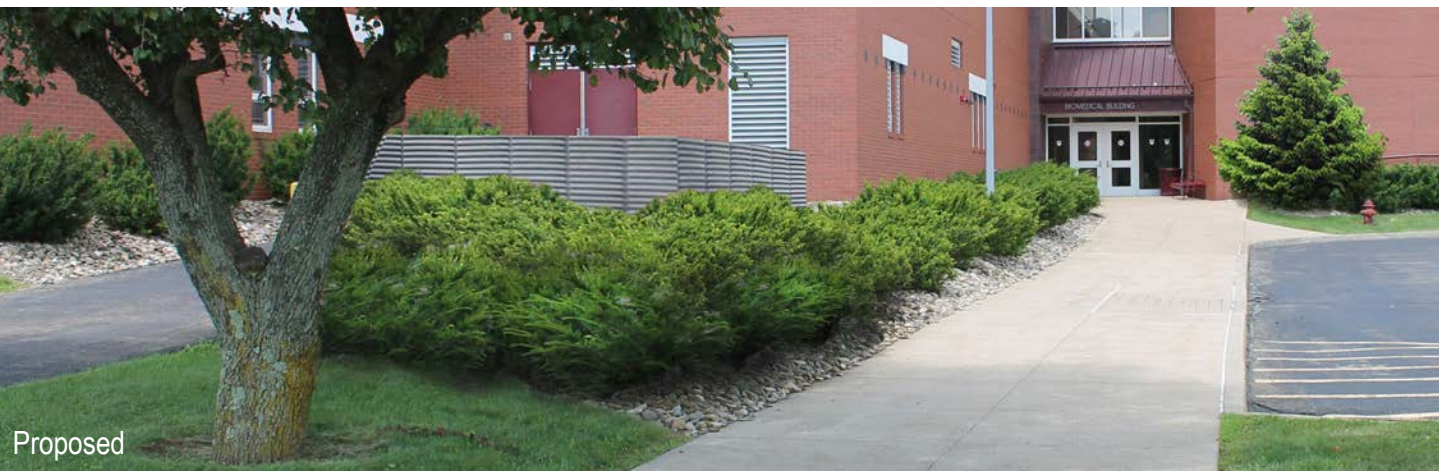
## Screening Utilities

Plantings, walls, or fences should screen utility areas, contributing to the overall beautification of campus. There are several locations around the campus where utilities are out in the open, some of which have been used as example on the following page. Plantings are typically recommended over architectural solutions for both cost and aesthetic reasons.

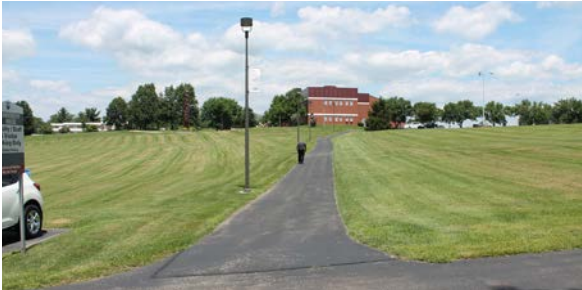
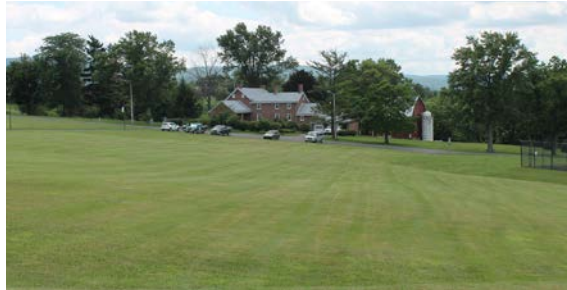
Existing

Large turf fields require a great deal of regular maintenance and create uncomfortably large spaces.

Allowing large areas of turf to naturalize will reduce maintenance costs/requirements. Reduce Mowing to once or twice annually. Maintain mowed edges as a cue to care and intention.

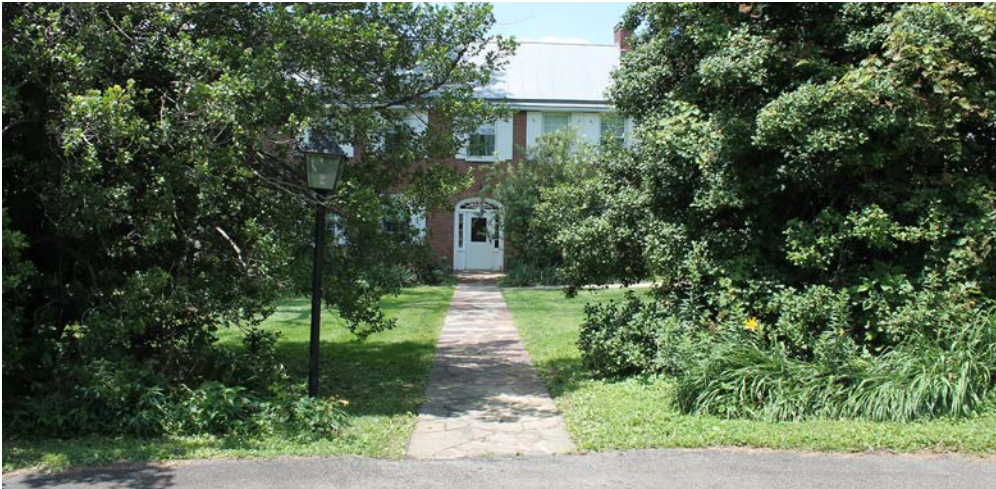
Existing landscaping is messy and hides the house from view. The house feels separated from the rest of the campus and inaccessible. Recommend simpler landscape design for ease of maintenance and improve aesthetics.

Prune trees and remove foreground plantings for a cleaner view of the University House

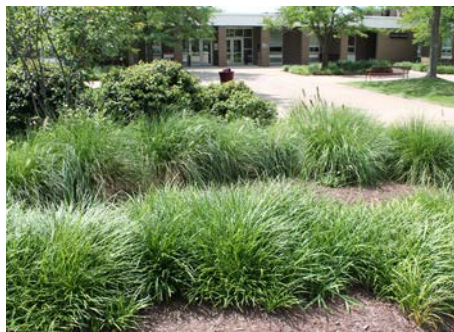
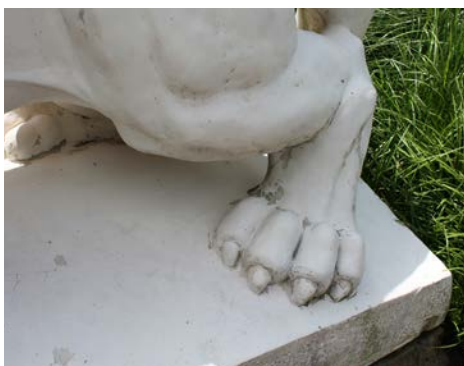
The lion statue is pockmarked and in need of a fresh coat of paint

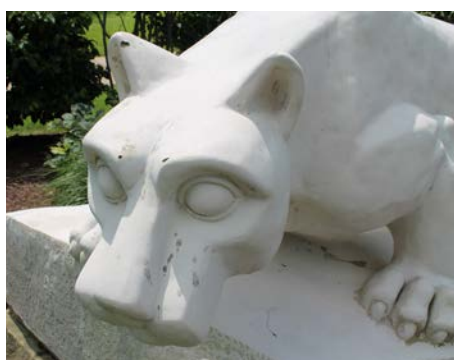
The lion statue is pockmarked and in need of a fresh coat of paint
