Penn State  
**Lehigh Valley**

Campus Exterior Architectural Plan  
January 2008

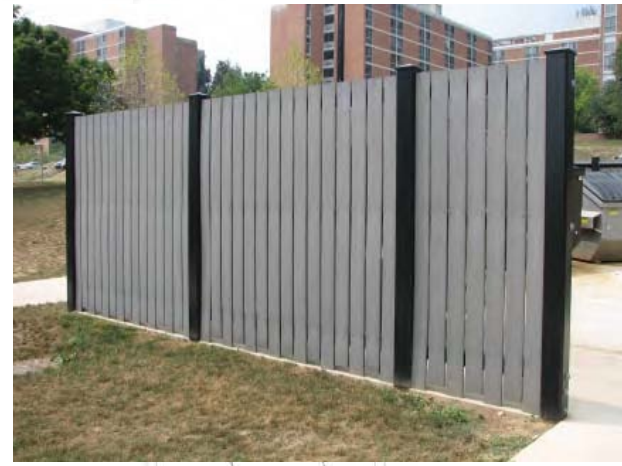
Screen fence fabricated from painted steel tube posts, and frame with recycled lumber planks.
