# CAMPUS EXTERIOR ARCHITECTURAL PLAN

September 2003

Prepared by:  
Pennsylvania State University  
Office of Physical Plant  
Division of Campus Planning and Design

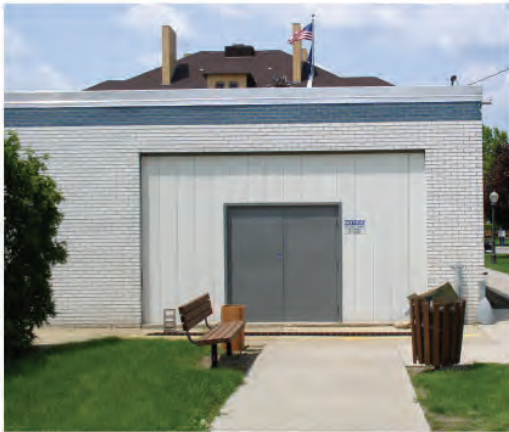
Major architectural modifications, additions and new construction are beyond the scope of this CEAP. What has been noted is the incongruity of color choices of several existing buildings in relation to the landmark Sharon/Lecture Hall.

Deteriorating wall finishes and siding material are noted on Black and Bashore Building and McDowell Hall.

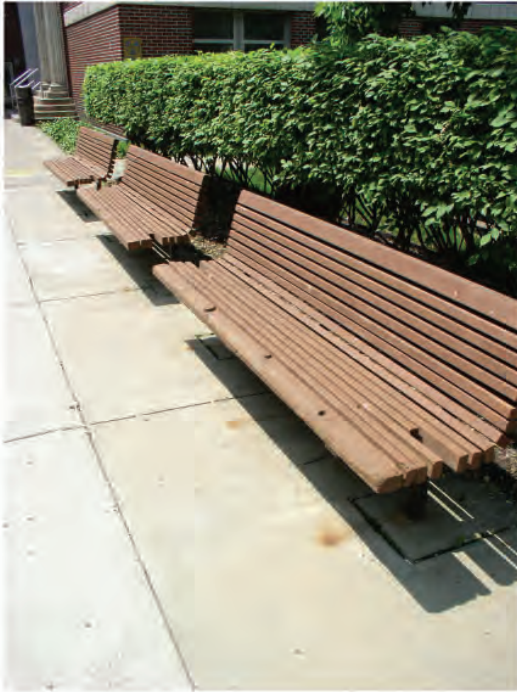
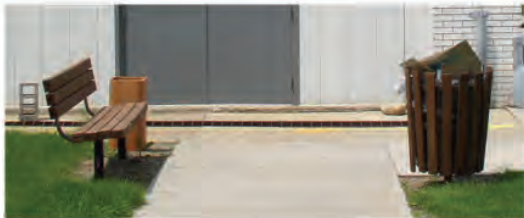
A variety of styles and sizes of benches, tables, trash receptacles and ash urns are spread across the campus. The campus currently does not take full advantage of the opportunity to define an aesthetic character through stylistically complimentary furnishings.

In addition to aesthetic appropriateness, the longevity and maintenance of site furnishings should be considered when specifying. The existing wooden furnishings require painting and are vulnerable to vandalism.

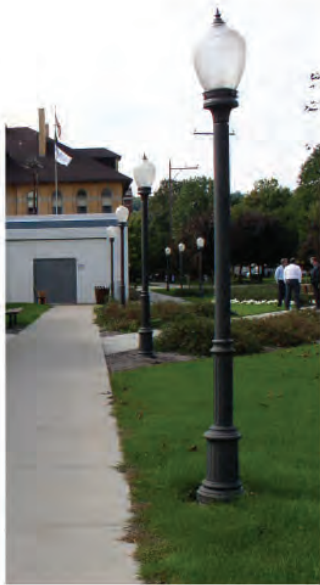
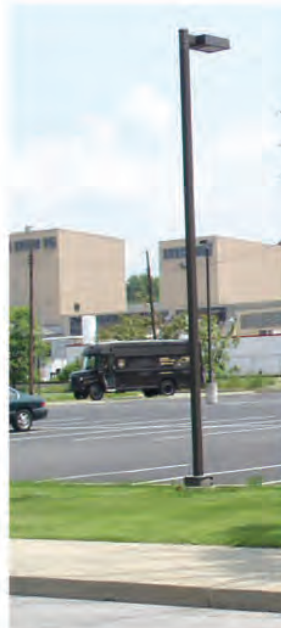
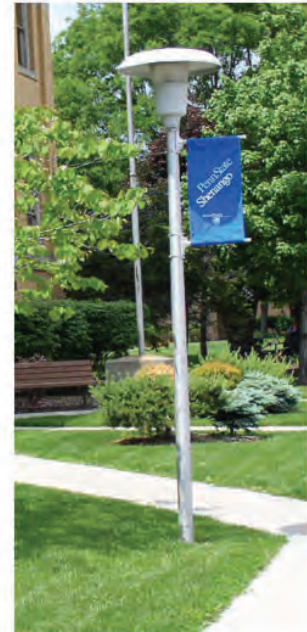
Campus fixture types

Campus lighting is inconsistent stylistically with respect to luminare and lamp type as well as pole design and color. The campus currently does not benefit from the unifying effect of a comprehensive exterior lighting scheme.

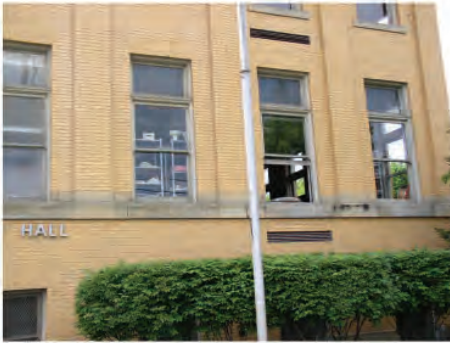
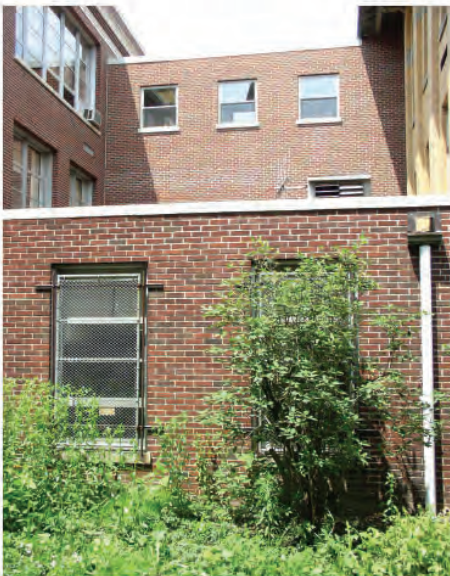
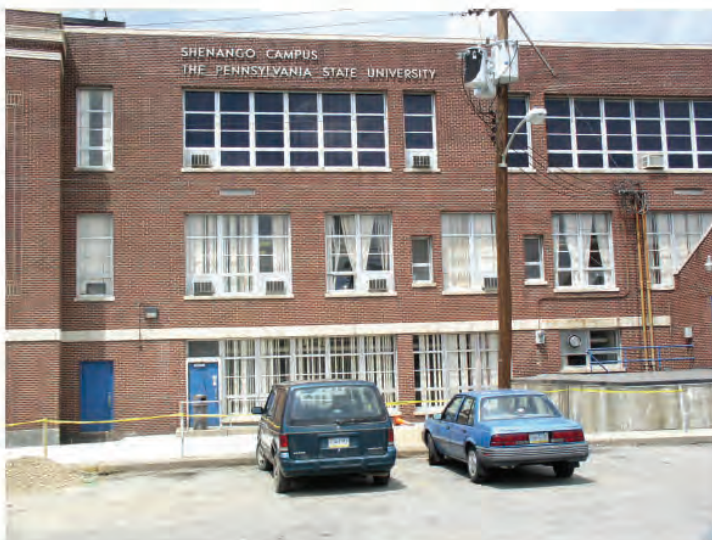
Onlookers assessment of the visual quality of a building can be effected by something as simple as the appearance of windows. Storage in front of windows is noted on Lecture Hall. Some windows are grated and barred for security reasons. Some window coverings appear dated and worn.

Low or no cost alternative measures can be implemented to maintain security without giving the impression from outside as well as within that the building requires fortification.

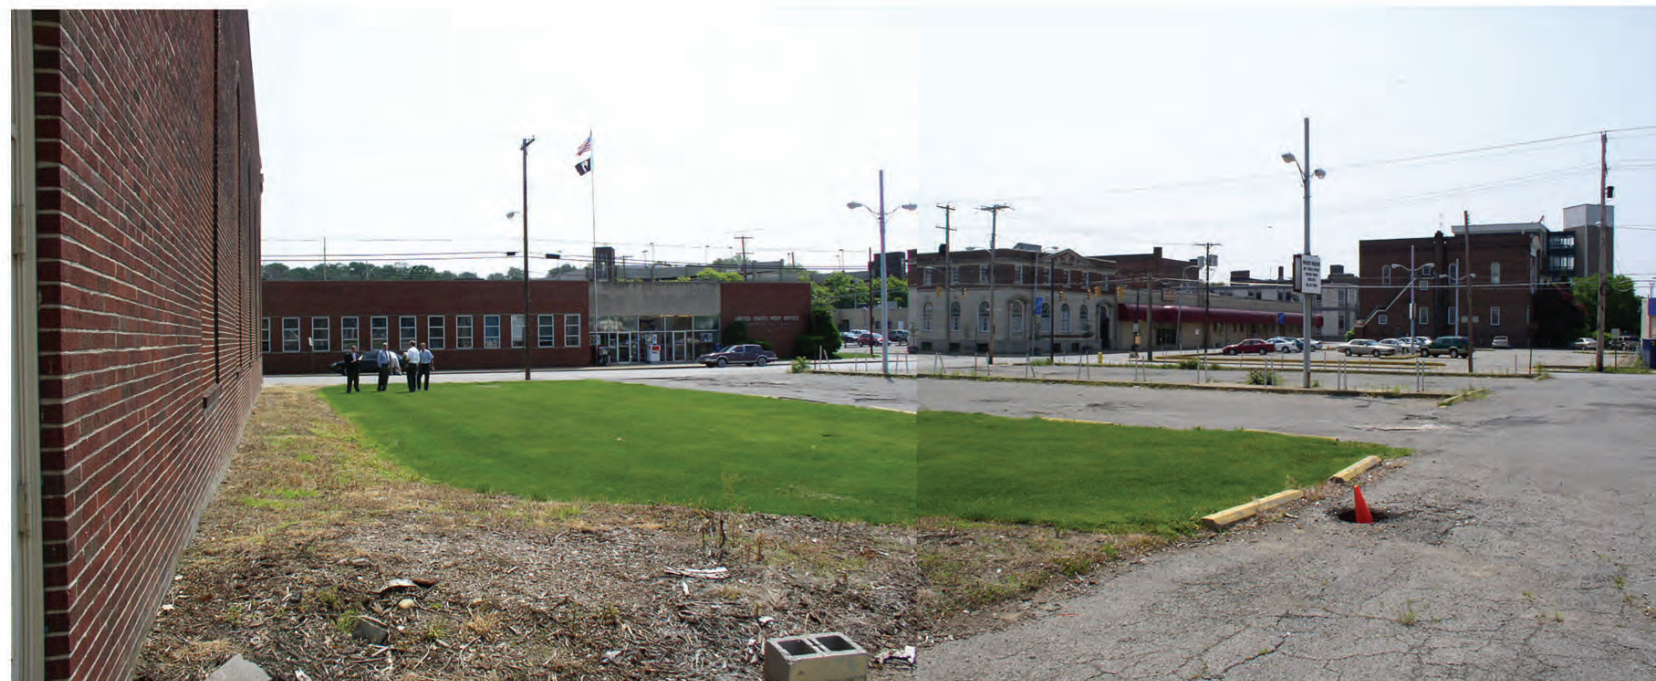
Before

The primary approach to campus is characterized by the stark facade of the south side of the auditorium wing of Sharon Hall and a deteriorated parking lot. A busy civic use occupies the opposite corner in the City of Sharon post office.

The opportunity exists to create a multi-functional parklike area. In addition to the softening effect of landscape plantings, the space can provide seating as well as an identification signage opportunity on the masonry corner wall.

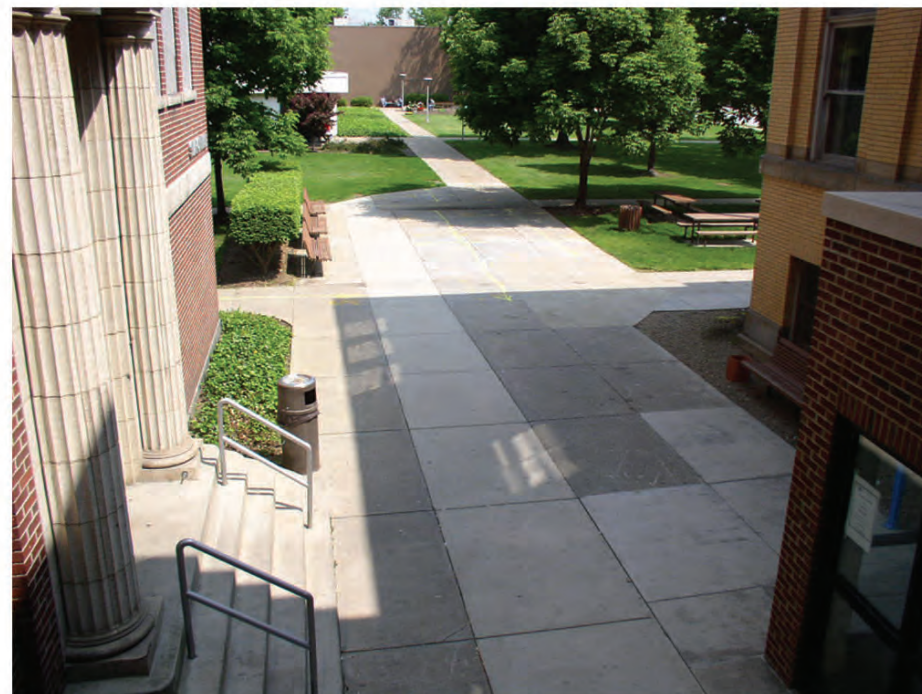
Before

Lecture Hall and Sharon Hall join to form one of the most active open spaces on campus. The space is currently underdeveloped and poorly furnished. The opportunity exists to create an appealing outdoor gathering area while at the same time strengthening the existing east-west pedestrian mall.

Recommend installation of enhanced paving material and seating in addition to a focal element at the intersection of the mall walkways.

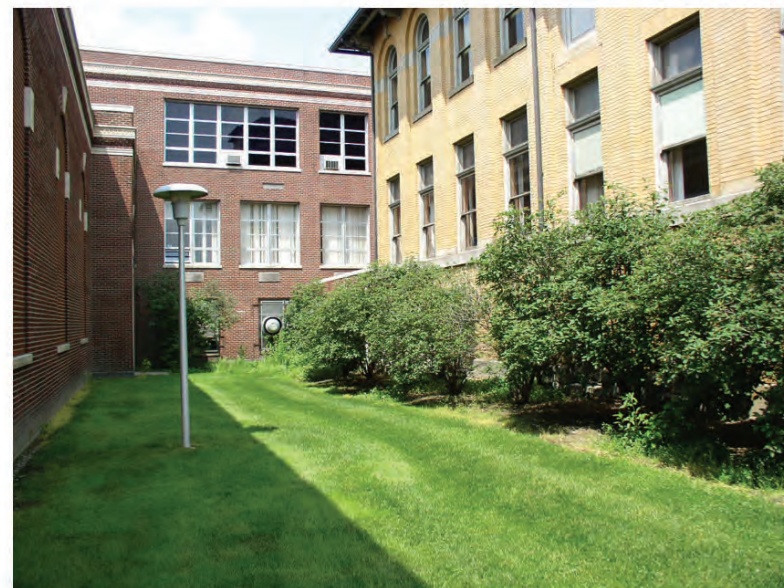
Before

The existing courtyard space between Lecture Hall and the auditorium wing of Sharon Hall is a dead space without purposeful use. The opportunity exists to provide an outdoor access to the student lounge space in the basement of Lecture Hall which can also function as breakout space for the auditorium.

Recommend storefront window and door replacement along south face of Lecture Hall and landscape improvements to courtyard space.

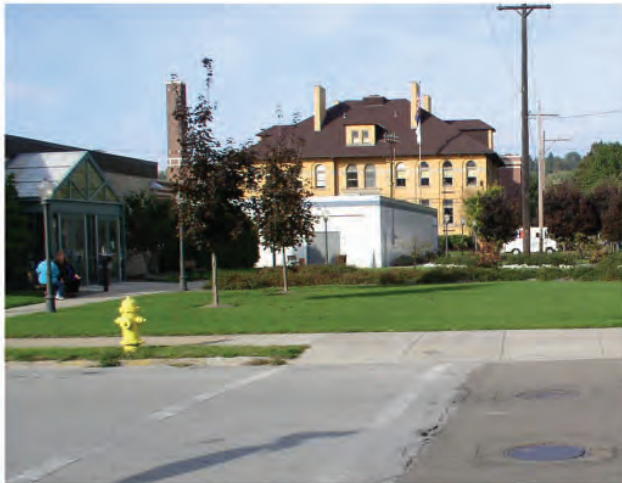
Before

The landmark building on campus is arguably Lecture Hall. The earth tones of the Library building and Forker Lab color schemes compliment Lecture Hall. On the contrary, the strong contrast of bright white and blue on Chadderton Lab is not sympathetic to the campus color scheme.

The “white shoebox” draws too much attention to itself and interrupts the visual flow of the mall.

Recommend painting the building a complimentary color to diminish its visual impact on the space. The estimated construction cost for this improvement is \$25,000.

Consideration should be given to complete removal of this structure and reconfiguration of the pedestrian mall at some point in the future.

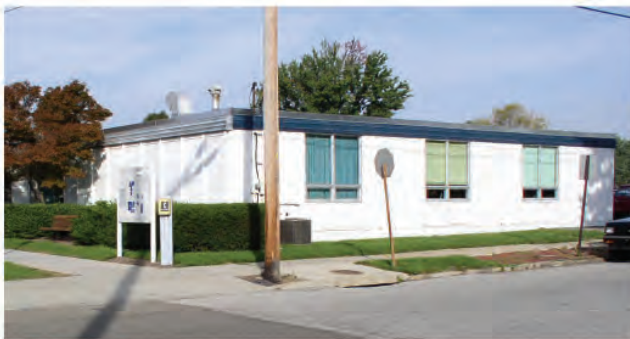
Before

As with Chadderton Lab, the color scheme of the Black and Bashore Building is not complimentary to the colors used on other principal campus structures. In addition, the existing siding on this structure is in disrepair. This structure flanks the entrance to the pedestrian mall opposite the library forming a “bookend” to this campus gateway.

Recommend siding repair and painting the building in a color scheme compatible with that of the library. The estimated construction cost for this improvement is in the range of \$25,000 to \$50,000 depending on the condition of the existing siding.

Consideration should be given to complete removal and/or replacement of this structure at some point in the future.

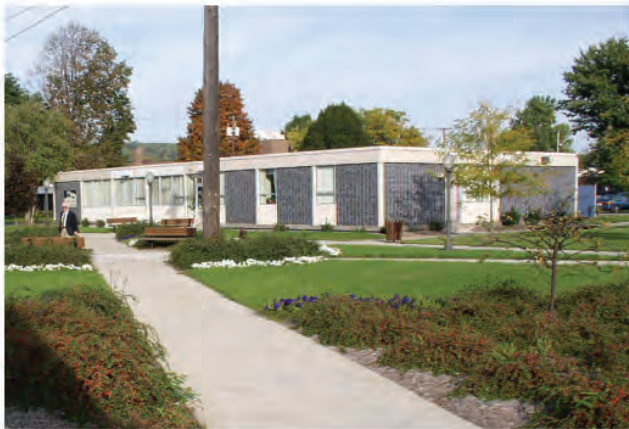
Before

As with Chadderton Lab, the color scheme of the Black and Bashore Building is not complimentary to the colors used on other principle campus structures. In addition, the existing siding on this structure is in disrepair. This structure flanks the entrance to the pedestrian mall opposite the library forming a “bookend” to this campus gateway.

Recommend siding repair and painting the building in a color scheme compatible with that of the library. The estimated construction cost for this improvement is in the range of \$25,000 to \$50,000 depending on the condition of the existing siding.

Consideration should be given to complete removal and/or replacement of this structure at some point in the future.

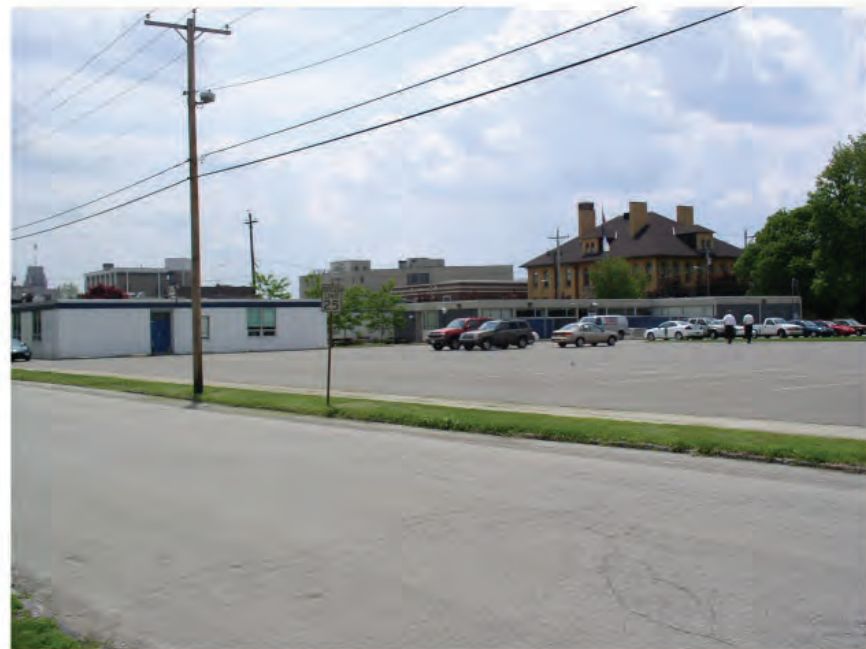
Before

Parking lots east of Shenango Avenue have been developed without the benefit of landscape screening to adjacent streets. The addition of plantings between parked cars and sidewalks will help to define campus edges as well as softening the harsh appearance of pavement and cars.

Establishment of screening will require removal of some pavement and replacement with suitable soil material and planting. Estimated construction cost range for this improvement is \$45,000 to \$50,000.

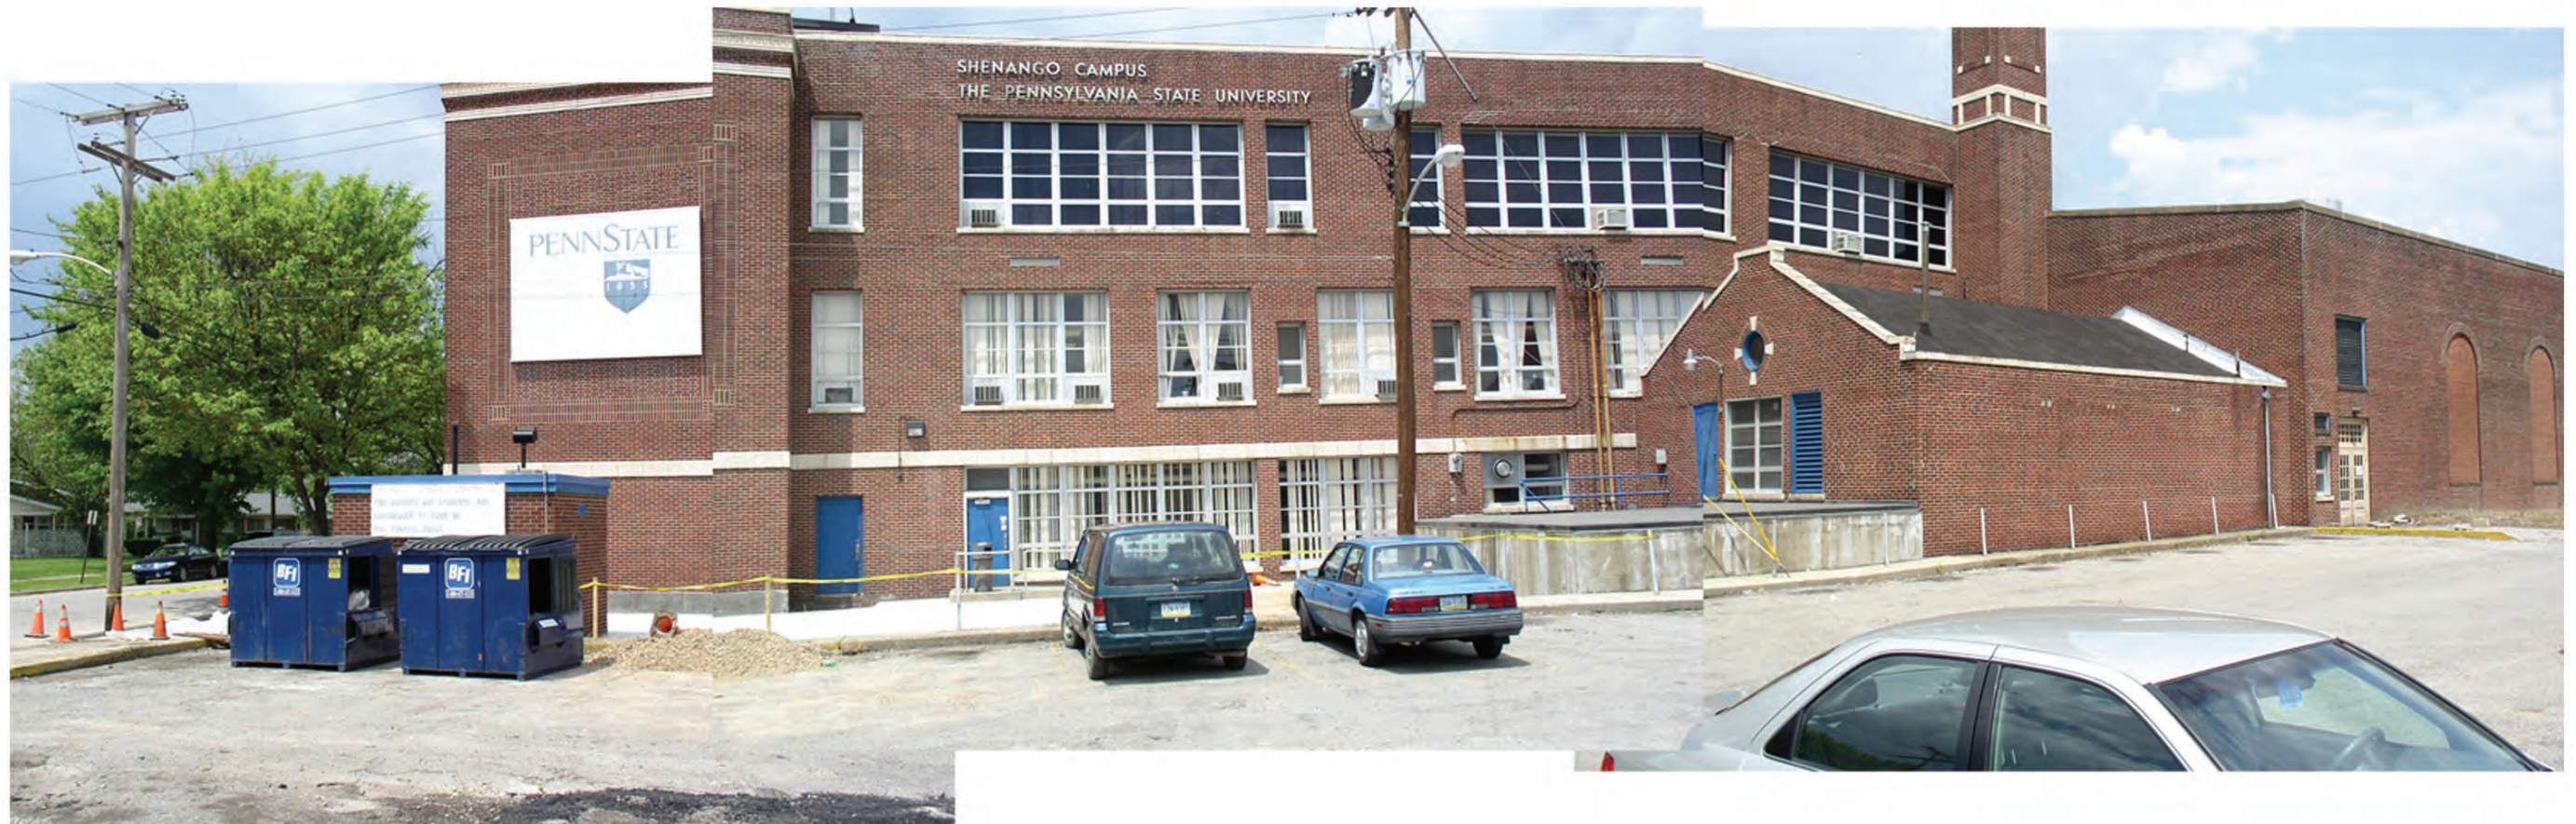
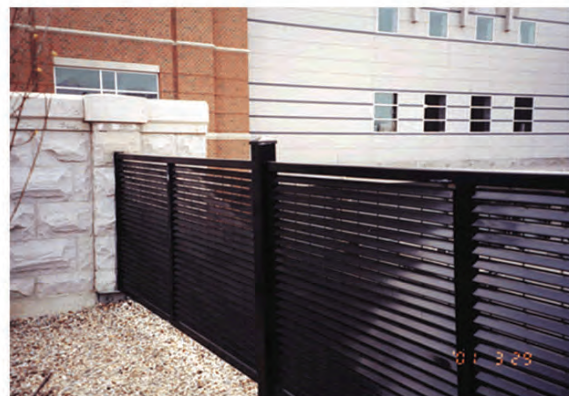
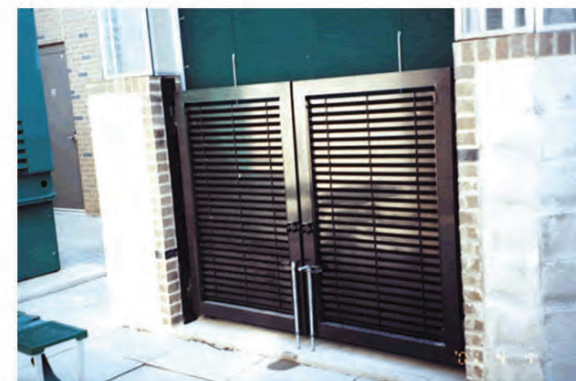
The southwest corner of Sharon Hall serves several utilitarian functions in the operation of the building. This corner is also highly visible from primary campus approach routes.

Example of metal fence and gate design to screen and secure the service area adjacent to Sharon Hall.

The estimated construction cost to provide this improvement is \$7,500-\$10,000.

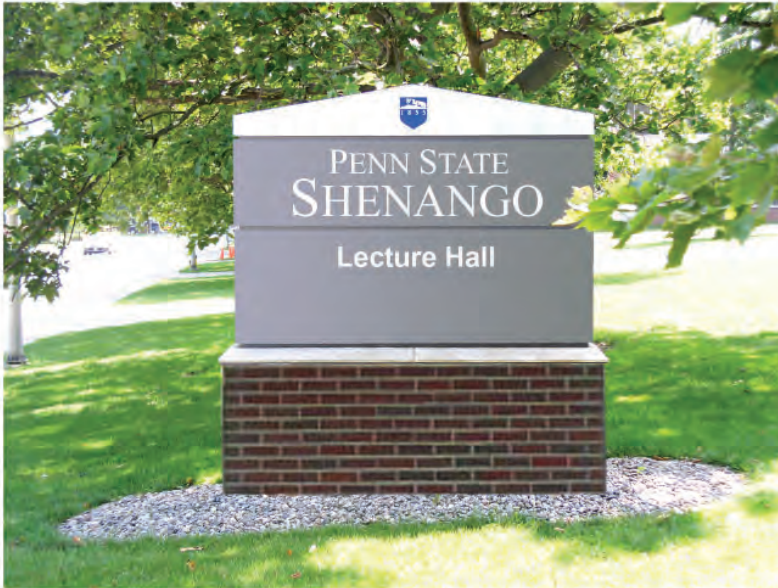
Campus Identification Sign

Signage identifying the campus, individual buildings and parking options is necessary for convenient use of the facility. Signage is also an important technique for unifying the visual appearance of the campus.

Recommend development and adoption of comprehensive signage standards governing size, content, style and color for all exterior signage applications.

Construction cost for a campus wide signage package is estimated to be in the range of \$50,000 to \$100,000.

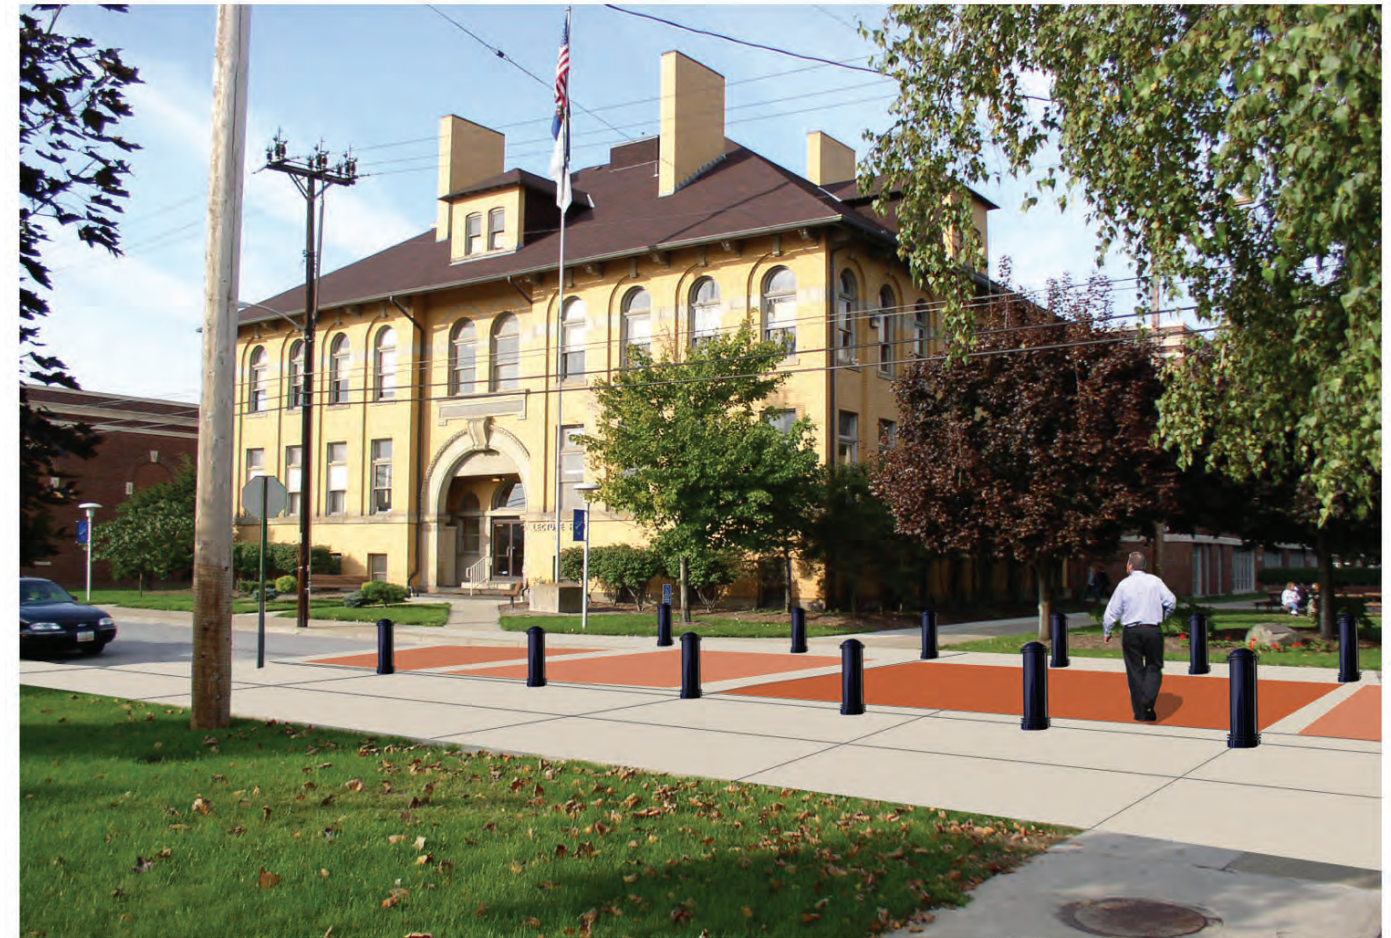
Shenango Avenue at the campus mall after lane reduction and paver installation

Construction cost for curb relocation, enhanced walkway surfaces, bollards, landscaping and paving restoration is estimated to be in the \$50,000 to \$100,000 range.

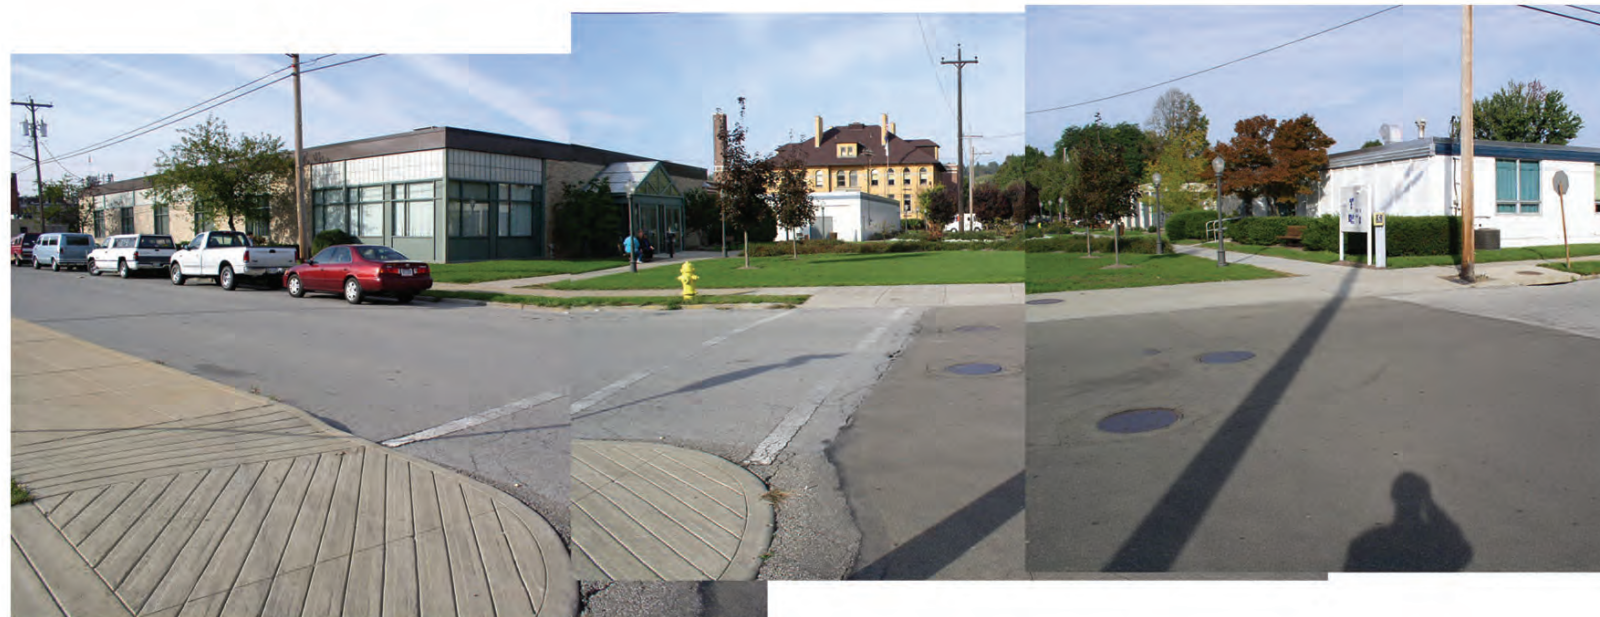
Vine Avenue at the campus mall before improvement

The existing pedestrian mall running north/south through campus intersects with city streets at Shenango and Vine Avenues in an unceremonious way.

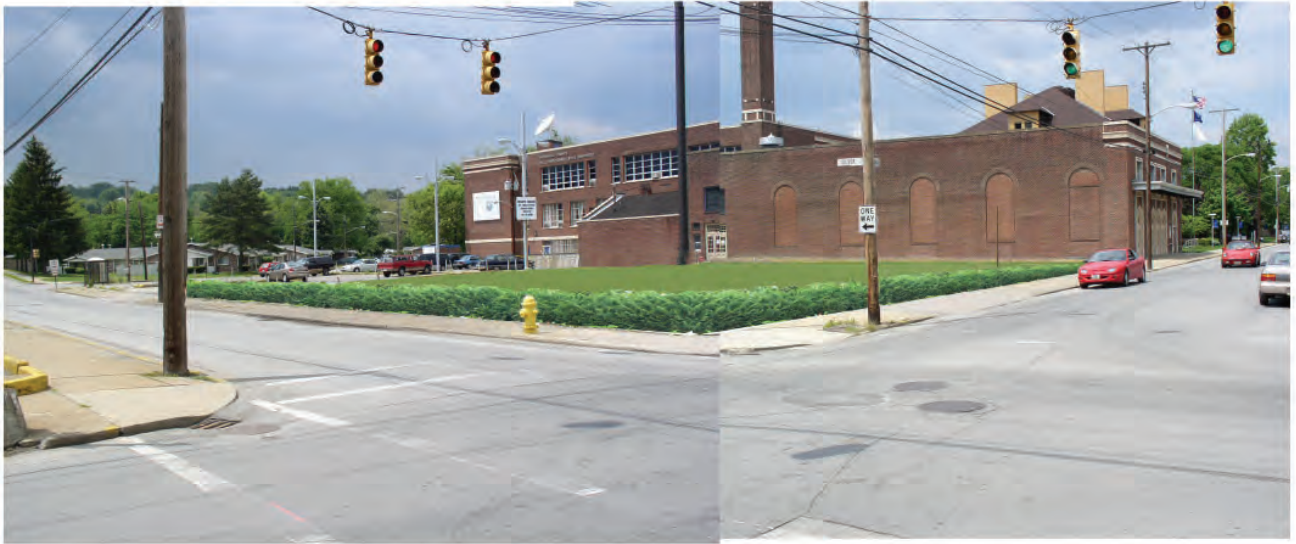
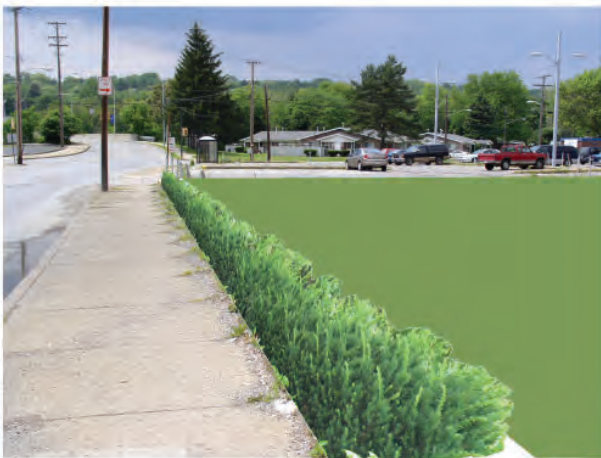
After

The corner of Shenango Avenue and Silver Street is currently occupied by a parking lot in degraded condition. Such an image is not suitable at the main entry to campus.

Upon reaching agreeable lease terms with the current owner, recommend removal of bituminous paving and concrete islands and replacement with a lawn surface and hedge screening. The estimated construction cost range for this project is \$15,000 to \$20,000.
