Penn State  
**Lehigh Valley**

Campus Exterior Architectural Plan  
January 2008

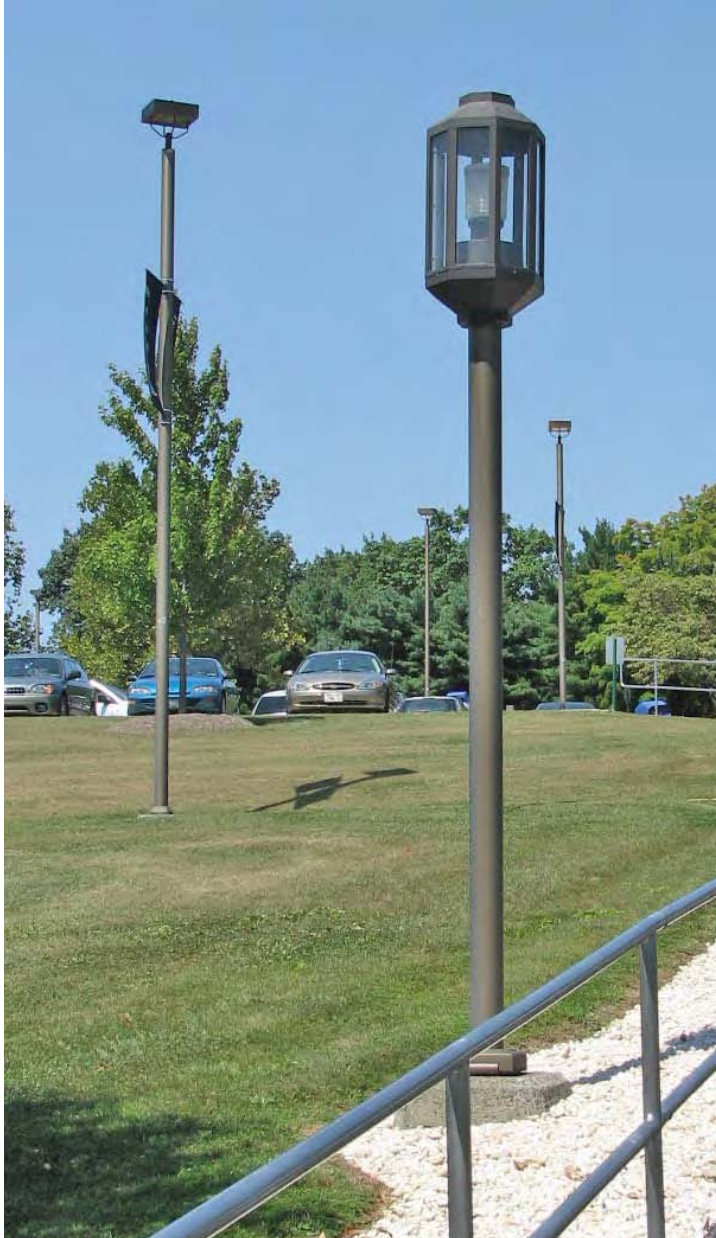
Exterior light styles are uniform across the campus.

Note that the use of cut-off optics are recommended to diminish the effect of light trespass and glare.

Metal halide lamps are also recommended for the quality of illumination they provide.

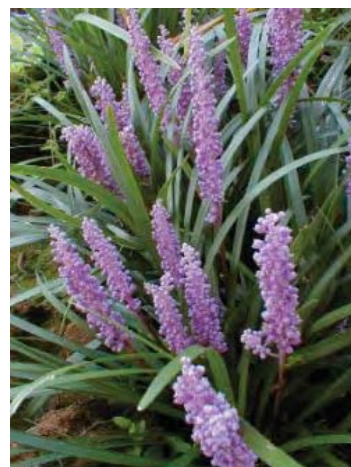
Liriope muscari  
16" oc triangular spacing

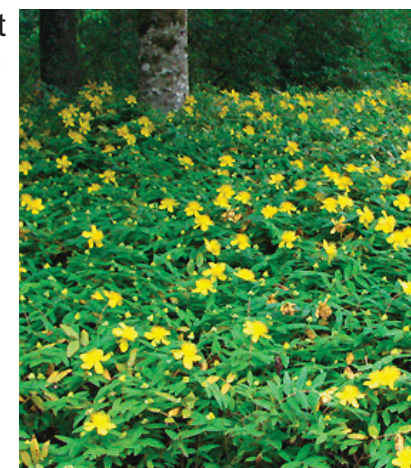
Creeping St. John's Wort  
36" oc triangular spacing

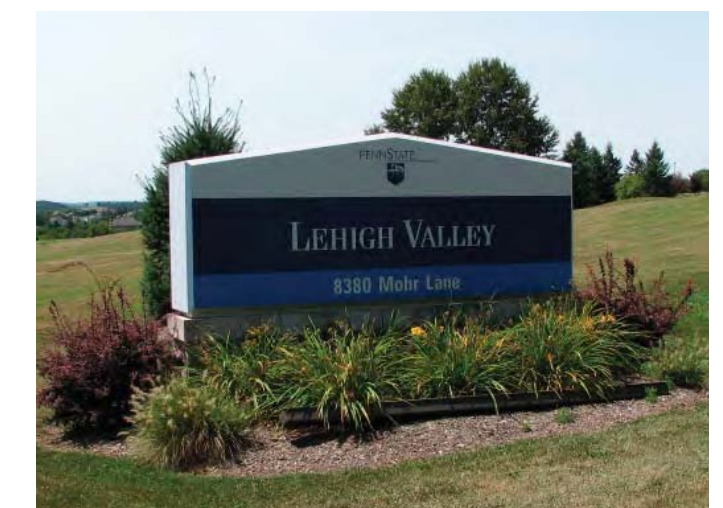
Existing campus identification sign

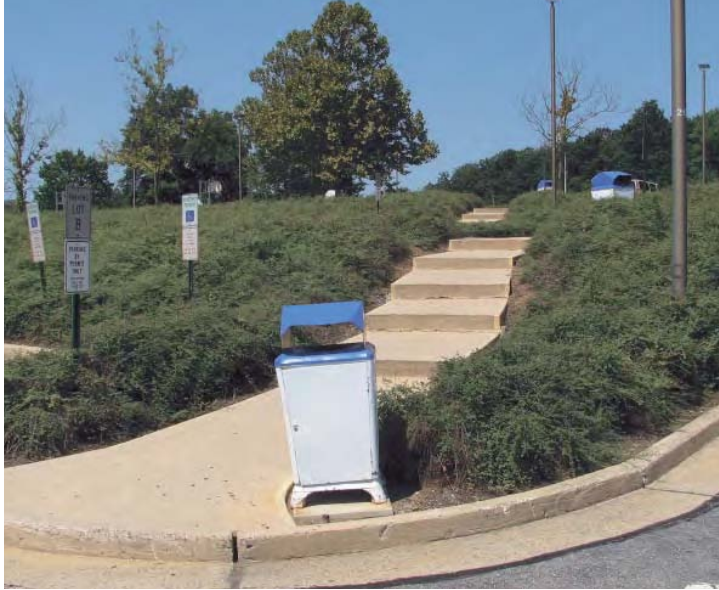
Existing

Safety codes mandate the placement of handrails on the outside edges of exterior stairs.

New handrails should match existing designs on campus.
